# Assessment and Decision Frameworks for Seawall Structures

Appendix  
E

## Case Study Bilgola

## Appendix E Case Study – Bilgola Beach

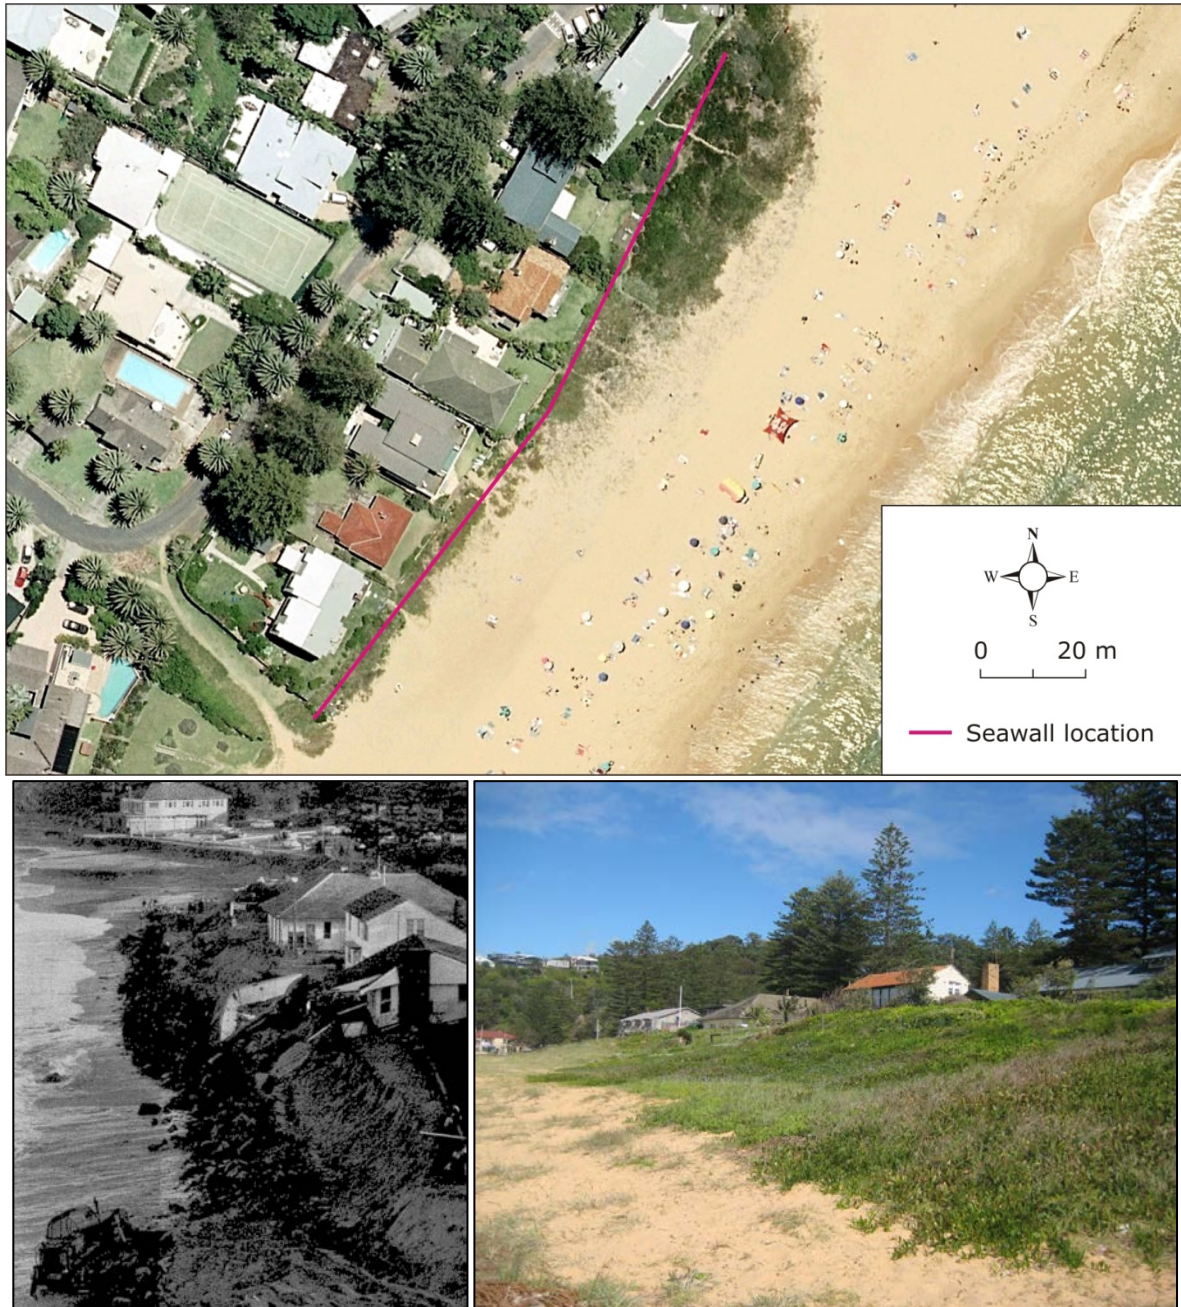
**Figure 2.3 Bilgola Beach Seawall 1 Fronting Allen Avenue Properties**

However, during the storms in May and June 1974, the wall was severely overtopped and several houses were threatened by wave action and inundation. The house at 9 Allen Avenue was badly damaged due to the combined effects of gale force winds and wave overtopping and was demolished (PWD, 1985). A swimming pool at 11 Allen Avenue was also destroyed during these storms, with some of its debris distributed within the seawall. Immediately following this storm, emergency coastal protection works consisting of timber poles (7 Allen Avenue) and sandbags (1 Allen Avenue) were also added to the damaged seawall. More extensive emergency protection works were undertaken in two stages later in 1974 using existing rock from the 1967 works and imported 2.0t basalt rock (Foster 1990). Again, no secondary armour or geotextile underlayer was used, and it is not known if outflanking protection was included in these additional emergency works.

At the time of writing, Seawall 1 was almost entirely buried by the dune (typical dune crest elevation 5.5 to 7.5 m AHD) and its condition was not able to be assessed. No information is available detailing the 'as-built' cross-section, however, data collected by WRL (Mariani and Coghlan, 2012) indicated that the seawall had a slope of 1V:2H or flatter, the crest level of the seawall varied from 5.5 to 6.5 m AHD and the toe level varied from 0 to 1.5 m AHD. It was not possible to determine the number of layers of rock in Seawall 1. In assessing the stability of the seawall, WRL has assumed that the seawall has a slope of 1V:2H, is composed of two layers of rough, randomly placed 2.0 t basalt (density  $\approx 2700 \text{ kg/m}^3$ ) with a porosity of 40 %, a crest level of 6.0 m AHD and a toe level of 0 m AHD.

Seawall 1 Bottom Left: 11 June, 1974 Damaged due to severe storms (Source: PWD, 1985)

Seawall 1 Bottom Right: 10 April, 2012 Buried under vegetated sand dune

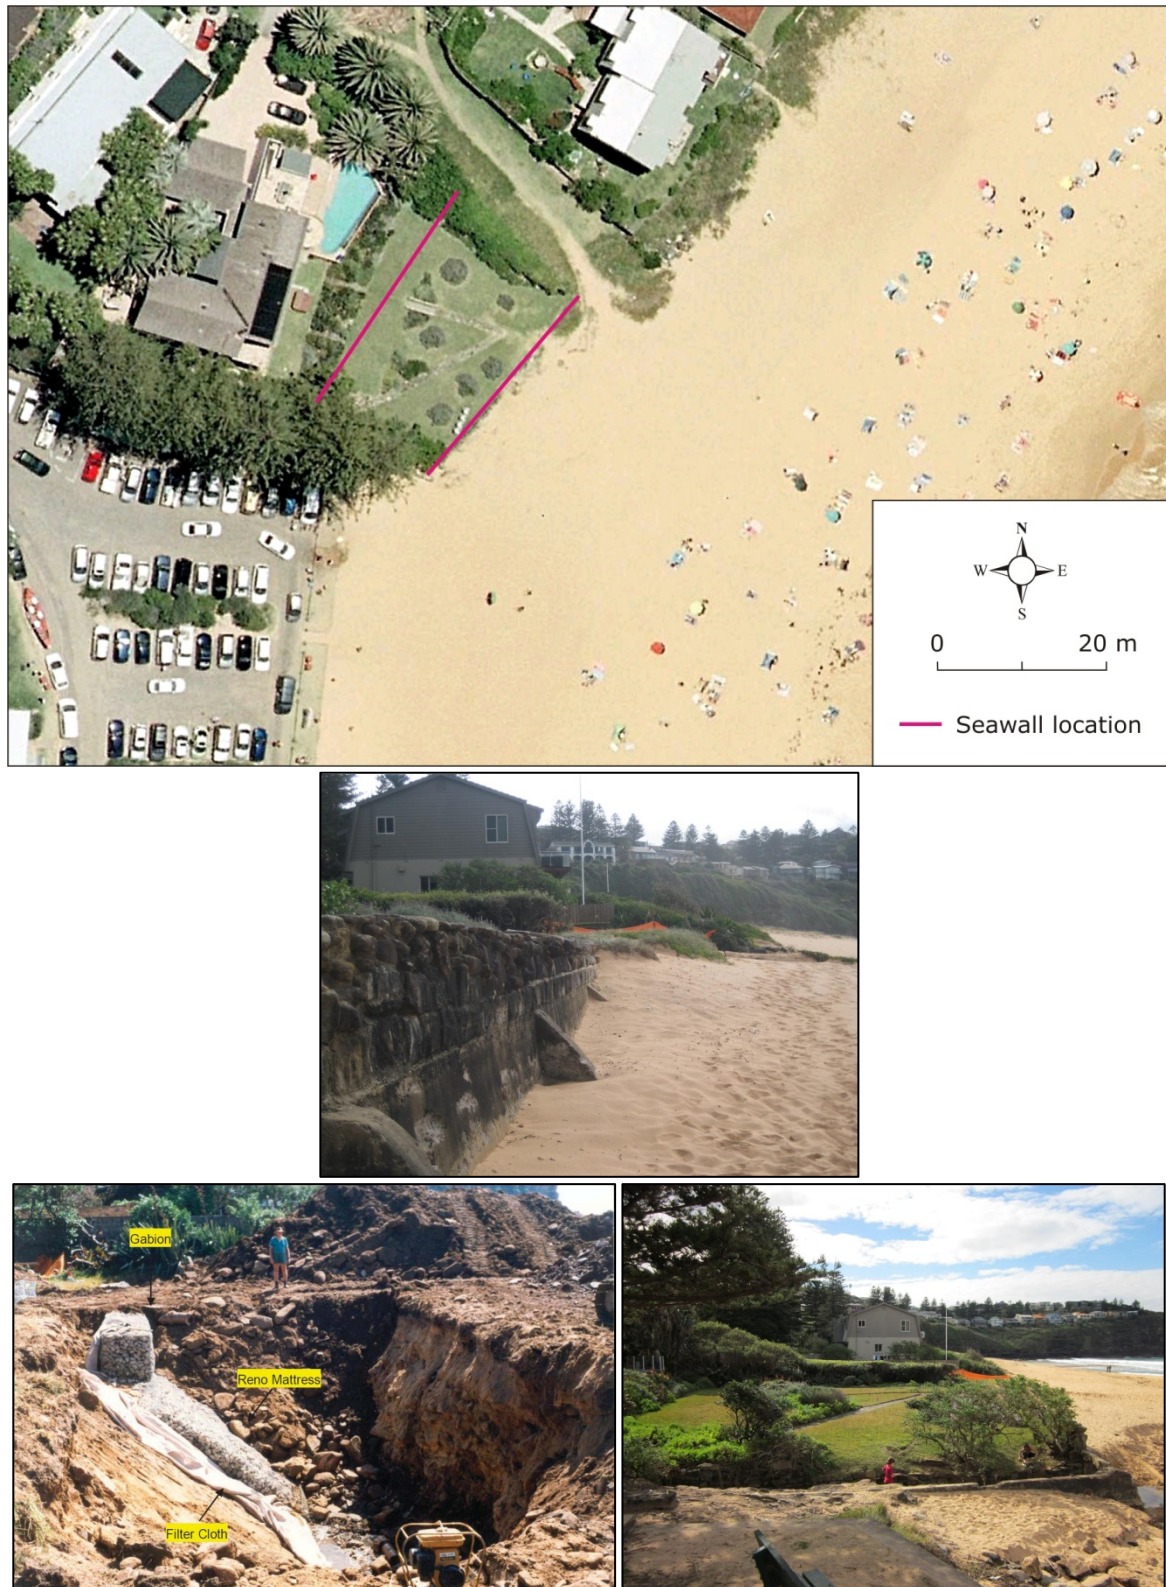
**Figure 2.4 Bilgola Beach Seawalls 2A and 2B Fronting 21 Bilgola Avenue**

Two seawalls are located seaward of the house at 21 Bilgola Avenue. The more seaward structure, Seawall 2A, is a vertical stone and concrete seawall and has been present since at least 1951 (PBP, 2005). This structure has successfully protected this property from erosion since that time. During the storms in May and June 1974, minor damage was reported to Seawall 2A, with wave overtopping of the seawall and deposition of sand landward of the structure (PBP, 2005). During storms in May 1997, the crest of the structure was slightly damaged with several sandstone blocks dislodged and carried landward. During the same storms, sand was washed into the property for a distance of about 10 m landward of Seawall 2A (PBP, 2005). During the overtopping events in 1974 and 1997, it is understood that waves would 'fold over' the crest of the structure and travel as a sheet flow with shallow depth across the property. The seawall was constructed as a buttressed counterfort wall. At least four buttresses (acting in compression against retained soil) with a spacing of approximately 10 m, strengthen and stiffen the wall against overturning forces on its seaward side. An unknown number of counterforts (acting in tension against retained soil) also extend from the wall on its landward side to stabilise Seawall 2 against overturning. The structure has outflanking protection, that is, protection extending landward and perpendicular to the seaward face of the seawall at the ends. PBP (2005) indicates that this seawall has a variable crest level of 4.4 to 4.6 m AHD and a constant toe level of 2.0 m AHD. In assessing the stability of the seawall, WRL assumed that the seawall has a crest level of 4.5 m AHD. No information is available detailing the precise construction of the wall; the exact cross-section is unknown. While of relatively early construction, it is generally in good condition and appears to be performing adequately at the present time.

Seawall 2B is the more landward structure located east of the house at 21 Bilgola Avenue. This structure is a sloping gabion and reno mattress seawall that was constructed underground in 1993. Seawall 2B is the only coastal protection structure on Bilgola Beach which has been designed and constructed to contemporary coastal engineering standards. Although it was recognised that this structure was not designed to provide complete protection in an extreme storm event, its designers asserted that failure of Seawall 2B would not imply loss of the dwelling and would abdicate the requirement for piered foundations (Geomarine, 1993a, 1993b and 1993c). The designers also asserted that Seawall 2B would not exacerbate erosion at neighbouring public and private properties due to the protection offered by existing seawalls (Seawalls 1 and 3) and its footprint being located further landward. The conceptual design drawings indicate that Seawall 2B has a crest elevation of

Seawall 2A Centre: 11 April, 2012

Seawall 2B Bottom Left: October, 1993 (Source: PBP, 2005) Bottom Right: 1 July, 2012

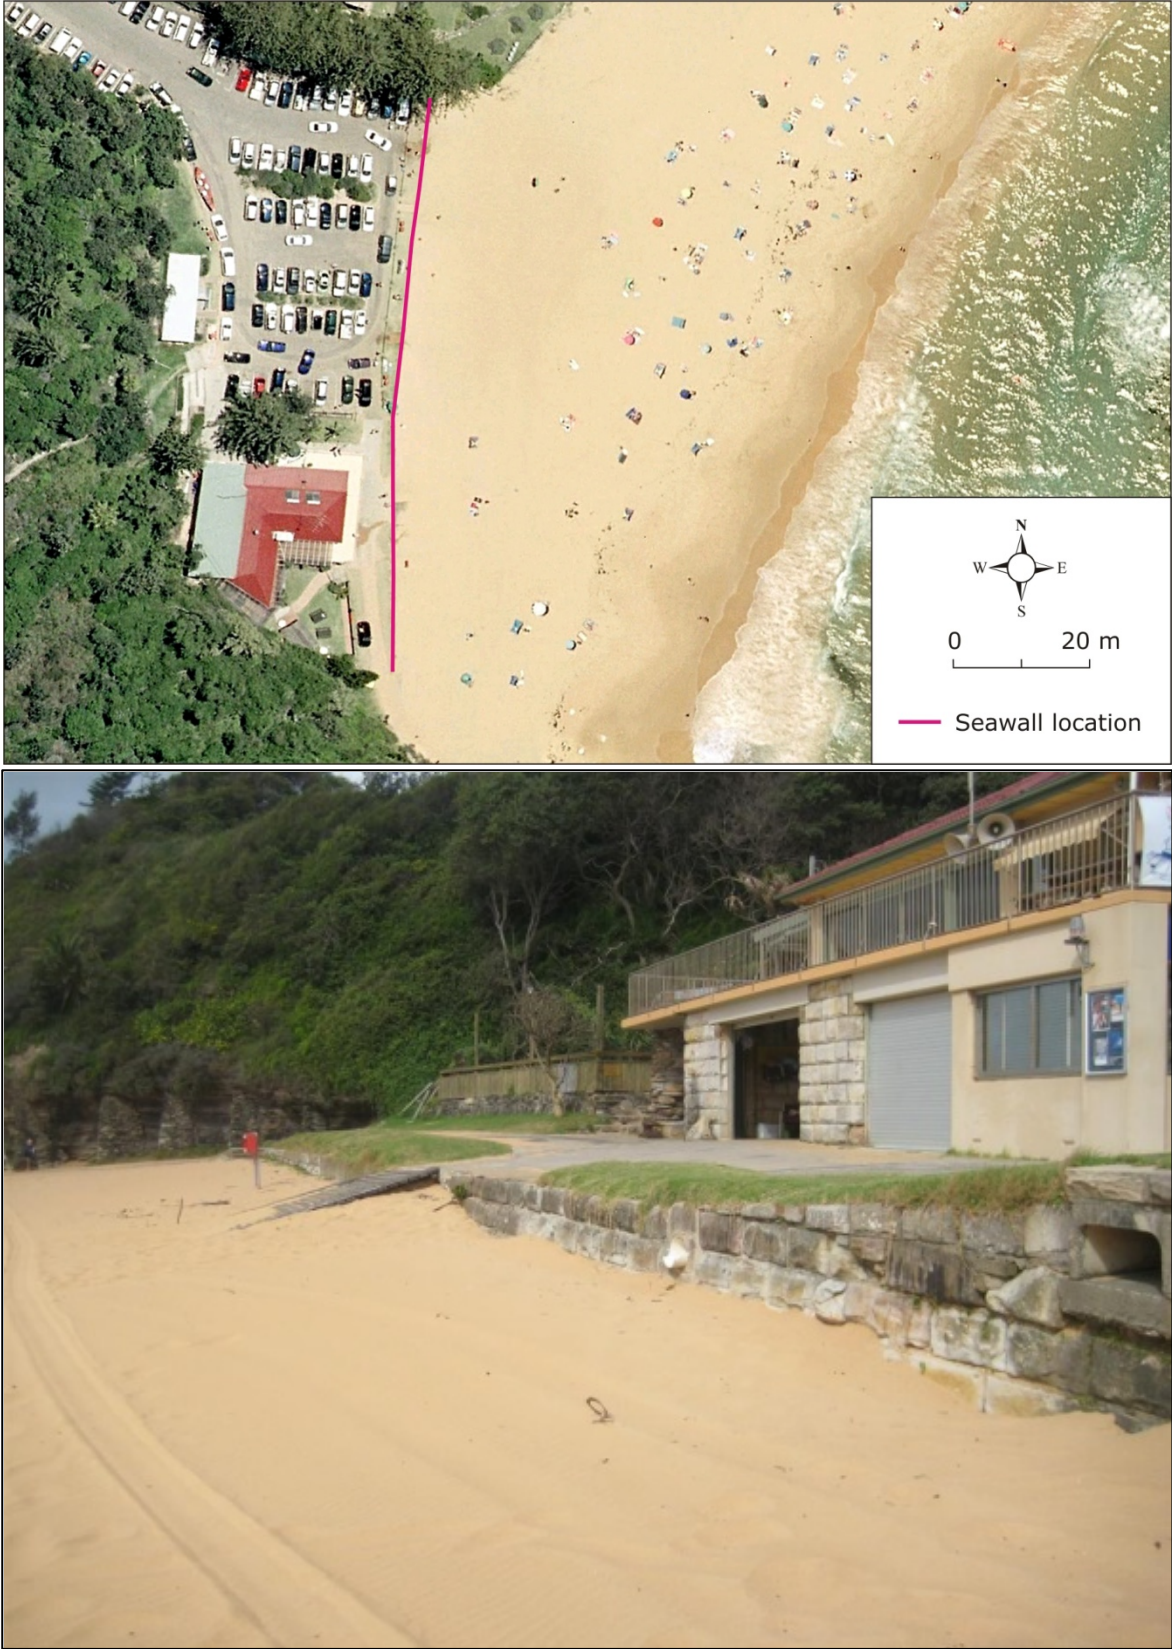
Figure 2.5 Bilgola Beach Seawall 3 Fronting Bilgola SLSC 10 April, 2012

Seawall 3 is located seaward of Billies Café, a car park and Bilgola SLSC. This vertical stone gravity structure is composed of dressed or cut sandstone blocks and was constructed in the late 1950s (Gordon, 1989). The seawall was damaged (with some blocks and steps dislodged) during the storms in May and June 1974 (Foster et al, 1975). During storms in May and June 1978, toe protection for the wall was exposed by erosion (PBP, 2005). During storms in May 1997, Seawall 3 was overtopped by waves causing damage to the Bilgola SLSC roller doors and some equipment in a ground floor storage area (but there was no damage to the building structure) (WorleyParsons, 2012b). Parts of the seawall were cosmetically upgraded (the sandstone capping was replaced) in the late 1990s along with the construction of steps (PBP, 2005). Exposure of the structure to outflanking is minimal, with the wall bordered by a mortared sandstone and concrete drain in the north (Bilgola Creek) and the promenade/seawall located between the southern end of Bilgola SLSC and the swimming pool in the south (PBP, 2007). Data collection by WRL (Mariani and Coghlan, 2012) indicated that the seawall has a variable crest level of 4.5 to 5.0 m AHD, a constant toe level of approximately 2 m AHD and toe protection in the form of flat rock blocks (high length-to-thickness ratio) densely placed in a double layer at approximately 3.0 m AHD. In assessing the stability of the seawall, WRL assumed that the seawall has a crest level of 5.0 m AHD. No information is available detailing the precise construction of the wall; the exact cross-section is unknown. While of relatively early construction (late 1950s), it is in reasonable condition and appears to be performing adequately at the present time.

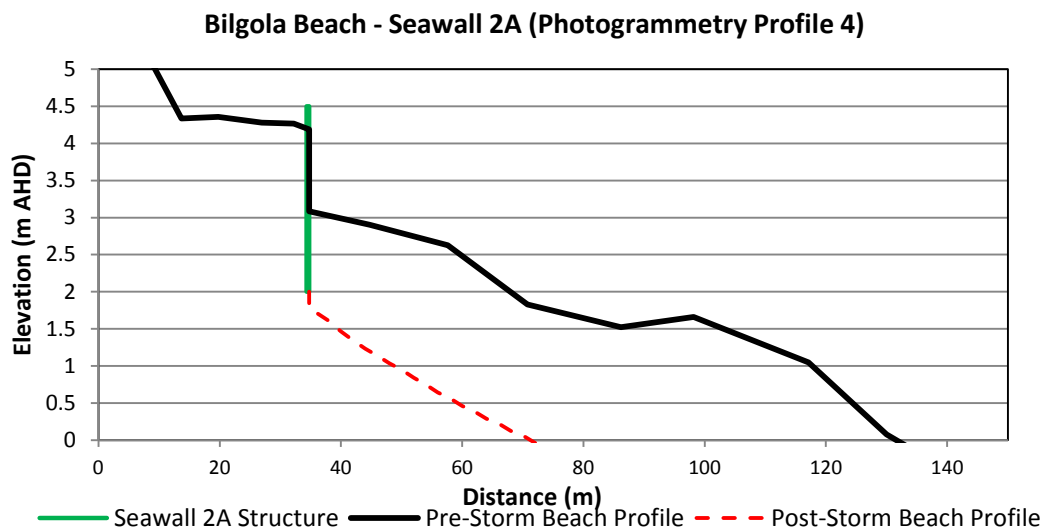
Figure 2.11 Example SBEACH Erosion Modelling for 100-year ARI Event on Seawall 2A

Profile response to the design events was assessed at three locations along Bilgola Beach coinciding with the four seawall structures. Pre-storm beach cross-sections were based on 2008 photogrammetry profiles 7 (Seawall 1), 4 (Seawalls 2A and 2B) and 1 (Seawall 3). These profiles provide just a single snapshot, and would in fact be changing in time. It should be emphasised that modelled scour levels are specific to the pre-storm beach profile conditions. However, a more eroded pre-storm profile would likely asymptote to equilibrium dissipative more quickly and therefore have smaller sand volume changes than those shown in Table 2.13. For those structures with multiple photogrammetry profiles, Seawall 1 (profiles 5 to 11) and Seawall 3 (profiles 1 to 3), WRL only considered one representative profile in assessing the stability of the seawall with respect to toe undermining. Note that profile 7 for Seawall 1 is co-linear with Section 13 from Mariani and Coghlan (2012). An example of model input and output with a seawall in place (such that erosion of the dune is prevented), is shown in Figure 2.11 for Seawall 2A. This illustrates that the predicted 100-year ARI (present day) scour level at Seawall 2A is approximately 1.8 m AHD and indicates undermining of the structure toe by 0.2 m.

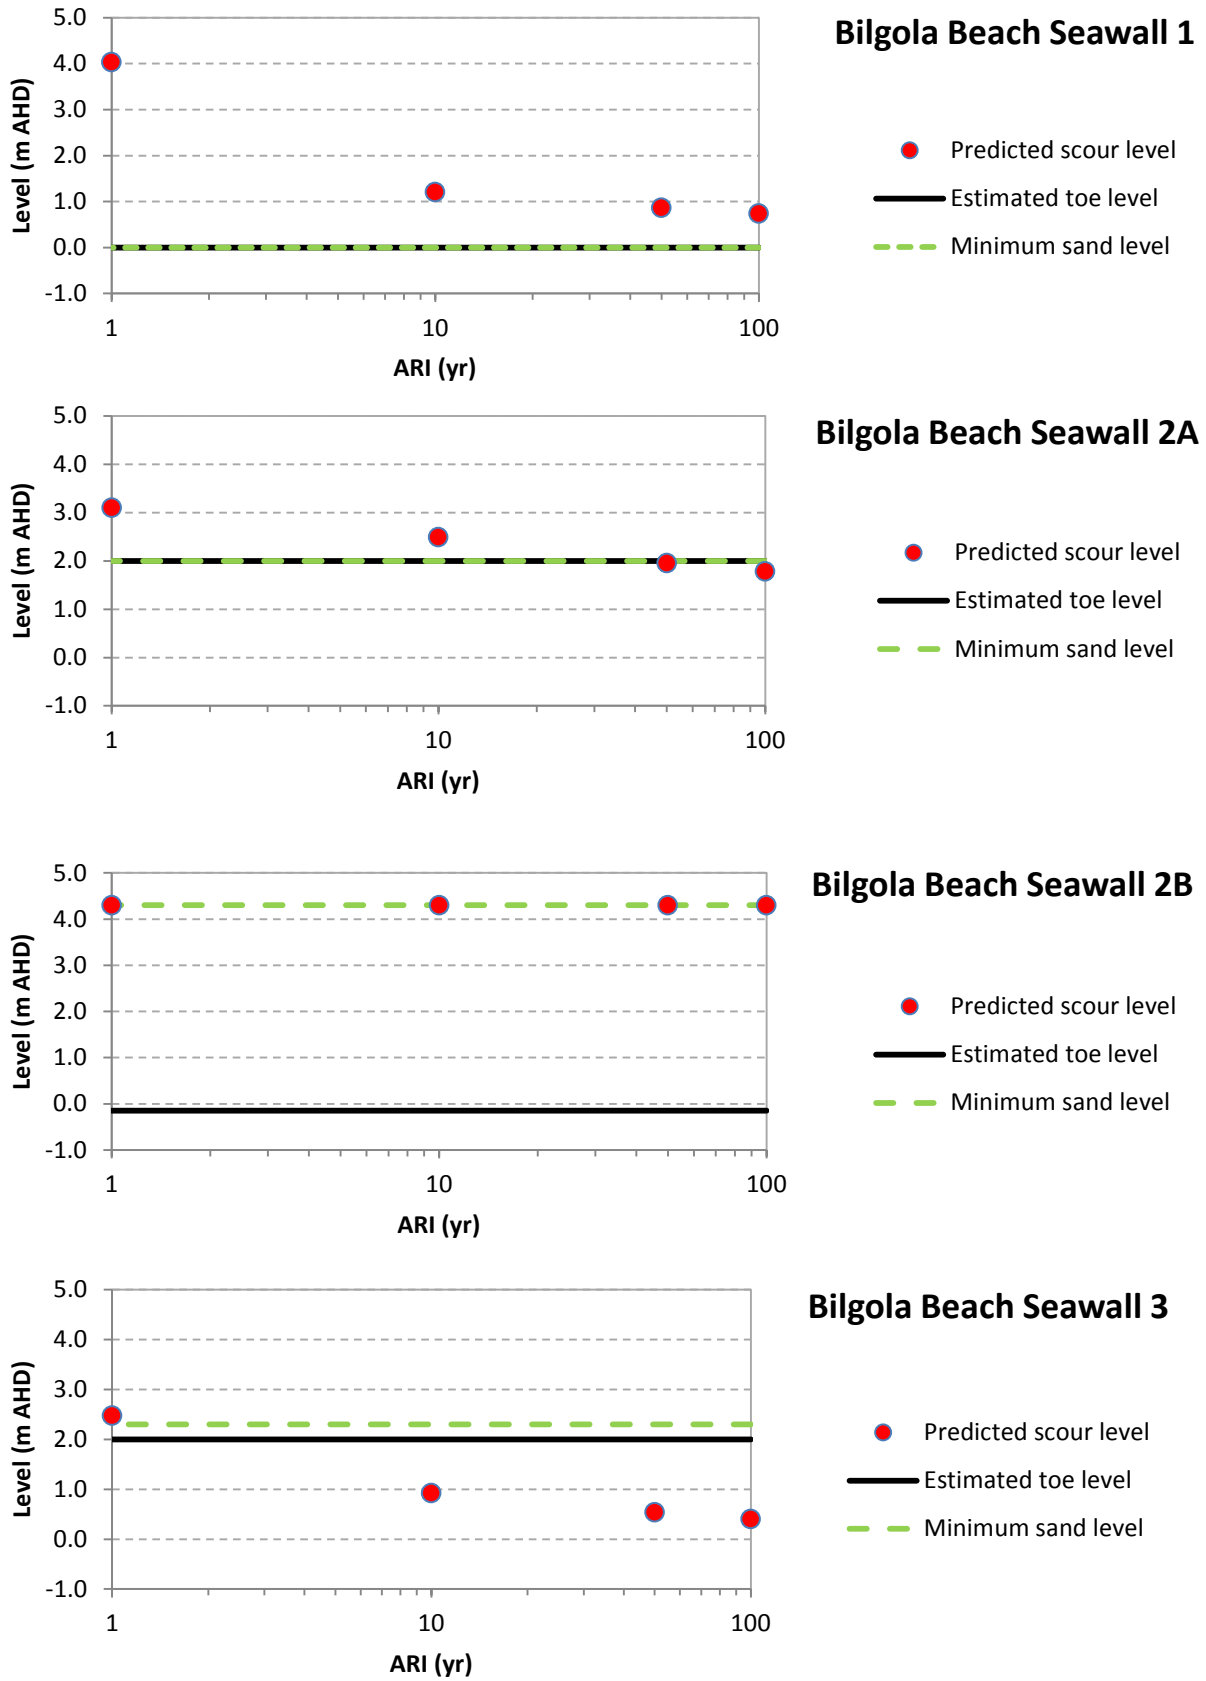
Figure 2.12 Comparison of Predicted Scour Levels with Existing Toe Levels

While WRL has selected the 100-year ARI event as the ‘design’ condition for each of the seawalls, scour for more frequent storms (1-, 10- and 50-year ARI events) was also assessed and are presented in Table 2.15. Based on the scour predictions, Seawalls 1, 2A and 2B are not at risk of toe undermining from these more frequent storms. However, Seawall 3 is at risk of being undermined during all present-day modelled storms except for the 1-year ARI event.
