# Antifouling Technologies for Coastal Pools and Platforms

## Project outline and specifications, February 2009

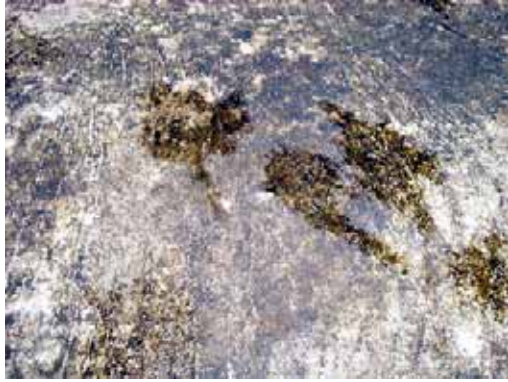
**Photo 1**

The concrete promenade on the southern and northern sides of Clovelly Bay is extensively fouled by black micro-algae (probably a blue-green alga). The fouled concrete is not slippery when it is dry but becomes extremely slippery when wet (photo 1). The growth of the micro-fouler occurs across the whole southern promenade but is more pronounced and of particular concern near the edges of the promenade adjacent to the bay. Problem areas of the promenade are cleaned (jet-blast with water) at approximately 3 weekly intervals (photo 2).

**Black micro-fouler on concrete promenade at Clovelly Bay. Note wet versus dry patches in photo 1 (slippery when wet). Compare area cleaned by jet blaster versus fouled area of promenade in Photo 2.**

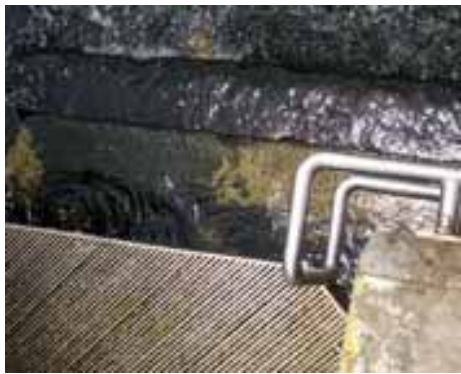
**Photo 3**

**Concrete steps in Clovelly bay heavily fouled with green algae (photo 3). Large concrete step after cleaning with jet blaster (photo 4)**

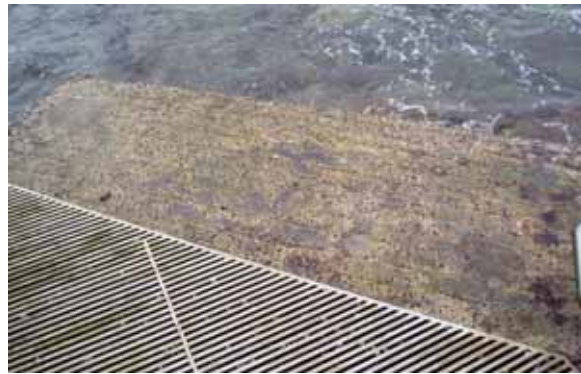
**Photo 4**

There are 5 access points (stair wells) into Clovelly Bay from the southern promenade and 4 access points from northern promenade. The access points are a set of stainless steel steps leading down to the waters edge. There are concrete steps at the bottom of the stainless steel steps which are submerged most of the time and get fouled with green algae (*Ulva lactuca* / *Enteromorpha sp.*) within a week or two of cleaning. These fouled concrete steps are extremely slippery and present a very real hazard for bathers entering or leaving the water (photo 3). The concrete steps are only accessible for jet-blast cleaning when the tide, sea conditions and public activity allow. The usual period between cleaning is approximately every 4-6 weeks (photo 4).

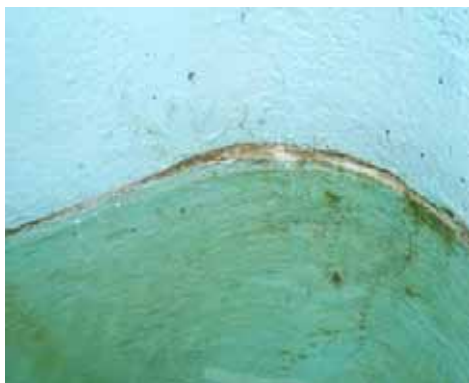
**Photo 5**

The concrete pool is painted with standard blue pool paint. Pool surfaces get fouled with green algae (photo 5) and become slippery within a week or two of cleaning. Kelp and sand also collect in the pool. The pool gets cleaned approximately 3 times per month by scrubbing with a broom. When the pool is filled with sand and kelp seaweed after a storm the pool is drained to help cleaning. When this occurs the pool sides and floor is jet-blasted to remove the algal fouling. This occurs approximately once a month. Pool maintenance would be greatly reduced if pool surfaces were not fouled.

**Fouling of pool surfaces by green algae**

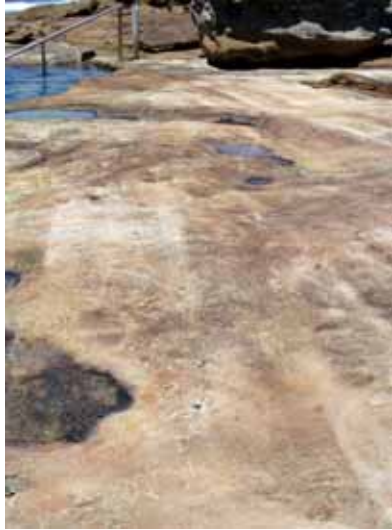
Mahon rock pool in Maroubra is a predominantly natural sandstone structure located on the oceans edge. There is a concrete walkway around the pool but the majority of surfaces (surrounds, walls, floor, steps) are sandstone. Black micro-algae grow on the concrete and sandstone areas surrounding the pool (photo 6). These areas are jet blasted as necessary, usually once a month. There are 3 sets of concrete/sandstone steps at the western end of the pool which get heavily fouled by green algae (photo 7). This rock pool seems to experience heavier fouling on submerged surfaces. The pool and steps are scheduled for cleaning once a month.

**Photo 6 – Sandstone platform at western end of Mahon Pool showing black micro-fouler**

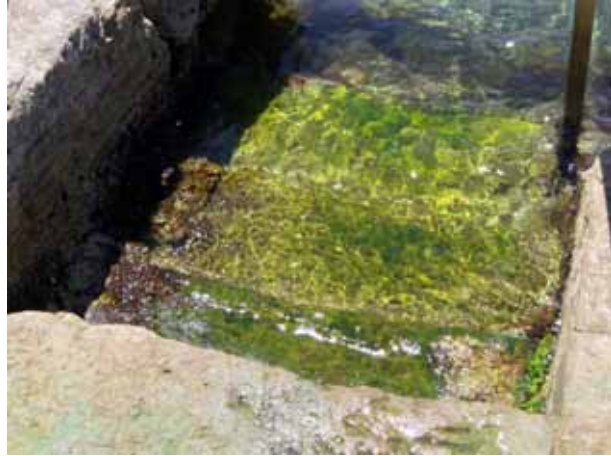
**Photo 7 – Steps in Mahon pool heavily fouled by green algae**

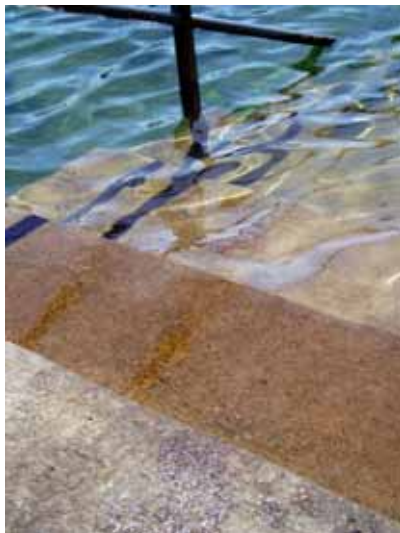
**Photo 8 – Steps in Malabar rock pool fouled by brown algae**

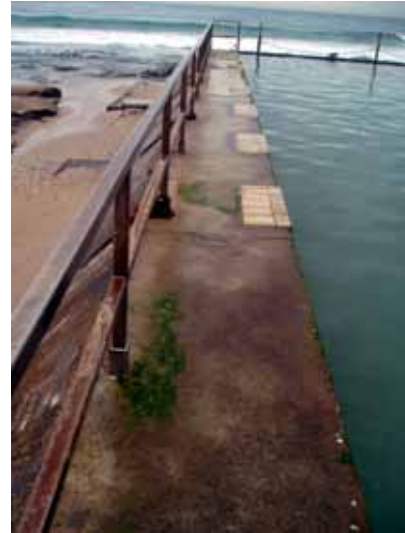
Cronulla rock pool is the most popular rock pool in the area. It experiences similar fouling conditions to the rock pools described for the Randwick area with a few notable differences. The main slip hazard here is the NW corner of the pool where the pool surrounds are constantly wet as it is the lowest point in the pool design. Access stairs are also in this corner and consequently it is a high use area. The concrete surface in this NW corner gets heavily fouled by brown and green algae (photo 9) which is extremely slippery. This area is usually cleaned every fortnight by scrubbing with a hard brush and a granular solution. Sometimes the area is cleaned by jet blasting but it is difficult to get the equipment to this area. Council staff consider jet-blasting to be an ineffective cleaning method due to rapid regrowth of fouling organisms (within 2 weeks of cleaning).

**Photo 9 – Northern edge of Cronulla rock pool fouled by brown and green algae**

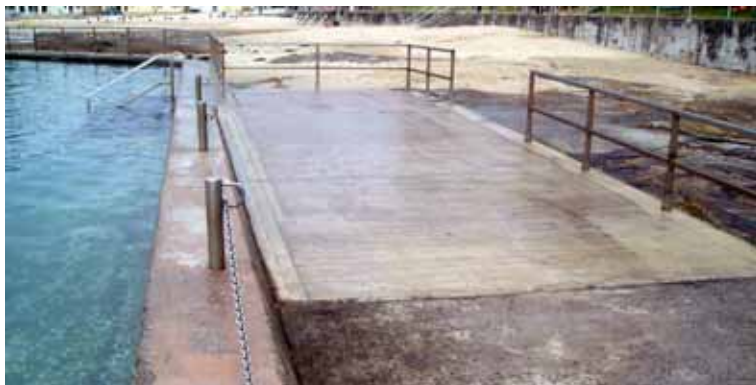
There is a large concrete access ramp on the western side (photo 10) which becomes very slippery when fouled by brown-orange micro-algae. Fouling is removed using a concrete grinding machine which removes the top layer of concrete. This procedure has proved to be effective for up to 6 months, depending on fouling pressure (i.e., sea and weather conditions). The steps in the pool are covered with thick black rubber which gets heavily fouled by green algae but the fouled rubber steps are not as slippery as fouled concrete steps found in other rock pools. These steps are cleaned by scrubbing with a hard brush and a granular solution when the pool is emptied for cleaning (every 2-6 months, depending on fouling pressure) and perhaps once in between pool cleans if necessary. Hard-fouling organisms such as oysters grow more abundantly in the rock pools in the Shire but are not a common fouling organism in the Randwick area. These are scraped off the vertical pool surfaces with a shovel when the pool is emptied for cleaning.

**Photo 10 – Access ramp at Cronulla rock pool gets fouled by microalgae**
