Antifouling Technologies for Coastal Pools and Platforms

Final Report on Field Trial (March-June 2009)

Written by Dr Rebecca Swanson

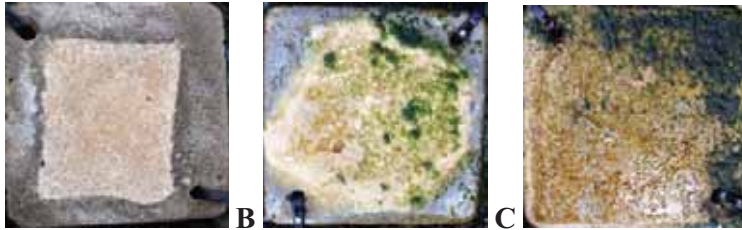
Photo 4 – Clovelly Bay Step

- Three out of five W1 blocks were lost in the first 2 weeks. Changes to W1 block design and attachment method should reduce loss of blocks in next trial
- One W1 block showed a low level of fouling by *Ulva* sp. at 4 weeks with no fouling observed on the 'sheared' W1 block. Control blocks showed a low-medium level of fouling at 4 weeks (Photo 4)
- The only remaining W1 block ('sheared') had low level fouling at 6 weeks with very little fouling actually growing on wax/sand inlay (Photo 5A). By 8 weeks, the outer concrete border of W1 block was completely fouled while the inner wax/sand inlay showed a low level of fouling (Photo 5C)
- Control blocks were heavily fouled at 6 weeks and completely fouled at 8 weeks (Photo 5B, D)

W1 blocks (A, B) and a control block (C) after 4 weeks.

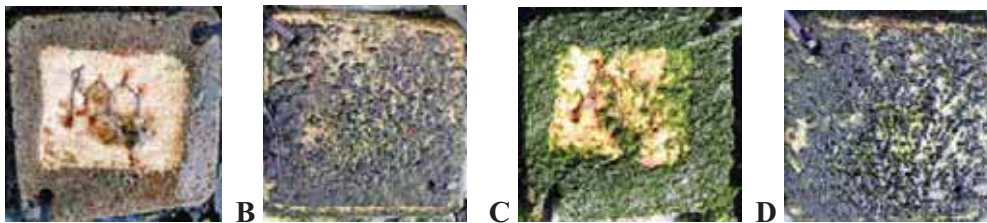
Photo 5 – Clovelly Bay Step

Last remaining W1 block (A) and a control block (B) after 6 weeks, note very little fouling on wax-sand inlay. W1 block (C) and a control block (D) after 8 weeks, note low level fouling on wax-sand inlay relative to concrete surround.

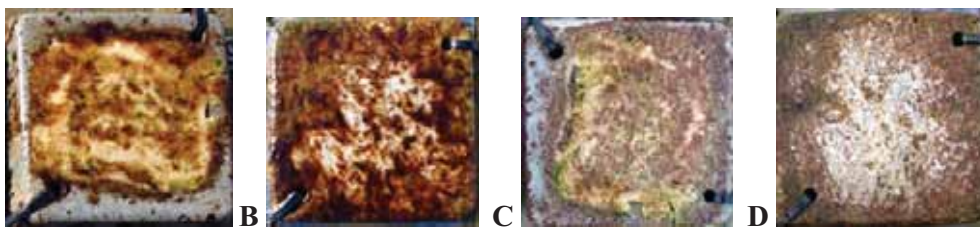
Photo 6 – Clovelly Bay Promenade

Last remaining W1 block (A) and a control block (B) after 11 weeks, note different species of fouling algae than that growing on step, and wet appearance of algae. Same W1 block (C) and control block (D) at 12 weeks, note dry appearance of algae.

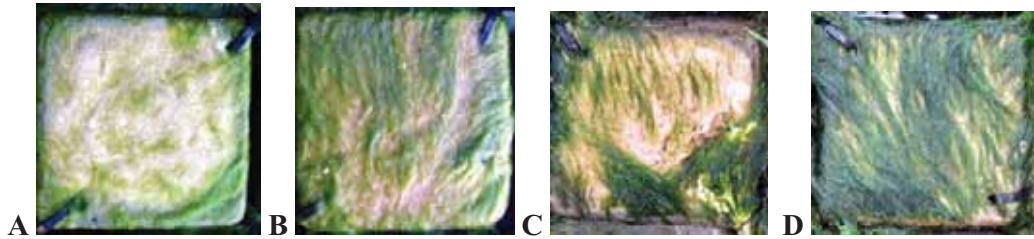
Photo 7 – Malabar Rock Pool

W1 block (A) and a control block (B) after 3 weeks. The least fouled W1 block (C) and a control block (D) after 12 weeks. Note that the heavy growth in bottom right hand corner of W1 block (C) originates from a crack in wax inlay and from the concrete border.

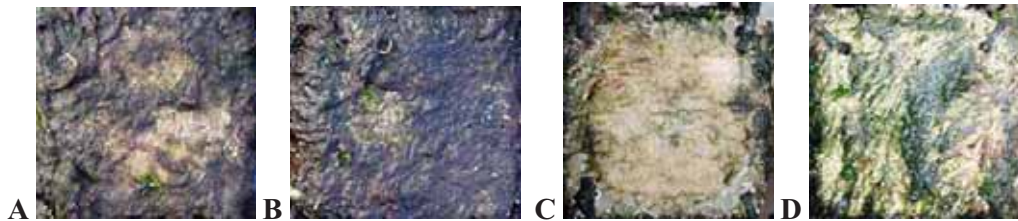
Photo 8 – Rozelle Bay Marina

Adhesion tests found algae to be firmly attached to W1 blocks at the conclusion of the experiment at Clovelly and Malabar i.e., negligible amounts of algae were removed by hosing at pressures up to ~160 kPa. The exception was W1 blocks from Rozelle bay: algae were not firmly attached to these blocks. Fouling was loosely attached to W1 blocks at the end of the experiment at 18 weeks and could be removed by hand and by hosing at house-mains pressure (Photo 8C). Considerably less fouling was removed from control blocks by hosing (Photo 8D).

W1 block (A) and a control block (B) after 5 weeks. Fouling algae was only loosely attached to W1 blocks at 18 weeks as some fouling could be rubbed off by hand and most fouling was removed by hosing (C). Algae attached more strongly to controls although some fouling was removed by hosing (D).

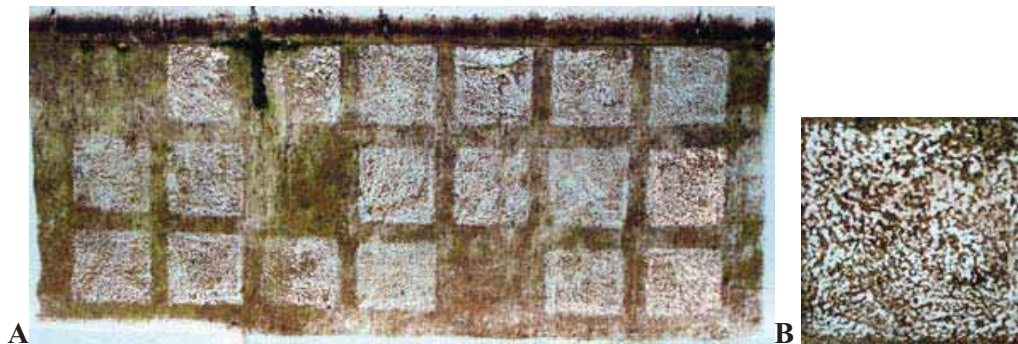
Photo 9 – Clovelly Bay Pool

The direct application of wax-based formulations on standard pool surface (pool paint, A) after 4 weeks. Squares represent test areas and areas bordering squares are untreated. One test square of W1 is shown up close (B). White areas are the raised surface where wax is attached which remain free of fouling

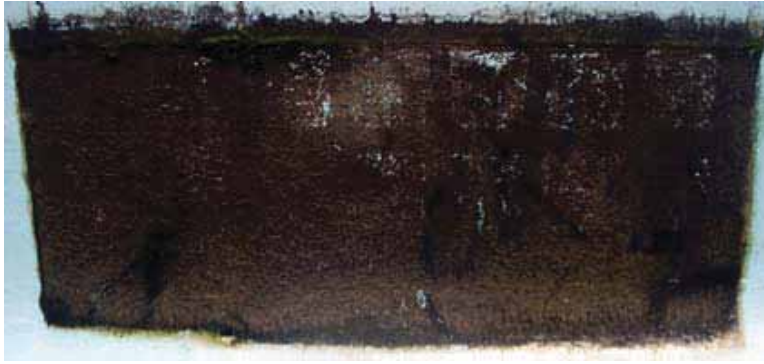
Photo 10 - Clovelly Bay Pool

The direct application experiment after 9 weeks. Whole test area is heavily fouled with very few white patches (wax) remaining free of fouling

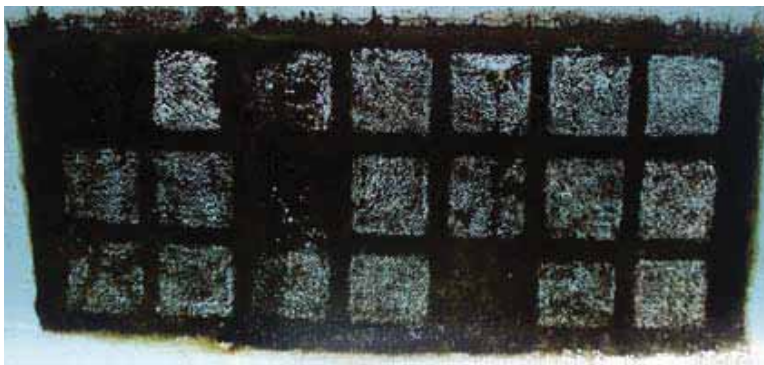
Photo 11 - Clovelly Bay Pool

The direct application experiment after 9 weeks after hosing at house-mains pressure. Even though test areas became fouled, fouling attaches loosely to wax-based coating and can be removed by hosing. Edge effects may have contributed to heavy fouling on test areas.

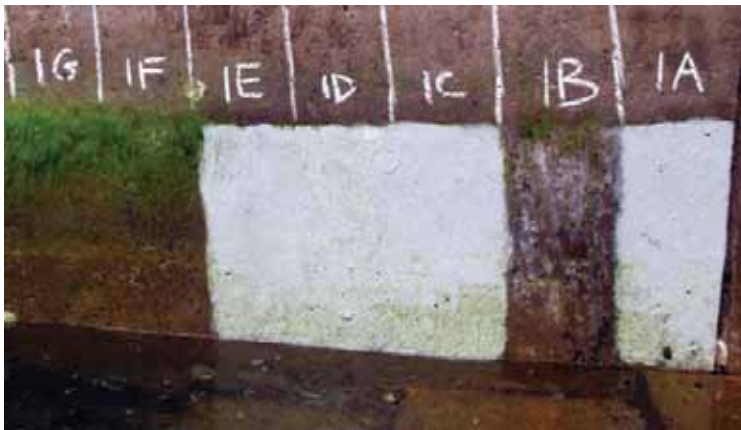
Photo 12 – Malabar Pool Wall

- W2 panels were not fouled at all at 3 weeks while control panels were lightly-moderately fouled (Photo 12)
- Algal growth on all test and control panels was reduced to almost zero at 5 weeks, probably removed by the large swell/seas of the previous fortnight
- At 8 weeks, W2 panels were lightly-heavily fouled (Photo 13) depending on their position in the test area. On moderately-heavily fouled panels, there was little fouling in sections of panels where wax was still attached (Photo 13, 14)
- Control panels were only lightly fouled however they were almost 2 metres away where adjacent test panels were also only lightly fouled. Fouling showed localised variation in this test area which spanned 4 metres
- Similar fouling patterns were observed at 12 weeks (as at 8 weeks) for W2 and control panels.
- No antifouling effects of W2 were observed at 15 weeks

A section of the direct application experiment at 3 weeks. Panel 1B is W1 (note white flaky appearance of W1). Panel 1D is W2 (wax on top of non-slip paint). Note very little fouling on panels 1B, 1D whereas other test panels (1F, 1G) have heavy growth in upper portion of panel. Control panels not shown but similar to panels 1F, 1G.

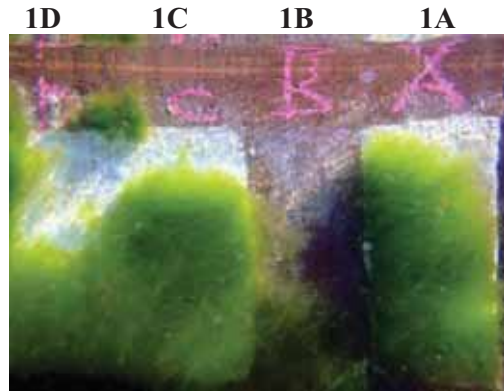
Photo 13 – Malabar Rock Pool

A section of the direct application experiment at 8 weeks. Panel 1B is W1, note no fouling in upper part of panel where wax attached. Panel 1D is W2, note no fouling in upper part of panel where wax attached. Note heavy fouling on other panels 1A, 1C which are non-slip paint

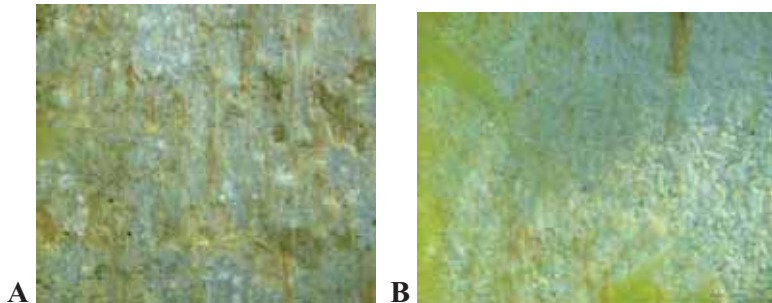
Photo 14 – Malabar Rock Pool

The upper portion of W1 panel 1B (A) and of W2 panel 1D (B). Note very little algal growth here where wax still attached.

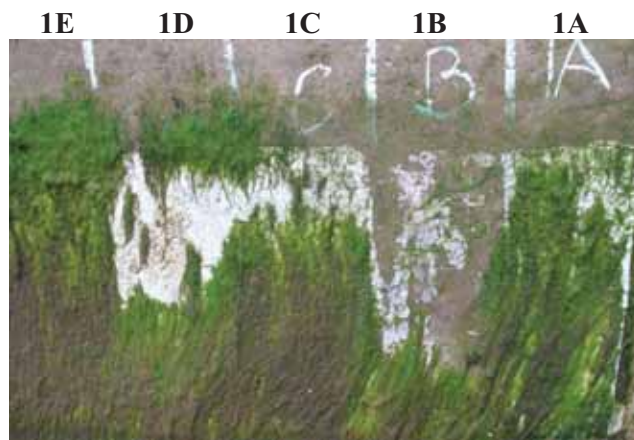
Photo 15 – Malabar Rock Pool

A section of the direct application experiment at 12 weeks. Panel 1B is W1, note very little fouling in upper part of panel where wax attached. Panel 1D is W2, note very little fouling in upper part of panel where wax attached. Note heavy fouling on other panels 1A, 1C which are non-slip paint

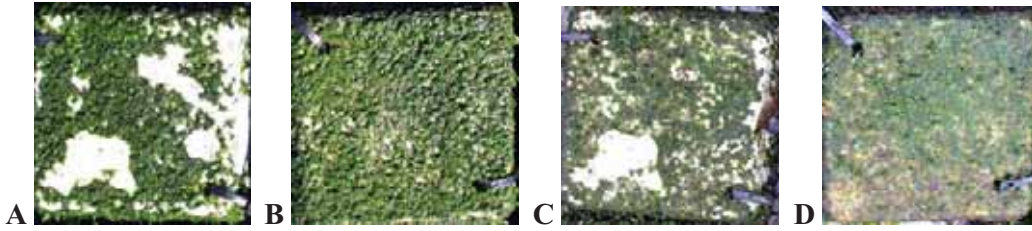
Photo 16 – Clovelly Bay Step

W2 blocks at 8 weeks (A) and at 12 weeks (C). Note that white areas on blocks are where wax is still attached to block. No fouling is attached to patches of wax in (A) whilst larger wax patch is free of fouling in (C). Control block completely fouled at 8 weeks (B) and at 12 weeks (D).

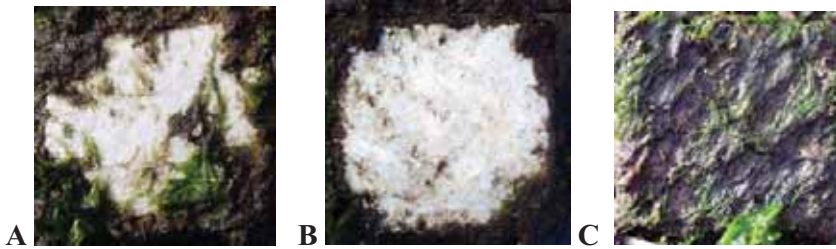
Photo 17 – Rozelle Bay Marina

The most fouled W2 block (A) and least fouled W2 block (B), and a heavily fouled control block (C), at 9 weeks. Note fouling on A was loosely attached and could be removed by hand

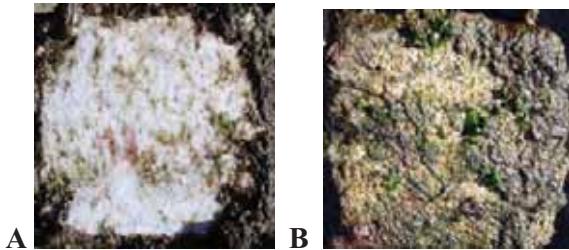
Photo 18 – Rozelle Bay Marina

A W2 block (A) and a control block (B) at 18 weeks. Blocks were cleaned by pouring water over them and gently swishing hand over block surface to remove layer of scum on surface of blocks. Note that some algae growing on control blocks has dyed since 9 week photographs.

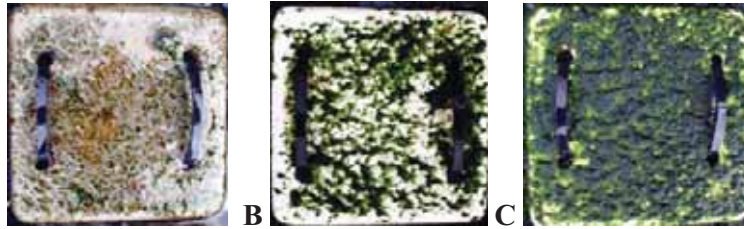
Photo 19 – Clovelly Bay Step

- Grey/green dots started to appear on X1 blocks at 2 weeks covering <5% of surface. No fouling was observed on control blocks.
- X1 blocks showed low-moderate fouling at 4 weeks with tufts/filaments of the green alga *Ulva* sp. (Photo 19B), which appear to have grown from grey/green dots observed at 2 weeks
- Most control blocks had very little fouling at 4 weeks but one control was moderately fouled (Photo 19A)
- X1 blocks and controls showed low-moderate fouling at 6 weeks
- X1 blocks were heavily fouled by 8 weeks while controls showed low-heavy fouling (Photo 20A, B)

- X2 blocks were covered with small grey dots at 2 weeks, more so than X1 blocks. No fouling was observed on control blocks.
- X2 blocks showed heavy-complete fouling at 4 weeks with tufts/filaments of the green alga *Ulva* sp. (Photo 19C)
- Most control blocks had very little fouling at 4 weeks but one control was moderately fouled (Photo 19A)
- X2 blocks were completely fouled by 6 weeks while controls showed low-moderate fouling (Photo 20C, at 8 weeks)

A control block (A), X1 block (B) and X2 block (C) after 4 weeks

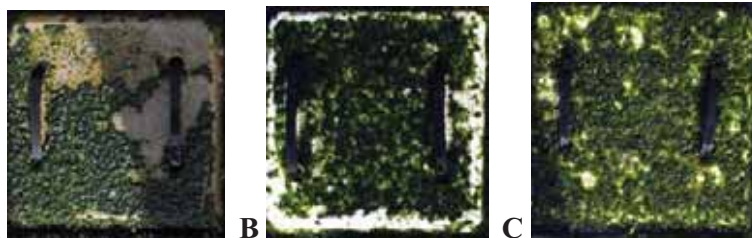
Photo 20 – Clovelly Bay Step

A control block (A), X1 block (B) and X2 block (C) after 8 weeks

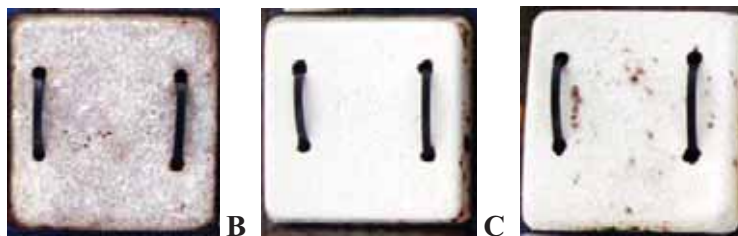
Photo 21 – Clovelly Bay Promenade

- The edges of X1 and control blocks began to foul with red and green algae at 10 weeks, probably because the edges of blocks remain moist for longer than the surface (seen in Photo 21B at 13 weeks)

- The edges (but not the surface) of X2 and control blocks began to foul with red and green algae at 10 weeks, probably because the edges of blocks remain moist for longer than the surface (seen in Photo 21C at 13 weeks)
- The surface of X2 blocks began to foul with red algae by 13 weeks. Control blocks were not fouled at 13 weeks (Photo 21A, C).

A control block (A), X1 block (B) and X2 block (C) after 13 weeks. Note algal growth only on edges of X1 block (B) and red algae growing on surface and edges of X2 block (C).

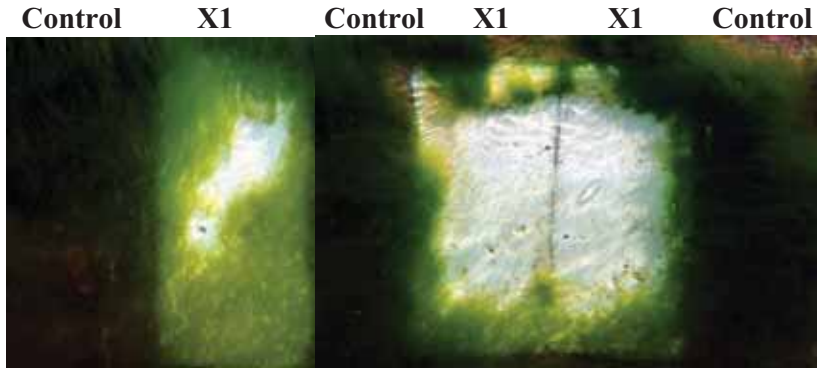
- X1 panels (2/3) remain largely without fouling at 5 weeks while adjacent control panels were heavily fouled. One X1 panel was heavily fouled but this panel was completely surrounded by heavy fouling therefore edge effects may have increased degree of fouling in this panel (Photo 24)
- Similar results for X1 and control panels were observed at 9 and 12 weeks (Photos 25, 26)

Two X1 panels show low level fouling at 5 weeks despite heavy algal growth on adjacent control panels. Note that the heavily fouled X1 panel was completely surrounded by dense algal growth so ‘edge effects’ may explain heavier fouling in this panel.

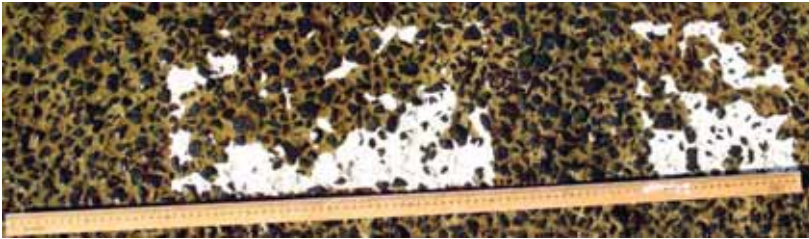
Photo 27 – Malabar Boat Ramp
Peeling X1 squares in direct application experiment at Malabar boat ramp at 4 weeks

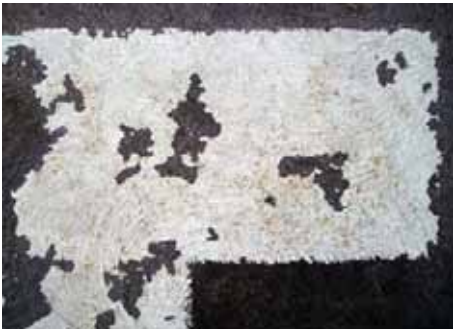
- X2 squares showed a low level of fouling with red-brown microalgae at 6 weeks
- X2 squares showed a low level of fouling with red-brown and green microalgae at 8 weeks
- X2 squares showed a moderate level of fouling with red-brown microalgae at 13 weeks (Photo 28)
- It is difficult to compare painted test squares to control squares as control squares are 'bare' concrete. It is hard to see low-level fouling on bare concrete which would otherwise be seen on lightly coloured paint (Photo 29).
- It appears the experiment was applied in a low-foul area as fouling barely visible on concrete control squares and on surrounding test area.
- A small amount of X2 paint started to peel off one square at 2 weeks, with small amounts peeling off other squares during the trial (Photo 28, 29).

Photo 28 – Clovelly Bay Promenade
X2 squares showing micro-fouling at 13 weeks and peeling of X2 paint

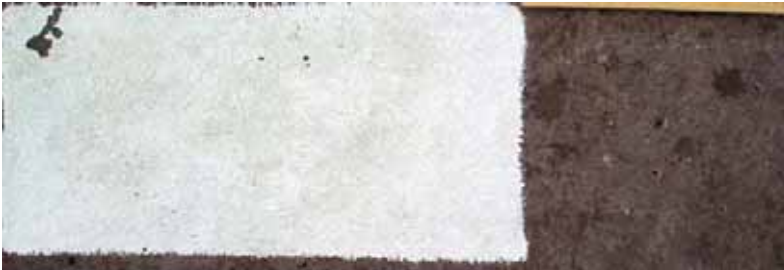
Photo 29 – Clovelly Bay Promenade
Other X2 squares and adjacent control square. Note that it is difficult to assess presence of micro-fouling in control squares due to background colour of concrete

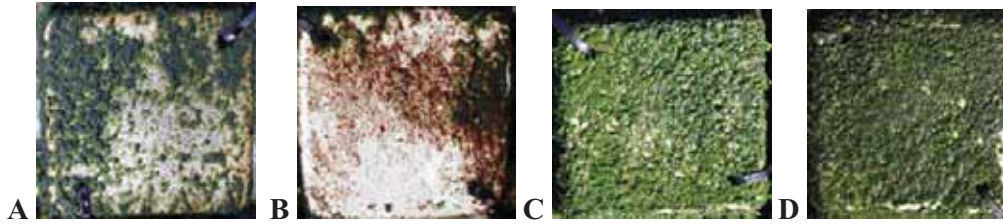
Photo 30 – Clovelly Bay Step

- Blocks coated with non-slip paint started to foul after 4 weeks
- Y1 blocks showed a low level of fouling by the green alga (*Ulva* sp. prostrate growth form) and a red-brown alga at 4 weeks (Photo 30B)
- Control blocks showed a low-medium level of fouling by *Ulva* sp. at 4 weeks (Photo 30A)
- Y1 and control blocks showed a high level of fouling at 6 weeks
- Y1 and control blocks were completely fouled at 8 weeks (Photo 30C,D)

A control block (A) and Y1 block (B) at 4 weeks, and a control block (C) and Y1 block (D) completely fouled at 8 weeks. Note the reduced growth of the green alga *Ulva* sp. on Y1 compared to control at 4 weeks. A red-brown alga was the prominent alga on Y1 blocks up until 6 weeks when it was outgrown by *Ulva* sp.

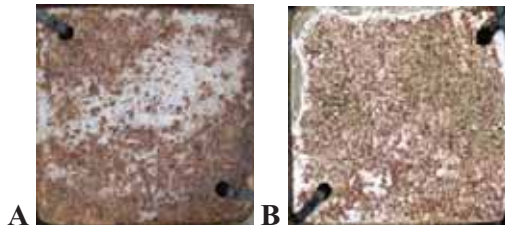
Photo 31 – Clovelly bay promenade

A control block (A) and Y1 block (B) heavily fouled by brown-red algae at 12 weeks

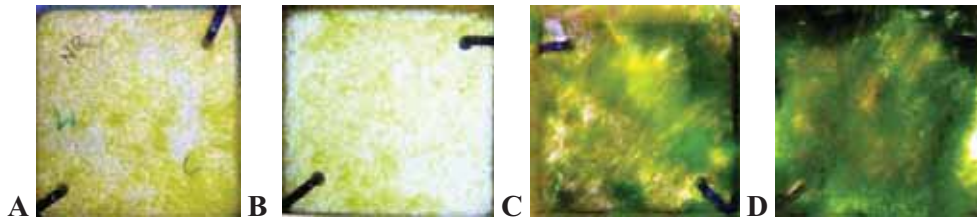
Photo 32 – Malabar Rock Pool Step

A control block (A) and Y1 block (B) at 2 weeks, and a control block (C) and Y1 block (D) heavily fouled at 8 weeks. Note filamentous growth form of *Ulva* sp. in C, D in contrast to prostrate growth form seen on Clovelly Bay step (Photo 3C,D).

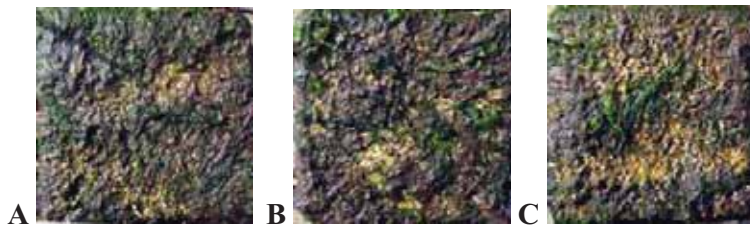
Photo 33 – Rozelle Bay Marina

A control block (A), Y1 block (B) and Y2 block (C) completely fouled with green and brown algae and hard worms at 5 weeks.

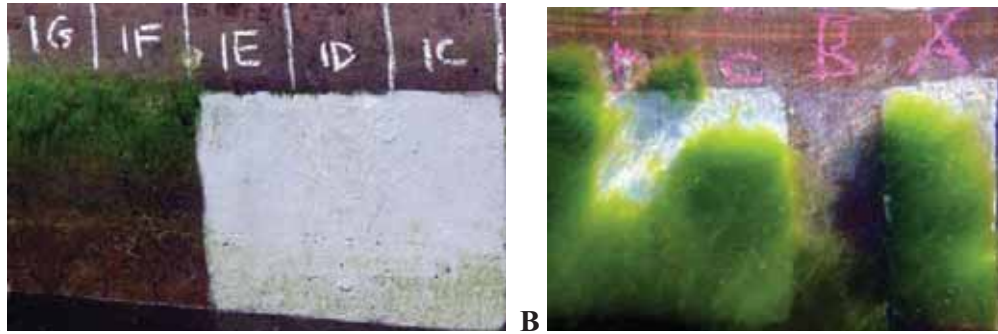
Photo 34 – Malabar Rock Pool Wall

Y1 test panels (panels 1C, 1E) after 3 weeks (A) showing minimal algal growth on Y1 non-slip paint. Note heavy algal growth in top section of other test panels 1G and 1F. Algae was growing directly above Y1 panels which was scraped off before photo was taken. (B) Y1 test panels (panels A, C) heavily fouled with *Ulva* sp. at 8 weeks

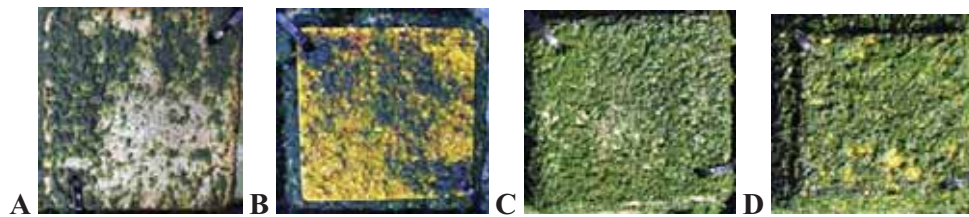
Photo 35 – Clovelly Bay Step

- *Ulva* sp. (prostrate growth form) started to grow in the crevices of some Y2 plates at 2 weeks. Control blocks were not fouled at 2 weeks
- Y2 blocks showed highly variable fouling at 4 weeks, ranging from low level cover to completely fouled
- Control blocks showed low-medium fouling at 4 weeks (Photo 35A, B)
- Y2 and control blocks were heavily fouled at 6 weeks
- Y2 and control blocks were completely fouled at 8 weeks (Photo 35C, D)

A control block (A) and Y2 block (B) at 4 weeks, and a control block (C) and Y2 block (D) completely fouled at 8 weeks.

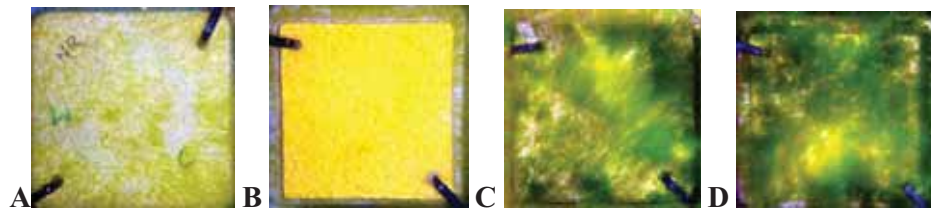
Photo 36 – Malabar Rock Pool Step

A control block (A) and Y2 block (B) at 2 weeks, and a control block (C) and Y2 block (D) heavily fouled at 8 weeks.

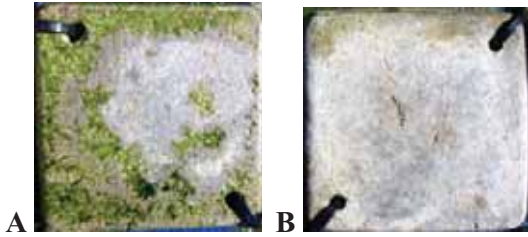
Photo 37 – Clovelly Bay Step

The most fouled Z1B block (A) and an un-fouled control block (B) at 2 weeks

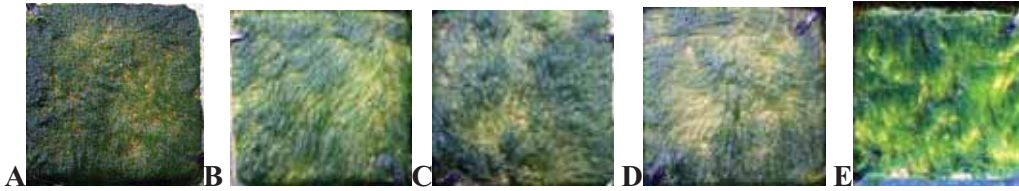
Photo 42 – Malabar Rock Pool

Heavily fouled blocks for each coating; Z1A (A), Z1B (B), Z2A (C), Z2B (D) and a control block (E) after 8 weeks

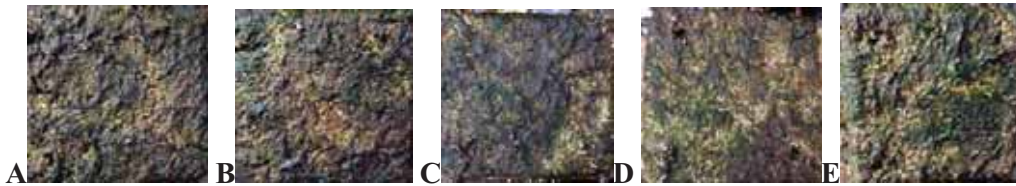
Photo 43 – Rozelle Bay Marina

Heavily fouled blocks for each coating; Z1A (A), Z1B (B), Z2A (C), Z2B (D) and a control block (E) after 5 weeks.

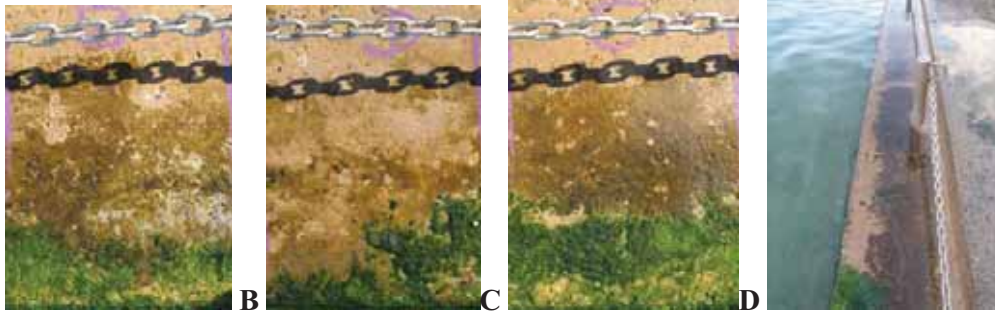
- This rock pool is exposed directly to ocean conditions, particularly to southerly swells
- There was some growth of green and brown algae in the first half of the test area (1A-1G) at 9 weeks. Green algae (*Ulva* sp.) grew on test panel 1A-1E, and brown micro-algae grew on test panel 1A-1G. Similar levels of fouling were observed on control and test panels (Photo 47A-C).
- Very little algal growth was observed on the test area before 9 weeks probably due to big seas which occurred during this part of the field trial. Sand-wash from swell results in pool edge 'self-cleaning'.
- No algal growth was observed on test panels 1H, 2A-2G at any time during the trial. This is in contrast to typical fouling observed on pool edge in February 2009. Brown micro-algae grew in section of test panels 2A-G (Photo 47D), however, calm sea conditions prevailed at this time (no self cleaning).

Representative panels at 9 weeks; PZ1 (A), Z1 (B), control (C), typical fouling observed on test area before the experiment (D)

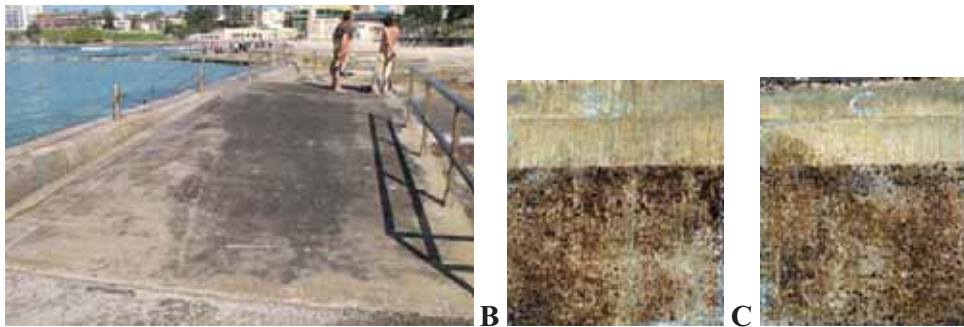
- While most of the ramp became heavily fouled after 12 weeks, the area of the experiment had less algal growth (Photo 48A).
- No difference was observed between test squares (Z1, PZ1, Z2, PZ2) and control squares (Photo 48B, C).
- This section of the ramp undergoes ‘self-cleaning’ during big swells.

Access ramp after 3 months (A). The experiment was on the left side of the ramp alongside the pool wall (in area that is least fouled). A representative test square of PZ1 coating (B) and a control square (C)

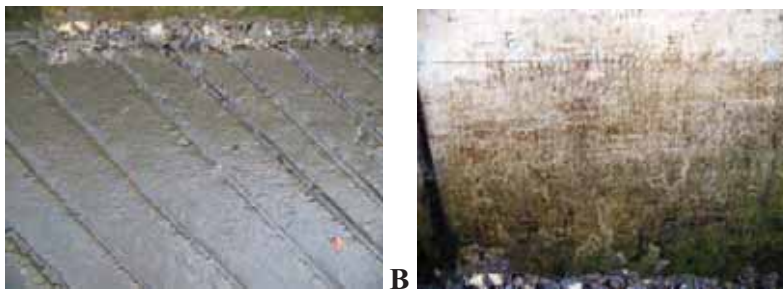
- The test area on the ramp itself was lightly covered in a brown film/scum, possibly brown algae and organic pollutants from boat use, after 3 weeks.
- Small patches of micro algae started growing on the adjoining wall also used as a test area at 3 weeks.
- Brown scum layer on the boat ramp steadily increased during the trial. No differences were observed between the test panels (Z1, PZ1, Z2, PZ2) and the controls (Photo 49).
- It is possible that brown scum layer on ramp (Photo 49A) masked any antifouling affect of test coatings. However, no antifouling effect was observed on the test panels (Z1, PZ1, Z2, PZ2) on the adjoining wall (Photo 49B).

Boat ramp showing brown film/scum seen on boat ramp below mid tide level (A) and the adjoining wall showing algal/microbial growth observed in all test panels (B)
