Assessment and Decision Frameworks for Seawall Structures

Appendix F

Case Study Clontarf

Appendix F Case Study – Clontarf

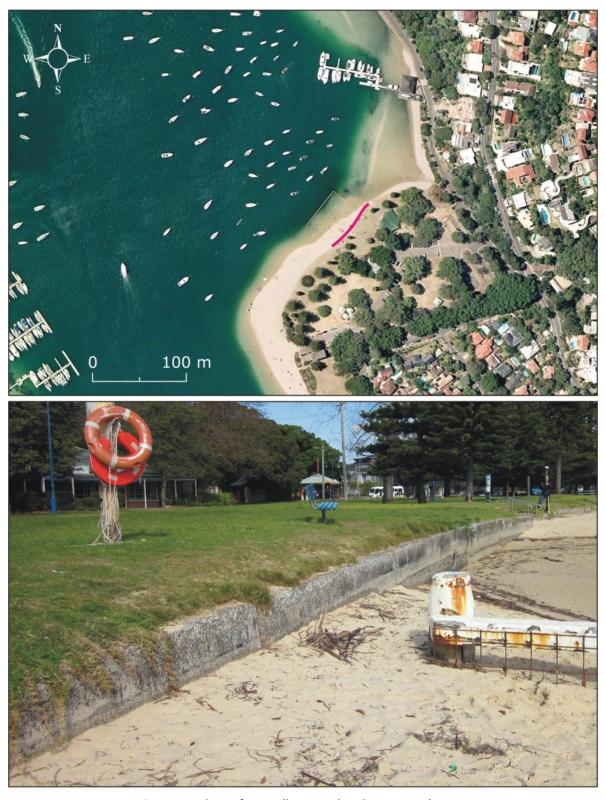
Figure 2.4 Clontarf Seawall 2 at Pool Enclosure 27 July 2001

Adjacent to the swimming enclosure, the sandstone wall (Seawall 2) is replaced by a vertical concrete wall of unknown cross-section and toe depth. However, based on previous geotechnical investigations, the seawall toe level is located below 0.3 m AHD. In assessing the stability of the seawall (and in the absence of further information), WRL conservatively assumed that the seawall

had a toe level of 0.3 m AHD. This section of the wall is generally in poor condition, showing cracking and rotation. Exposed reinforcing steel is rusting. The sections of wall east of the swimming enclosure and within Sandy Bay have a crest level generally at 1.4 m AHD to 1.5 m AHD.

The performance of Seawall 2 during the 100-year ARI event is predicted to be generally similar to Seawall 1 except that the scour level is predicted to remain above the toe. Failure of the structure is again expected to be induced by wave overtopping. Ongoing erosion following the failure of Seawall 2 is likely to damage the foreshore at Clontarf Reserve. Up until the point of failure of this structure, wave overtopping is likely to be unsafe for pedestrians near the structure crest.

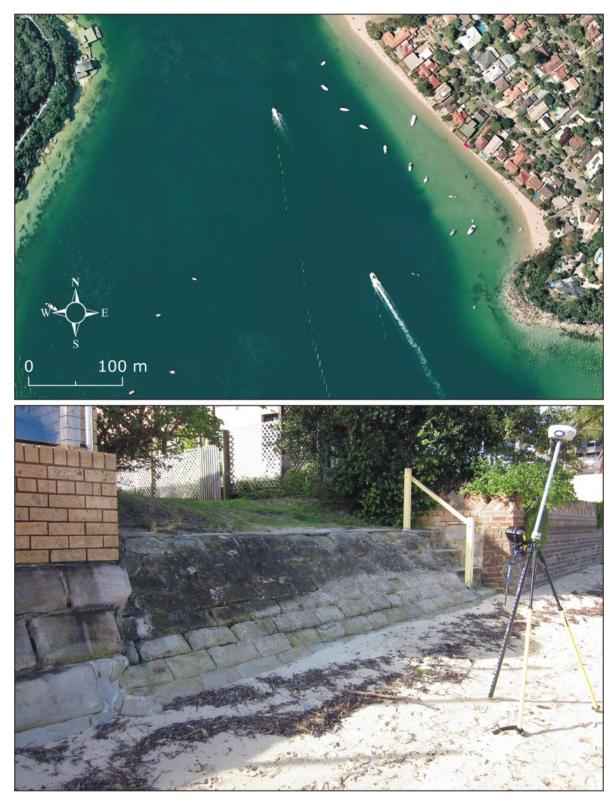
Figure 2.5 Clontarf Seawall 3 at Monash Crescent Public Access 27 July 2001

Seawall	Location	Crest Level (m AHD)	⁽¹⁾ Toe Level (m AHD)	⁽²⁾ Ave. Sand Level (m AHD)	⁽³⁾ Present Condition
1	Between Sandy Bay and the Marina	1.5	-0.4	0.0	Generally reasonable condition, localised erosion of sandstone and mortar, isolated cracks, settling and rotation
2	At pool enclosure	1.4	< 0.3 (0.3 adopted)	1.1	Reasonable condition, isolated forward leaning and corrosion of reinforcing steel
3	Public access from Monash Crescent	1.9	- (1.0 adopted)	1.3	Reasonable condition, weathering of mortar

At the public access from Monash Crescent, Seawall 3 is expected to fail due to toe undermining. Once the sand level in front of the wall is reduced below the toe level, the structure is likely to subside and collapse seaward. Prior to the failure of Seawall 3, wave overtopping is likely to be unsafe for pedestrians near the structure crest. Most importantly, the failure of Seawall 3 may also lead to outflanking of the adjacent private seawalls. This could potentially lead to the progressive unravelling of all coastal protection works along this stretch of foreshore, but it is likely that this would occur over several months following the initial failure of Seawall 3. If this were to eventuate, ongoing erosion following the failure of these works may threaten the leeward buildings on private property (if they are not founded on rock or piled foundations, and if emergency protection were not provided). It is also likely that stormwater drainage systems would be affected by 'quasi-static' inundation (excluding wave runup but including storm surge and wave setup) during the event.
