A METHOD FOR ASSESSING THE VULNERABILITY OF BUILDINGS TO CATASTROPHIC (TSUNAMI) MARINE FLOODING

August 2009

This report “A method for assessing the vulnerability of buildings to catastrophic (tsunami) marine flooding” was prepared for the Sydney Coastal Councils Group Incorporated by:

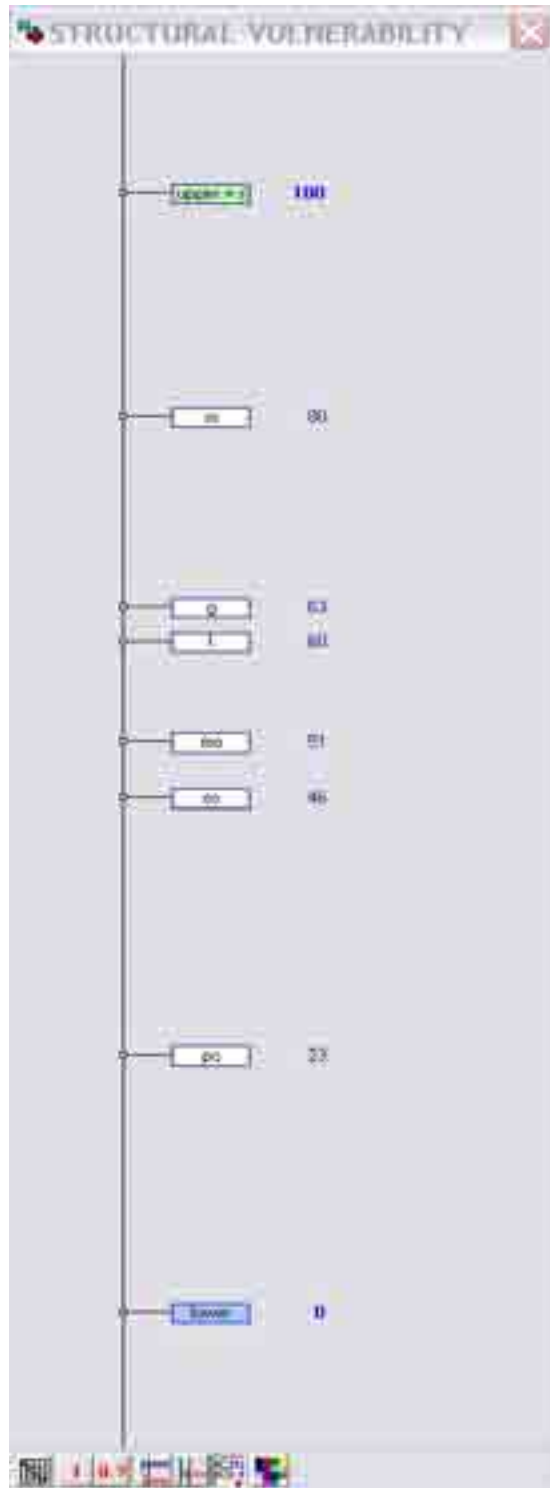
Figure 4. The relative weights of the structural vulnerability factors derived from pair-wise comparisons between various factors

-1	-0.5	0	(+0.25)	+0.5	(+0.75)	+1
s (number of stories)	more than 5 stories	4 stories	3 stories		2 stories		1 story
m (material)	reinforced concrete		double brick		single brick		timber
g (ground floor hydrodynamics)	open plan	open plan and windows	50% open plan		not open plan, but many windows		not open plan
f (foundation strength)	deep pile foundations (>5 stories)		average depth foundations (3 stories)				shallow foundations (1 story)
so (shape and orientation)	poor hydrodynamic shape		average hydrodynamic shape				high hydrodynamic shape
mo (movable objects)			minimum risk of being damaged by movable objects	moderate risk of being damaged by movable objects	average risk of being damaged by movable objects	high risk of being damaged by movable objects	extreme risk of being damaged by movable objects
pc (preservation condition)	very poor	poor	average		good		excellent

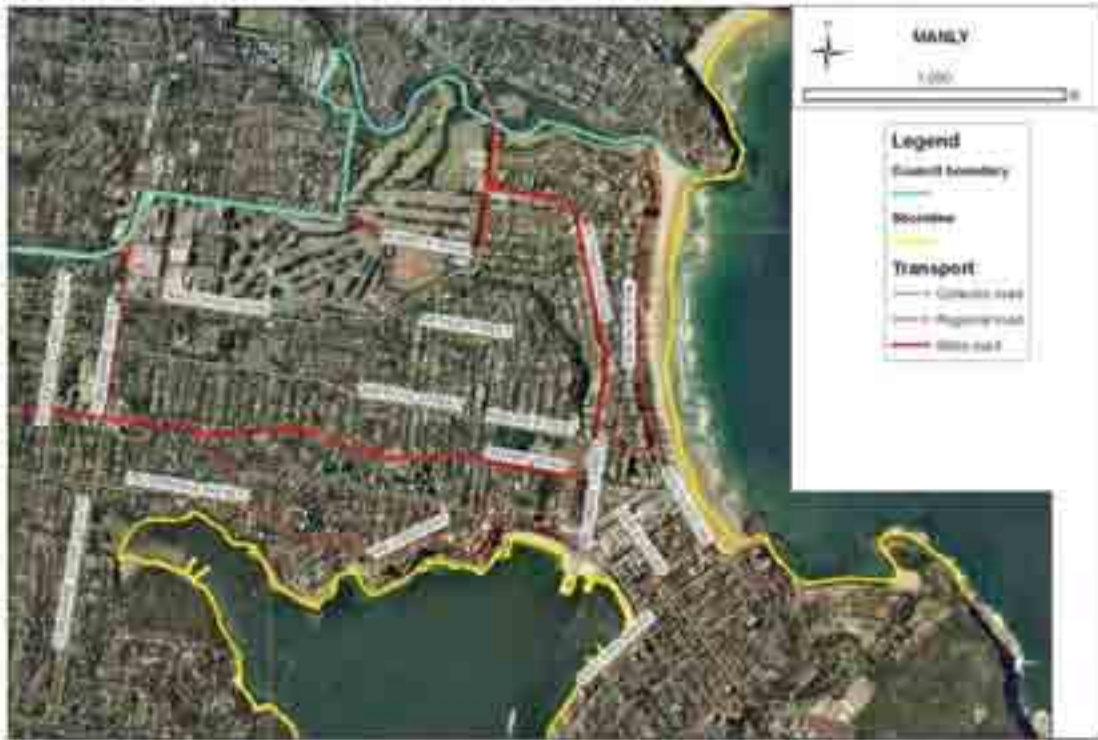
Figure 7. The construction of the GIS database for Manly

The data provided by Manly and Randwick Councils were entered into a GIS database, and categorised according their format and different thematic areas (Figure 7).

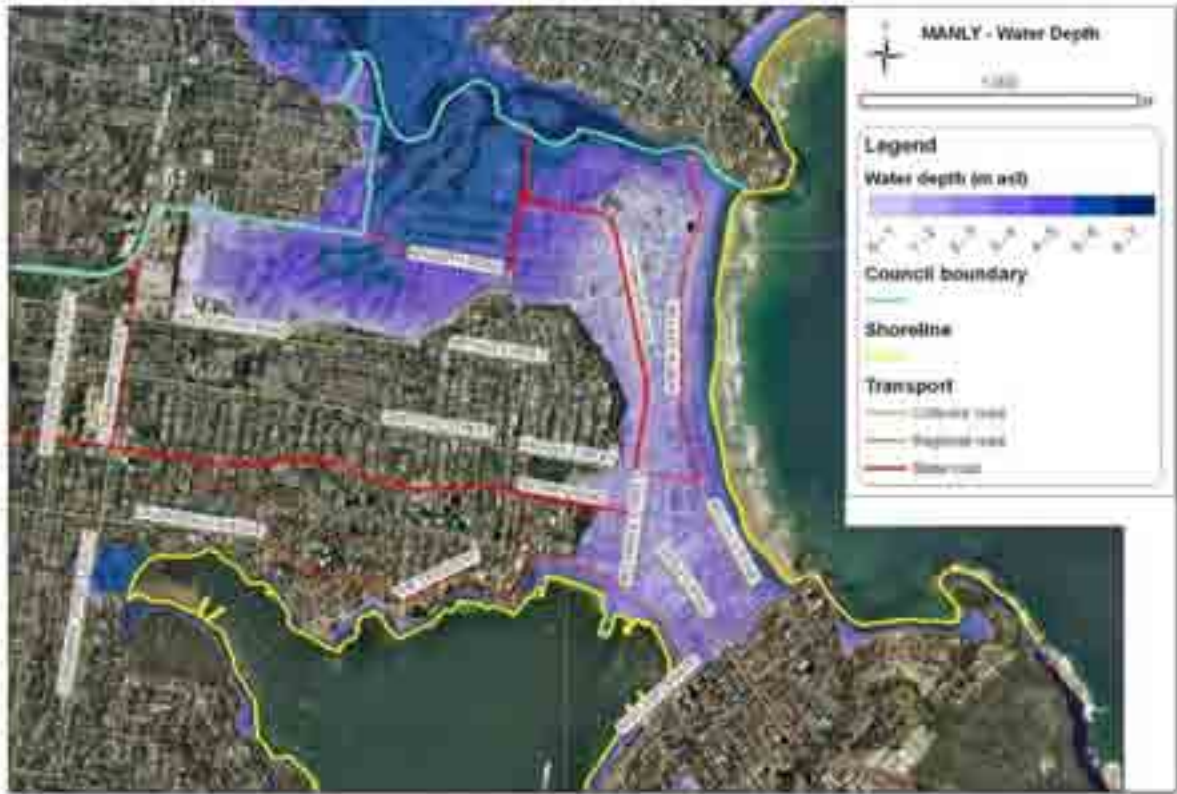
Figure 8. Inundation map for Manly

Topographical data were converted from a “.txt” format into a polygon shapefile. The marine flood water depth for our scenario given by the 5 metre tsunami (plus 2 metres maximum astronomical tide = 7m AHD) were projected onto the whole study area (Figure 8).

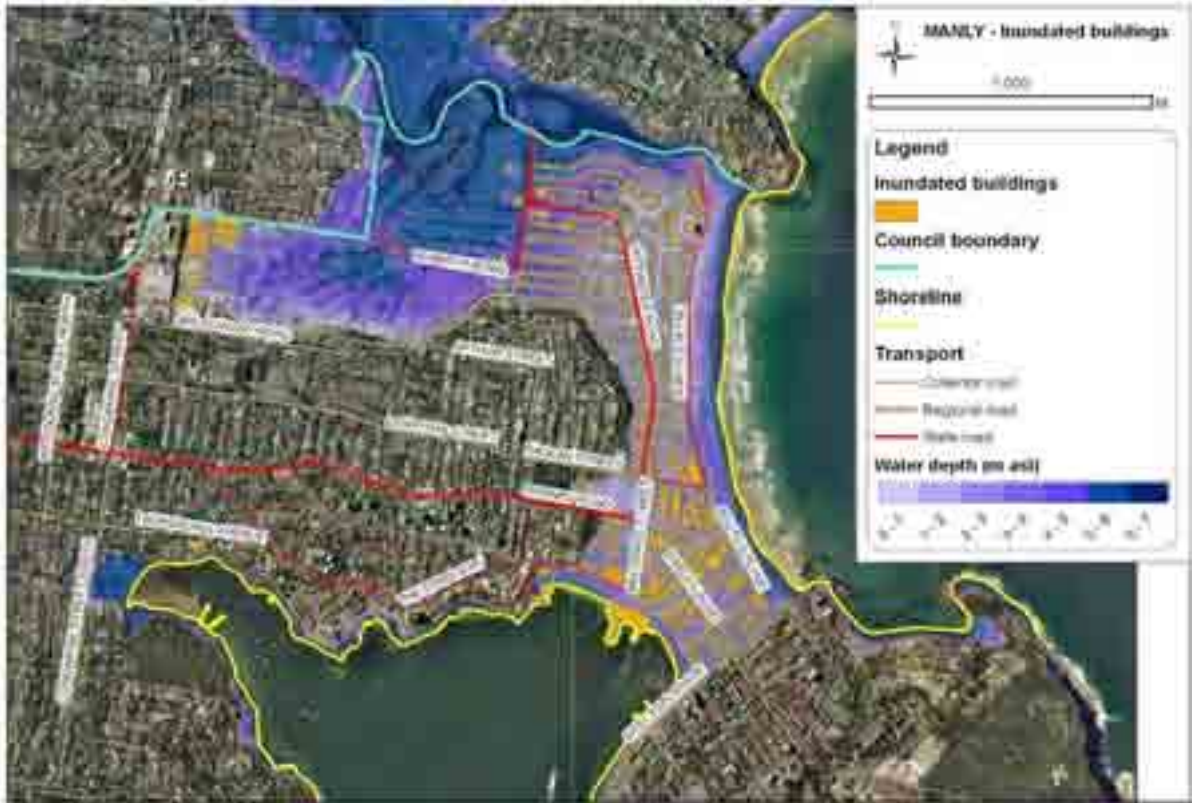
Figure 9. Building footprints have been manually extracted and plotted on to the Manly map

In the case of Manly, the combined 'Buildings' shapefile was modified in order to be used in the vulnerability model. A total of 1141 individual building footprints were manually extracted (Figure 9). For Maroubra, inundated buildings were manually digitalized.

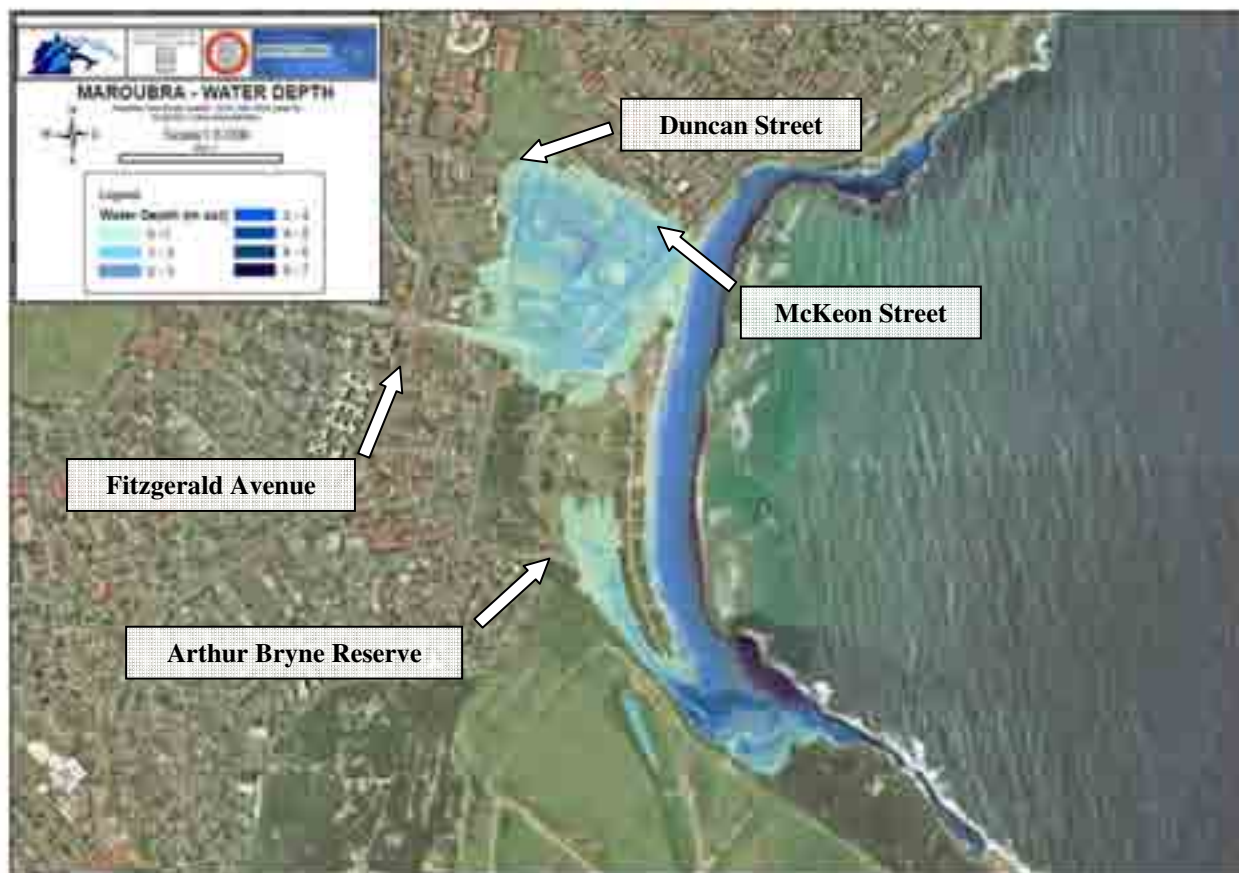
Figure 13. Inundation at Maroubra

Figure 13 shows the area of Maroubra that would be inundated by a tsunami achieving a run-up of +5 metres above sea level (m asl).

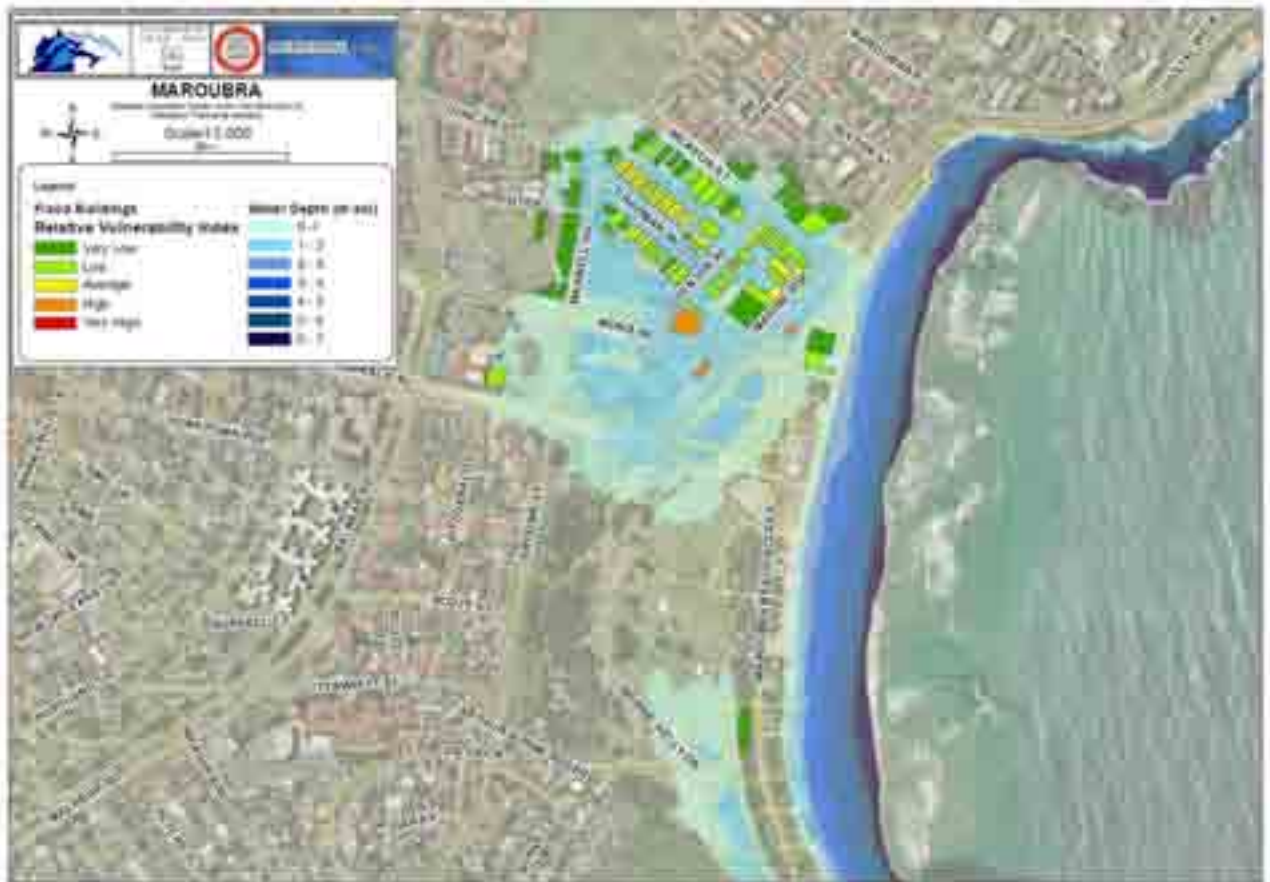
Figure 14. The Relative Vulnerability Index scores of all exposed buildings in Maroubra

A total of just 96 buildings (of all building class types) would be ‘touched’ by tsunami flood water in our scenario (Figure 14). We then calculated the ‘Relative Vulnerability Index’ (RVI) score of every building located within the inundation zone using the approach outlined in Section 2.3. The results are also shown in Figure 14.

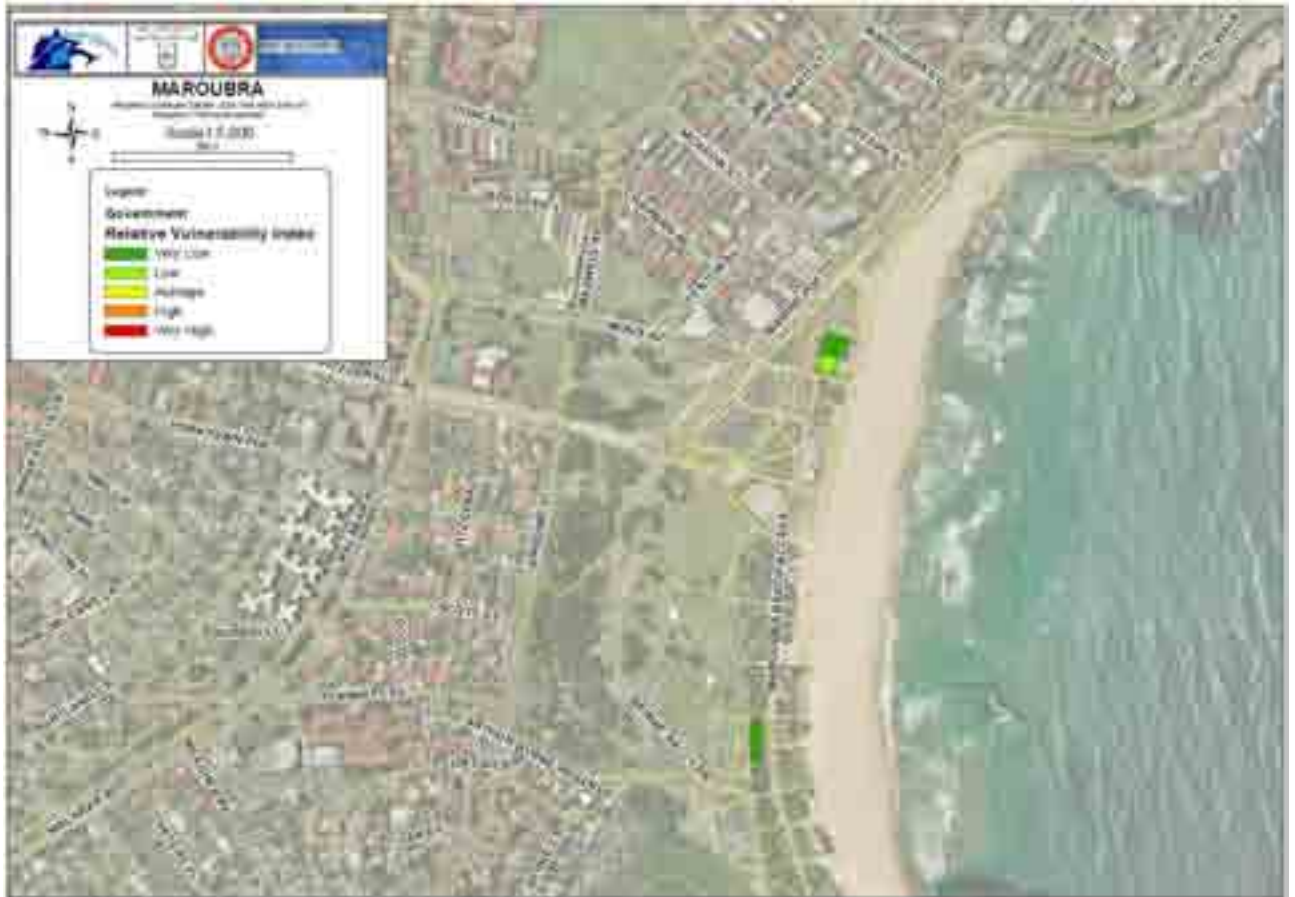
Figure 15. The Relative Vulnerability Index scores of local government buildings

Figure 15 shows the RVI scores of those buildings in Maroubra that are the responsibility of local government. The RVI scores of these structures are “Very Low” and “Low” and there are only four such buildings in the area. It is fortunate that the RVI scores are low since each of these buildings is located close to the shoreline and well within the deep inundation zone (Figure 13).

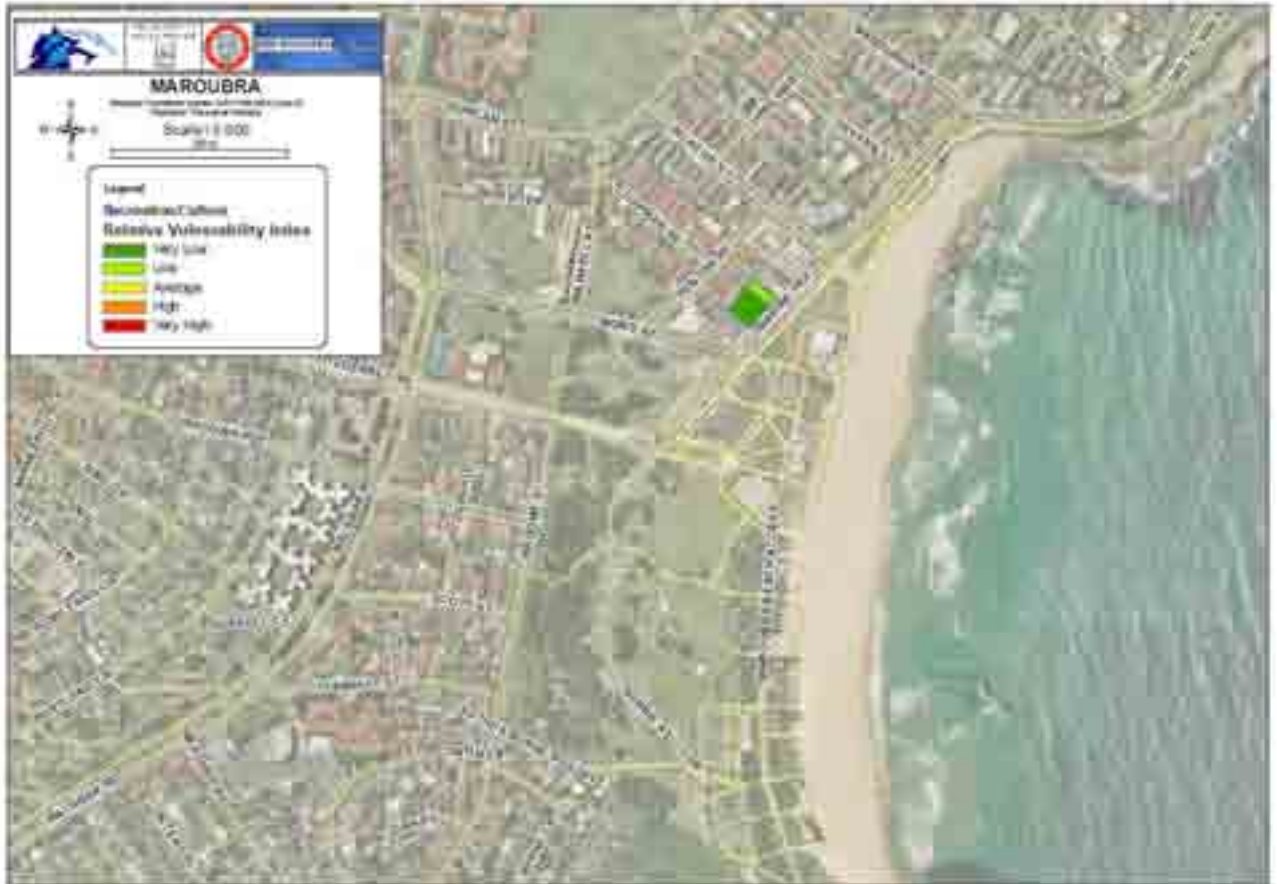
Figure 17. The Relative Vulnerability Index scores for recreation and culture buildings in Maroubra

Figure 17 shows the calculated RVI scores of those buildings in Maroubra that are related to recreation and culture. There are just two buildings of this type and they have RVI scores of “Very Low” and “Low”.

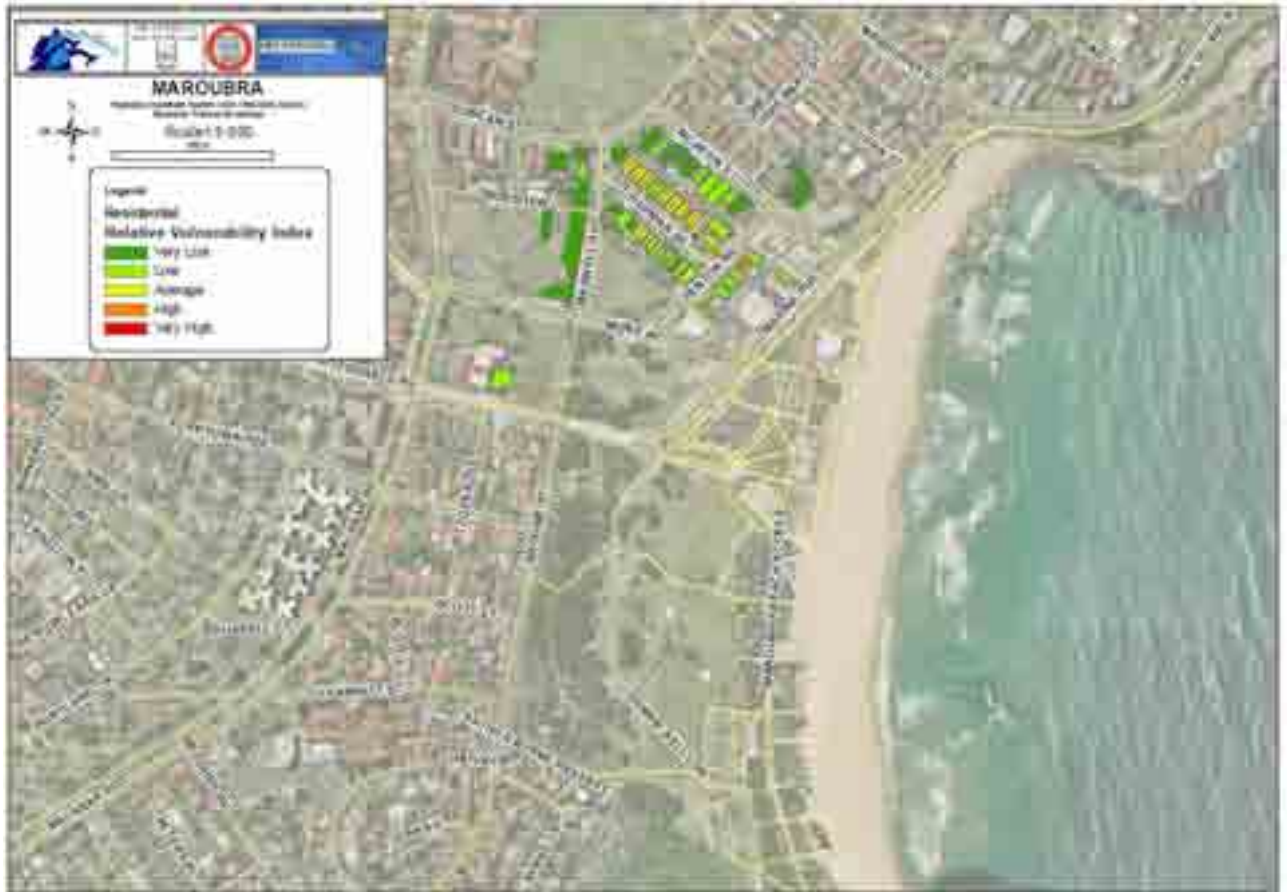
Figure 21. The Relative Vulnerability Index scores for residential buildings in Maroubra

There are a total of 67 residential buildings within the tsunami inundation zone of Maroubra. Figure 21 shows the RVI scores of each of these buildings. The vast majority of residential structures are classified as having “Very Low”, “Low” or “Average” vulnerability. Only one residential building is classified as having “High” vulnerability.

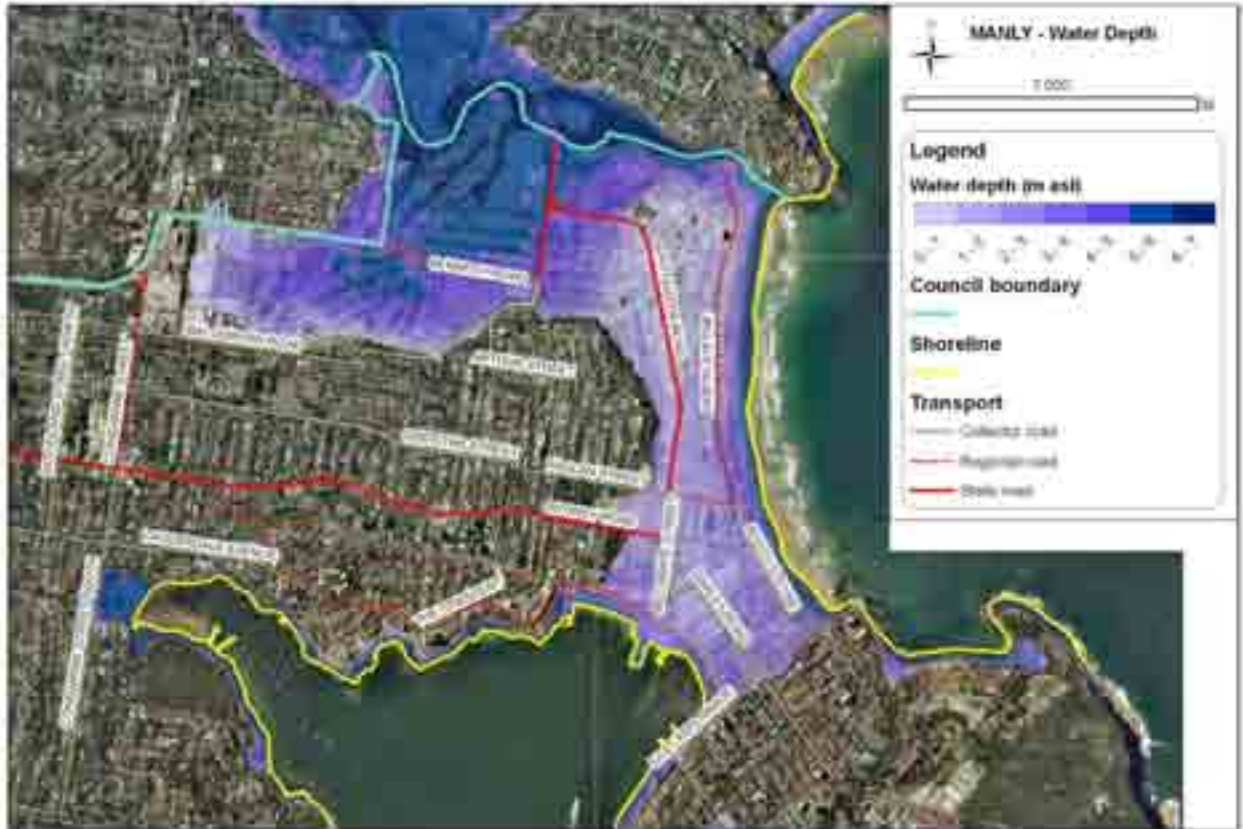
Figure 22. Area of Manly local government covered by tsunami flood water in our scenario

Manly is a much more complex situation than Maroubra with a significantly larger area of land inundated in our scenario (169.5 ha) (Figure 22).

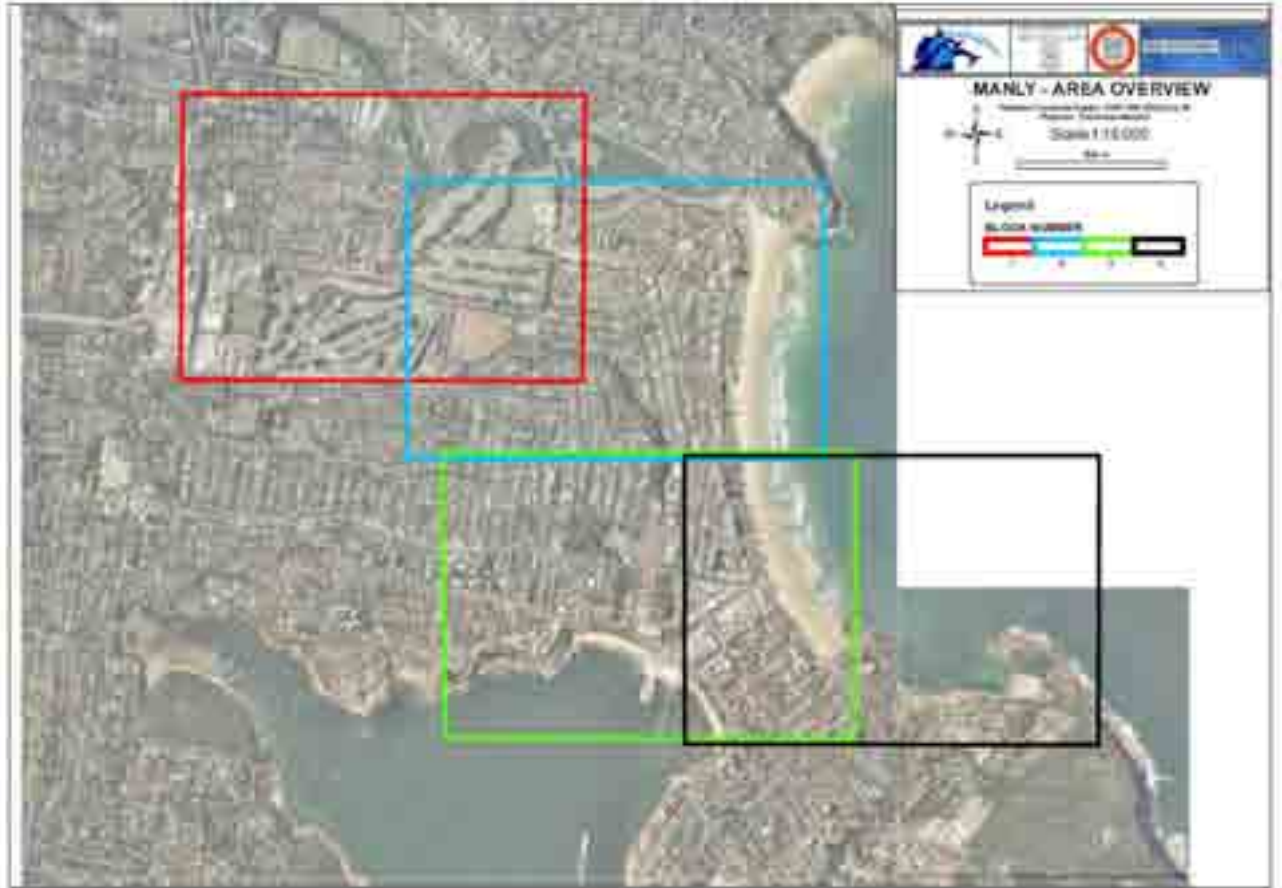
Figure 23. The four “blocks” used to divide manly in manageable areas for display purposes

A total of 1133 buildings (plus 8 sites that were under construction at the time this study was undertaken) are touched by tsunami flood water in our scenario. This is far too large an area to easily display on a single map. Therefore, for graphical reasons, we have divided the Manly area affected by inundation in to four smaller blocks shown in Figure

23. In the remainder of this Section of the report, we will sequentially deal with Manly Blocks 1, 2, 3 and 4. In Section 3.2, we described the absolute number of buildings of each class in the inundation zone of Maroubra. We do not do this for the Manly case study since the four sub-blocks overlap. If we were to provide absolute building numbers as a sum of the buildings in each block, we would overestimate their actual number (1141), because buildings located in the overlapping areas of the blocks would be double-counted. Nonetheless the absolute number of buildings of each class, for the whole inundated area in Manly, is shown in Table 9.

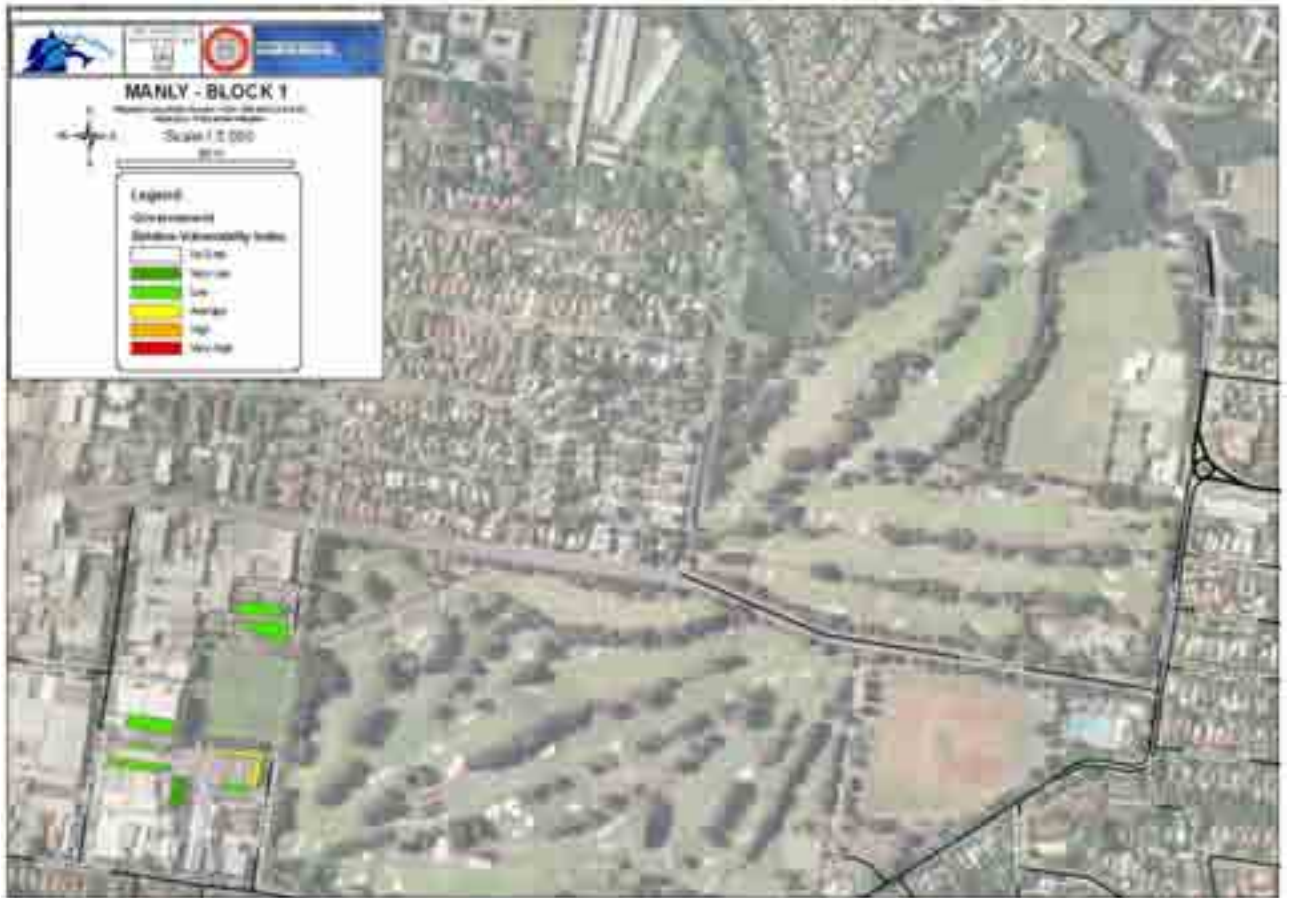
Figure 25. Distribution and final vulnerability classification of government owned-managed buildings in Manly Block 1

Figure 25 shows the RVI scores of those buildings in Manly Block 1 that are the responsibility of the local government. Only a small number of buildings fall within this class and fortunately, all buildings are classified as “Average” or lower in terms of their RVI. Furthermore, these buildings are all located at the most landward (western) extent of the inundation zone in the region of Quirk Road and Roseberry Street.

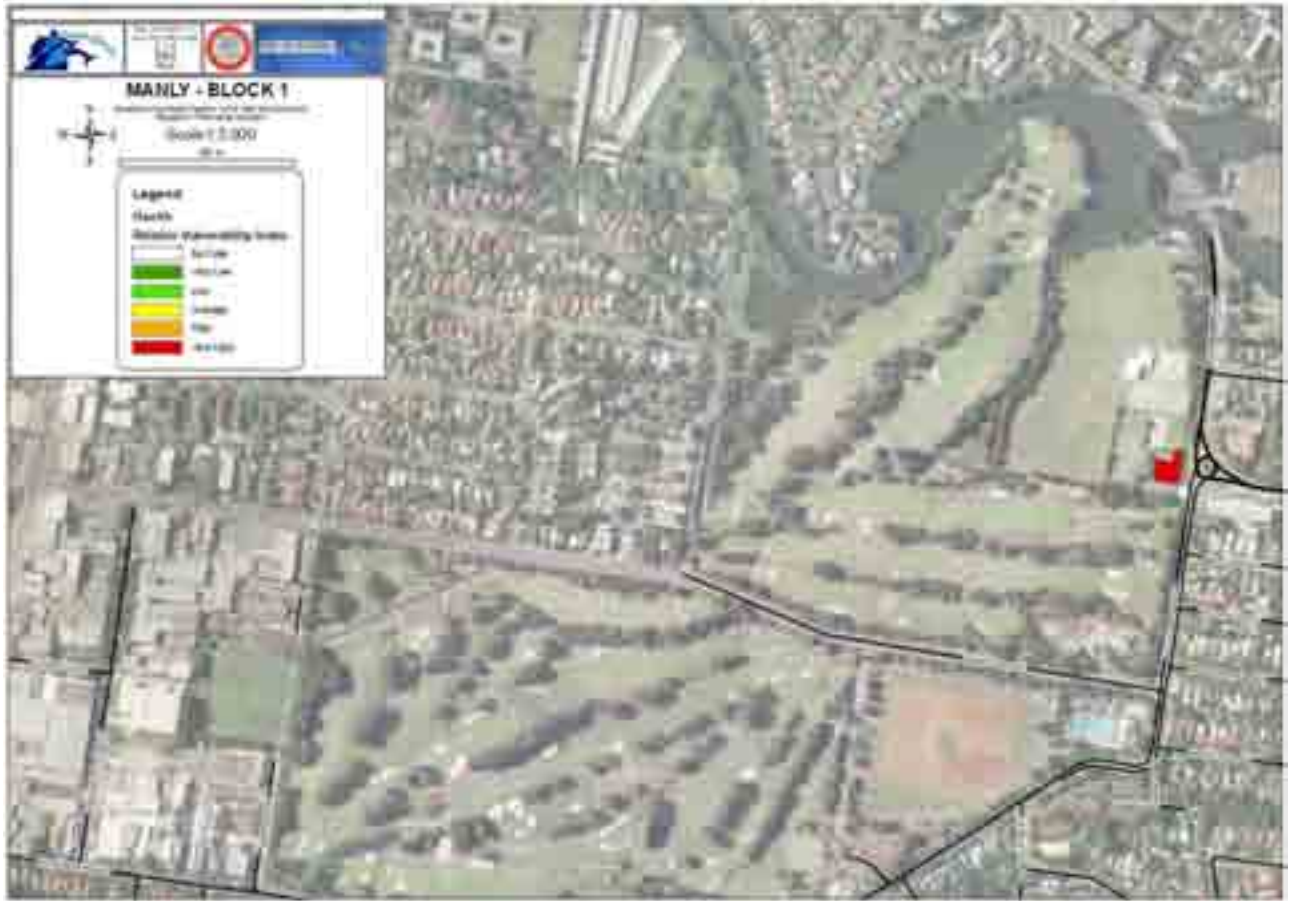
Figure 26. The vulnerability of the health and medical services building, Block 1, Manly

Figure 26 shows the RVI score of the one building in Block 1 that relates to health and medical services. This building is classified as having a “High” RVI score and is the Senior Citizen Centre at the edge of the Manly Golf Course off Pittwater Road.

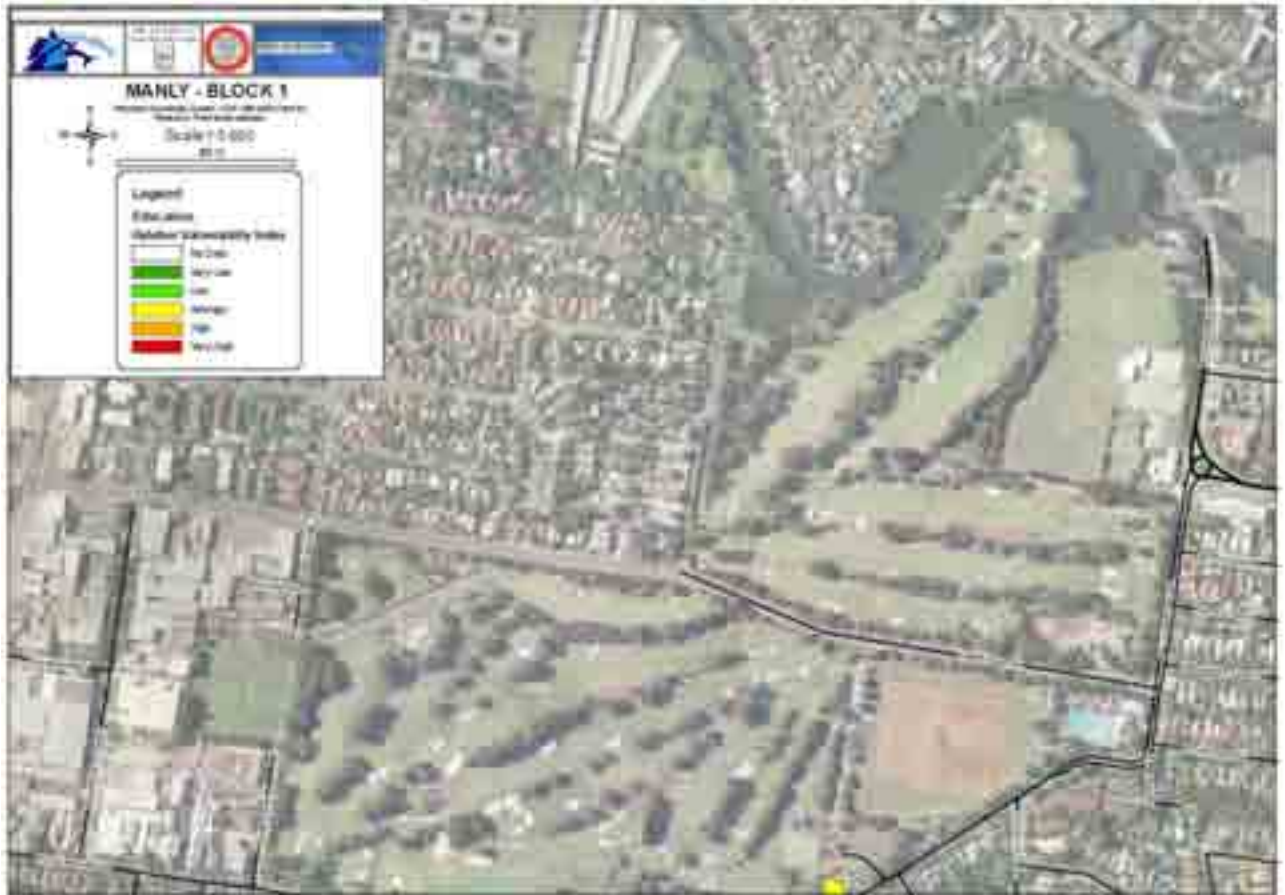
Figure 27. The vulnerability of the education buildings in the Manly Block 1 area

Figure 27 shows the calculated RVI score of those buildings in Block 1 that relate to the education sector. These buildings are classified as having an “Average” RVI score.

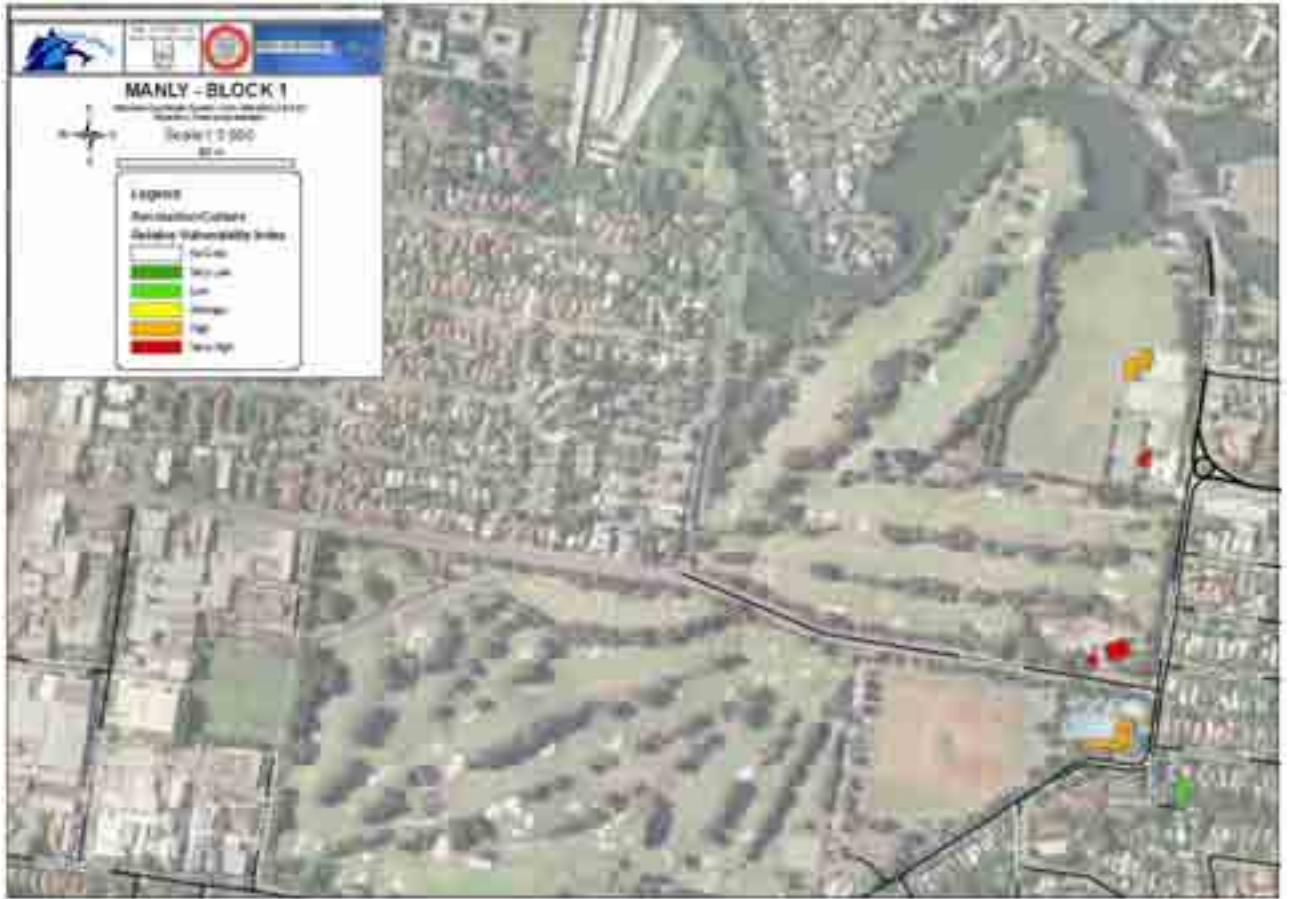
Figure 28. The vulnerability of recreational and cultural buildings in Manly Block 1

Figure 28 shows the RVI scores of the recreational and cultural buildings in Manly Block 1 located within the tsunami inundation zone. These buildings are characterized by a mix of “Very High”, “High” and “Low” RVI scores.

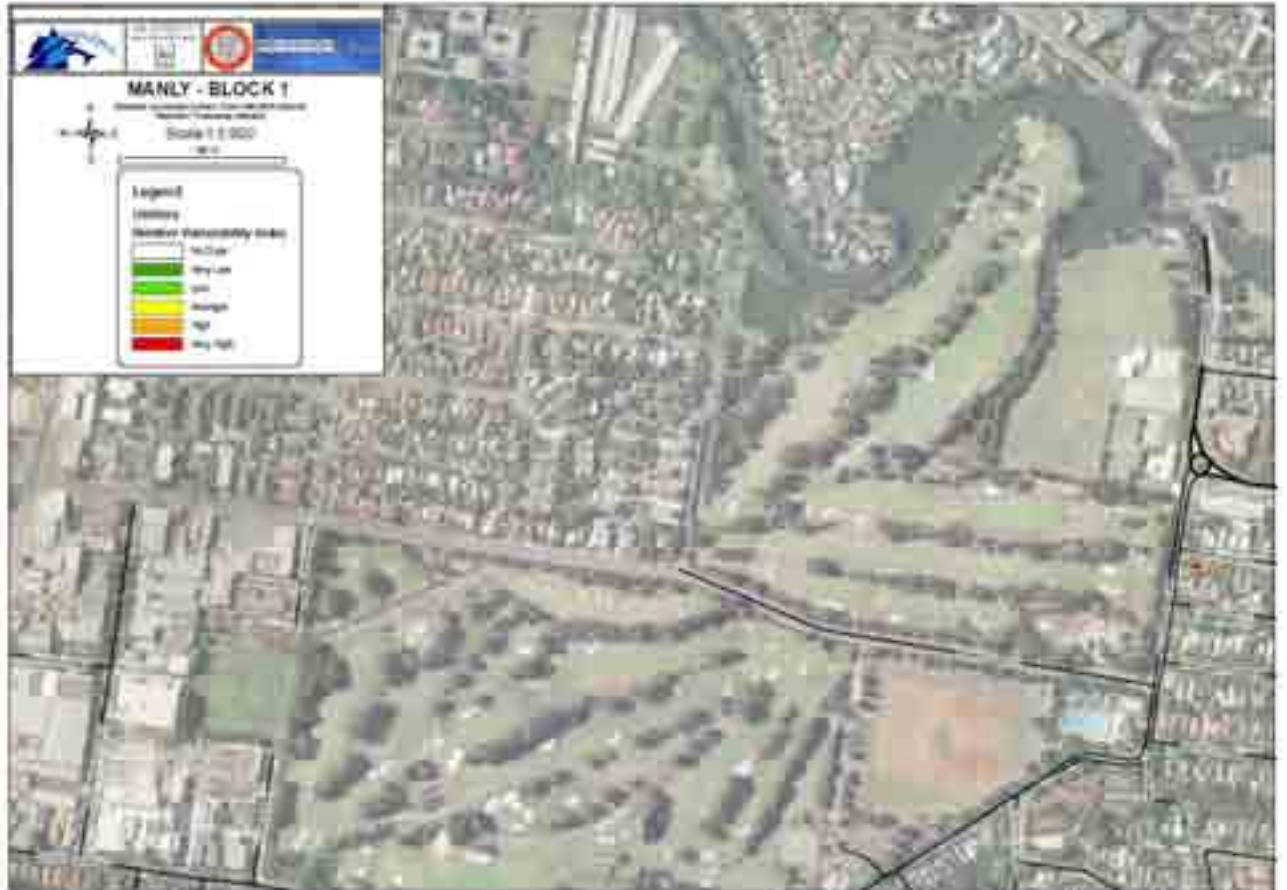
Figure 29. The vulnerability of utility buildings in Block 1, Manly

Figure 29 indicates that only a very small number of individual buildings classified as utility buildings are located in this area. However, their RVI scores are “High” and “Very High”.

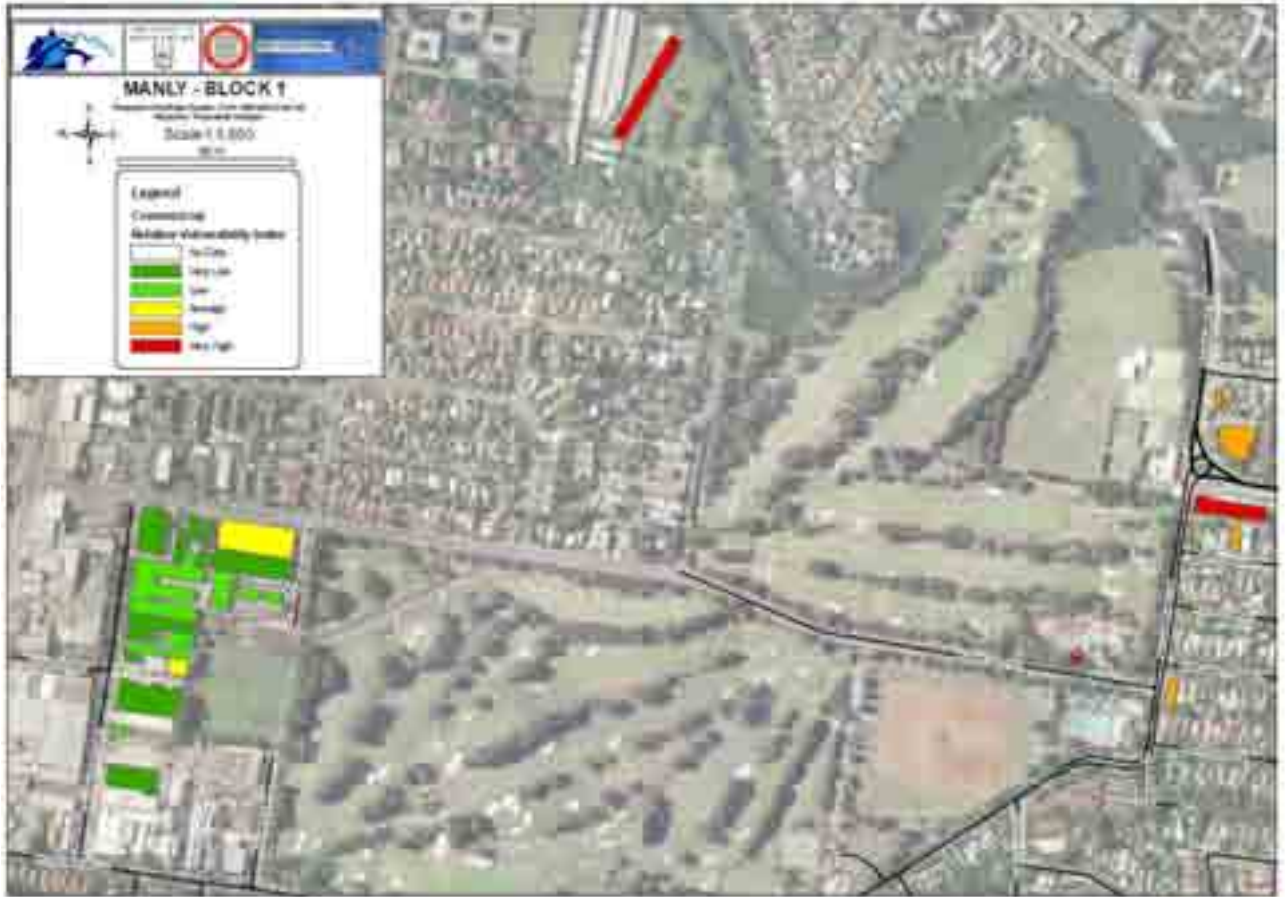
Figure 30. The vulnerability of commercial buildings in Block 1, Manly

Figure 30 shows the calculated RVI scores of the commercial buildings in Block 1 located within the tsunami inundation zone. A relatively small number of commercial buildings are located within the inundation zone and most have RVI scores of “Average” or lower.

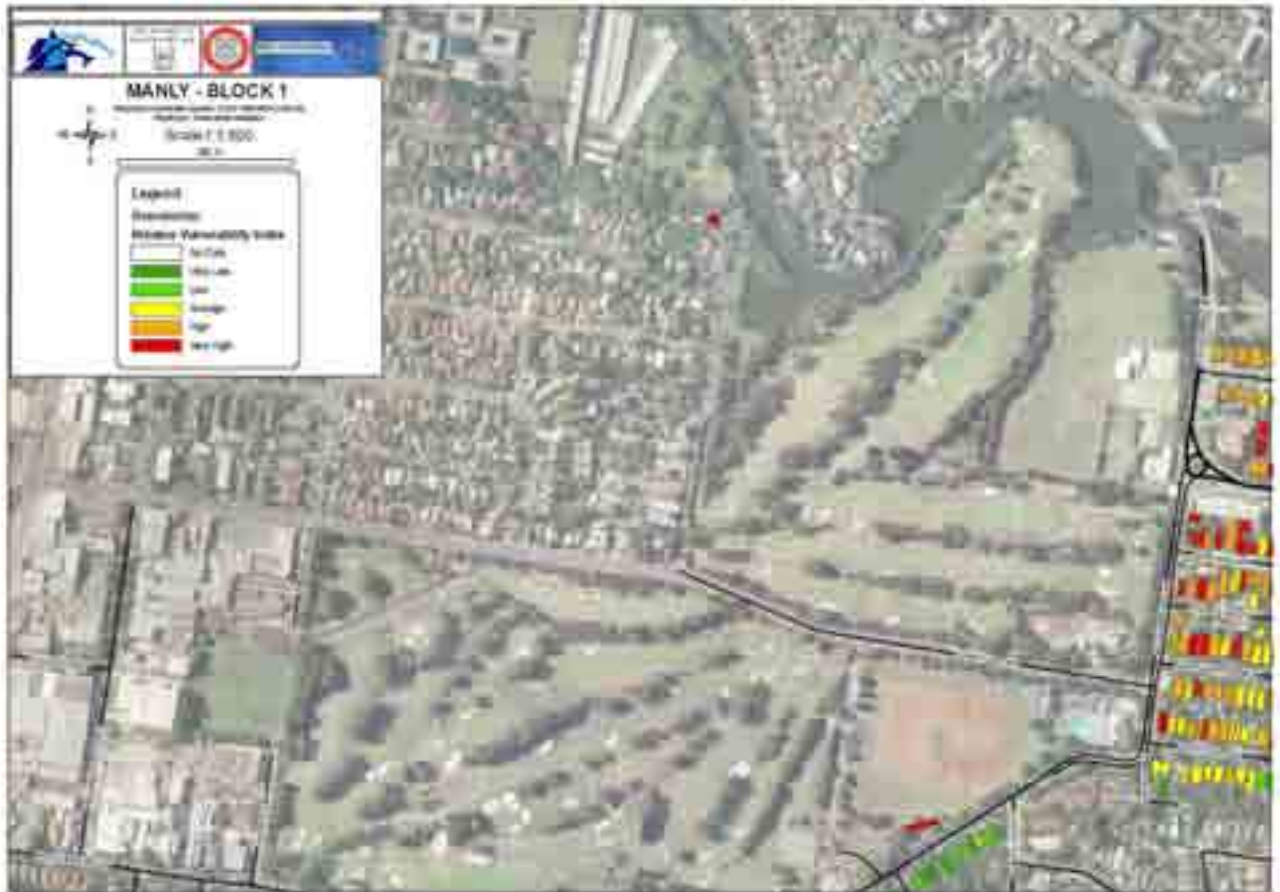
Figure 31. The RVI scores of residential buildings in Block 1, Manly

Figure 31 shows the RVI scores of residential buildings located within the tsunami inundation zone of Block 1. A relatively large number of residences would be inundated. The majority of residential buildings have an RVI score of “Average” and higher.

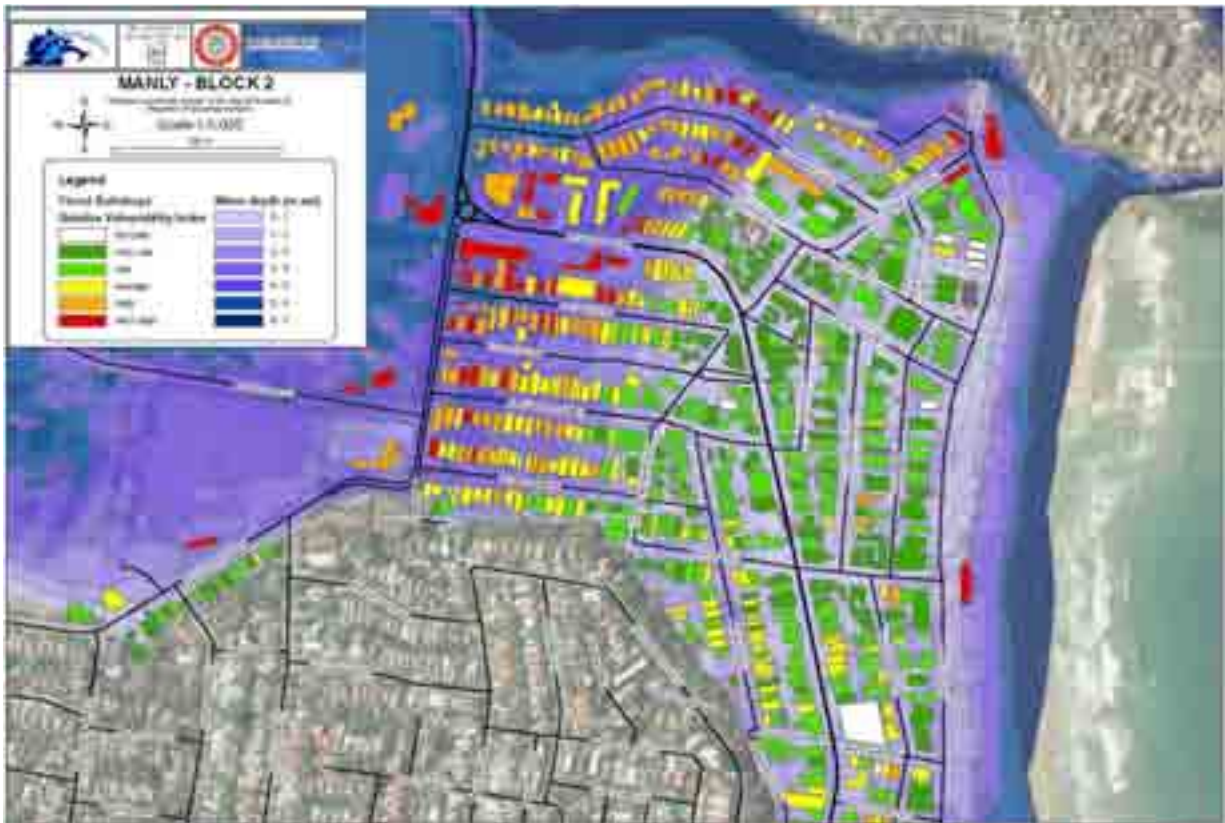
Figure 32. Inundation by the tsunami and the RVI scores in Block 2, Manly

The area of Manly Block 2 inundated by the tsunami in our scenario is indicated in Figure 32.⁴ This is a large area bounded to the north by the entrance to Manly Lagoon and to the east by the ocean. It extends as far south as Steinton Street and to the west to Pittwater and Balgowah Roads.

Examination of Figure 32 shows that a relatively large area of Block 2 would be inundated in our scenario. A large number of buildings of all types would be ‘touched’ by the flood water. This represents the total ‘exposure’ to potential damage during the

hypothetical tsunami and it is clearly high. Figure 32 also displays the calculated RVI scores of each of the buildings located within the inundation zone. It can be clearly seen that a significant percentage of buildings are classified as having “High” and “Very High” RVI scores and most of these are located in the central and northwestern portions of Block 2.
