A METHOD FOR ASSESSING THE VULNERABILITY OF BUILDINGS TO CATASTROPHIC (TSUNAMI) MARINE FLOODING

August 2009

This report “A method for assessing the vulnerability of buildings to catastrophic (tsunami) marine flooding” was prepared for the Sydney Coastal Councils Group Incorporated by:

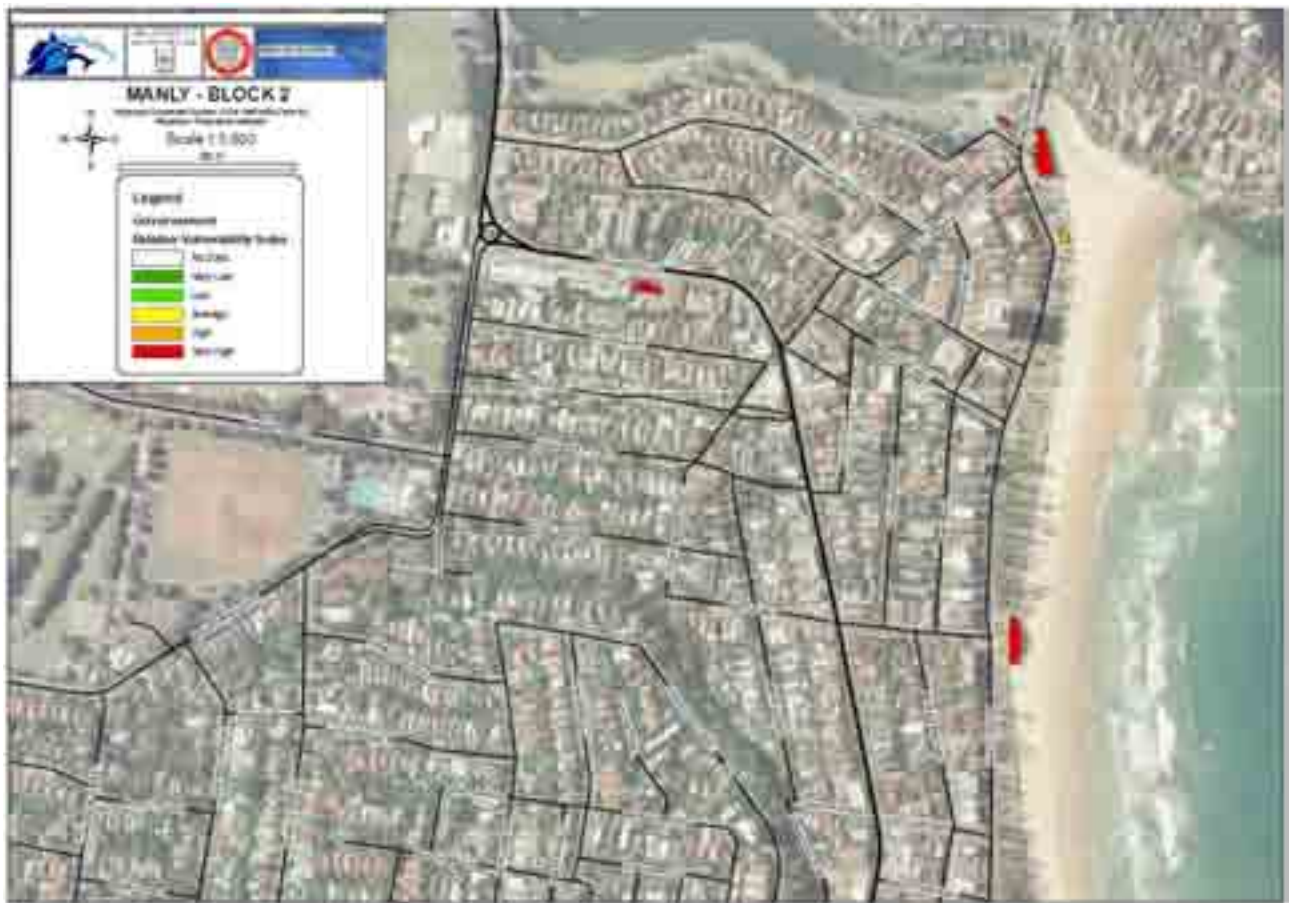
Figure 33. The distribution and final vulnerability classification of government owned-managed buildings in Block 2, Manly

Figure 33 displays the calculated RVI scores of those few buildings in Block 2 that are the responsibility of the local government. Just 5 individual buildings are the responsibility of local government. It can be seen that all these buildings have been classified as having “High” and “Very High” RVI scores.

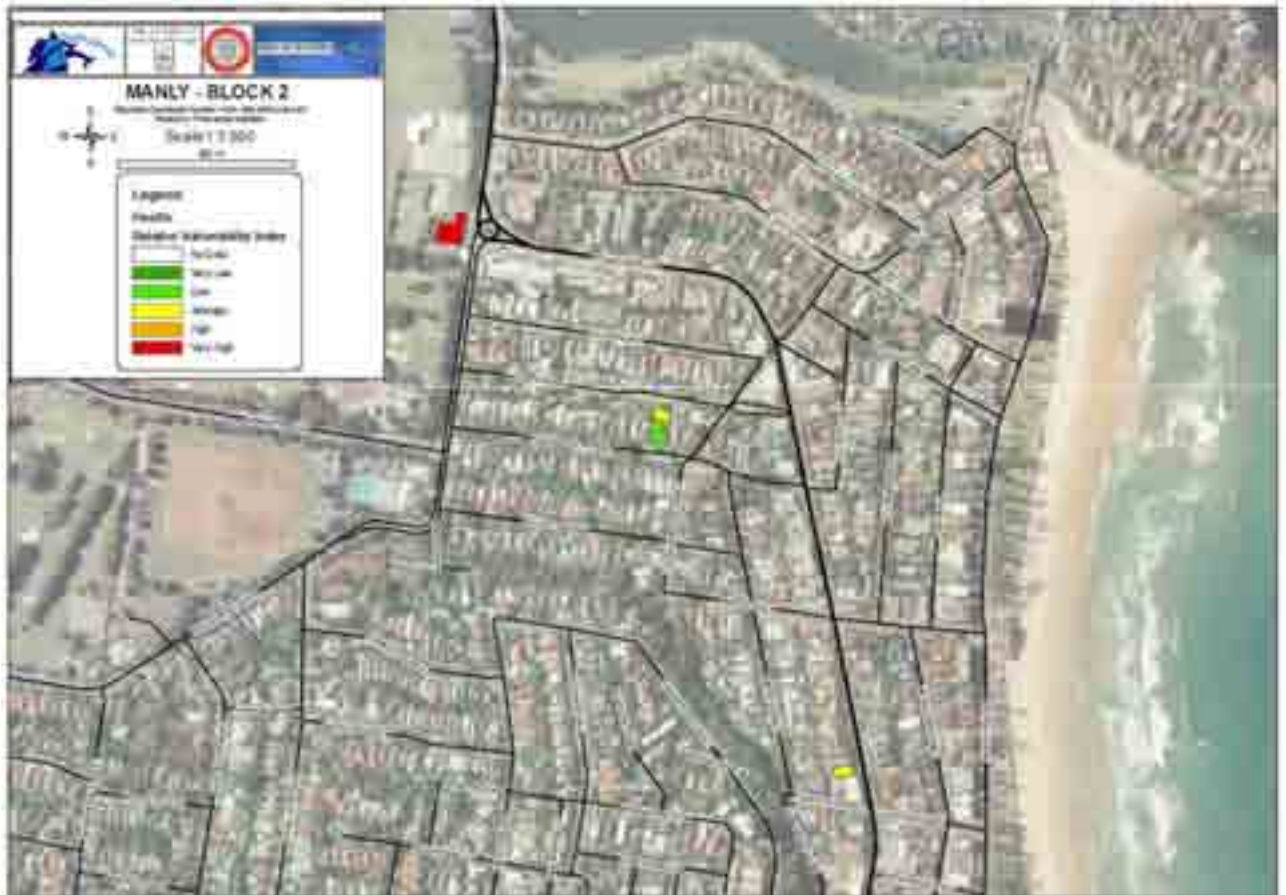
Figure 34. The vulnerability of health and medical services buildings in Block 2, Manly

Figure 34 shows the calculation of the RVI scores and the spatial distribution of those buildings in Block 2 that relate to the health and medical services sector. One building is classified as having a “Very High” RVI whereas the others have an average or lower RVI score.

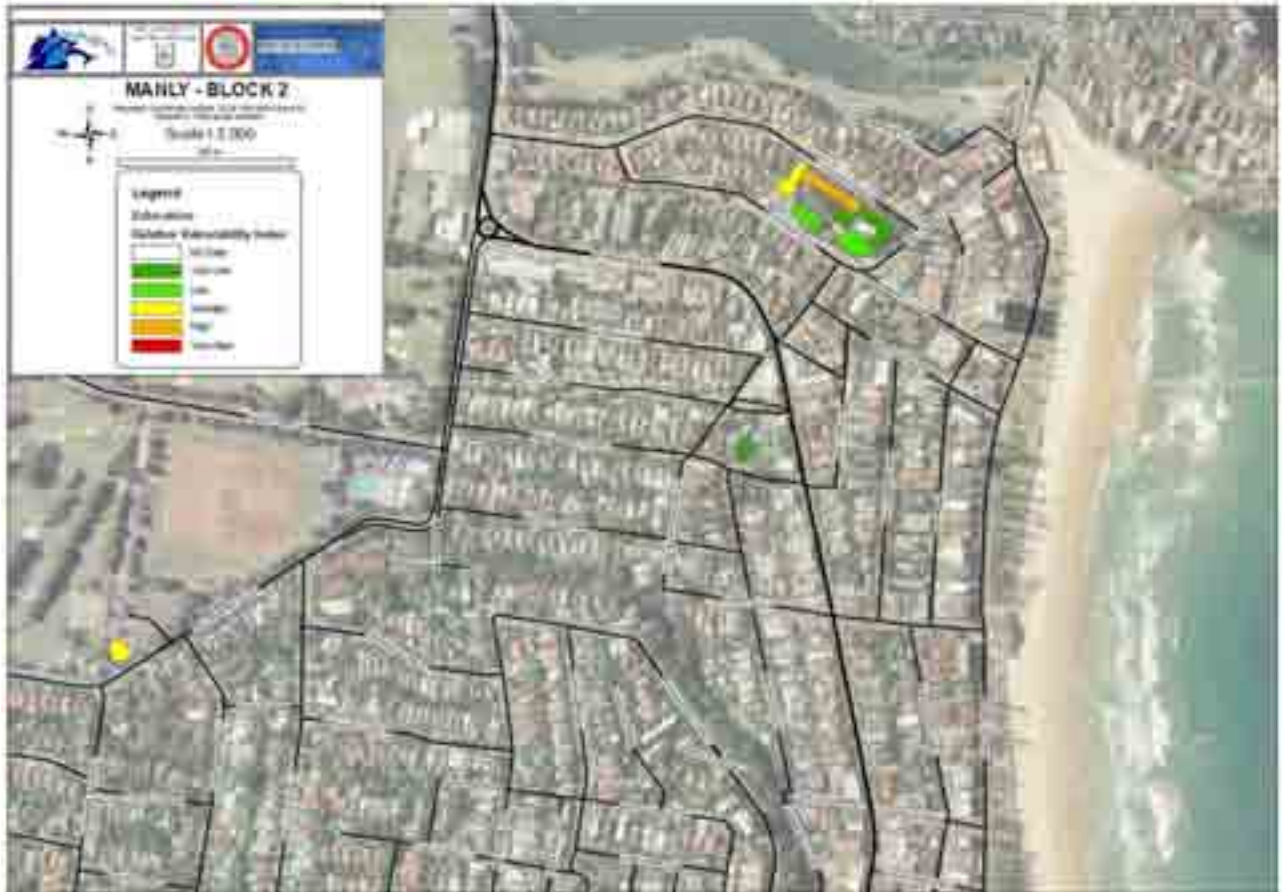
Figure 35. The vulnerability of education buildings in Block 2, Manly

Figure 35 shows the RVI scores of the small number of education buildings located within the inundation area of Block 2. These buildings have a mix of vulnerability but one, (which is a school) has a “High” RVI score.

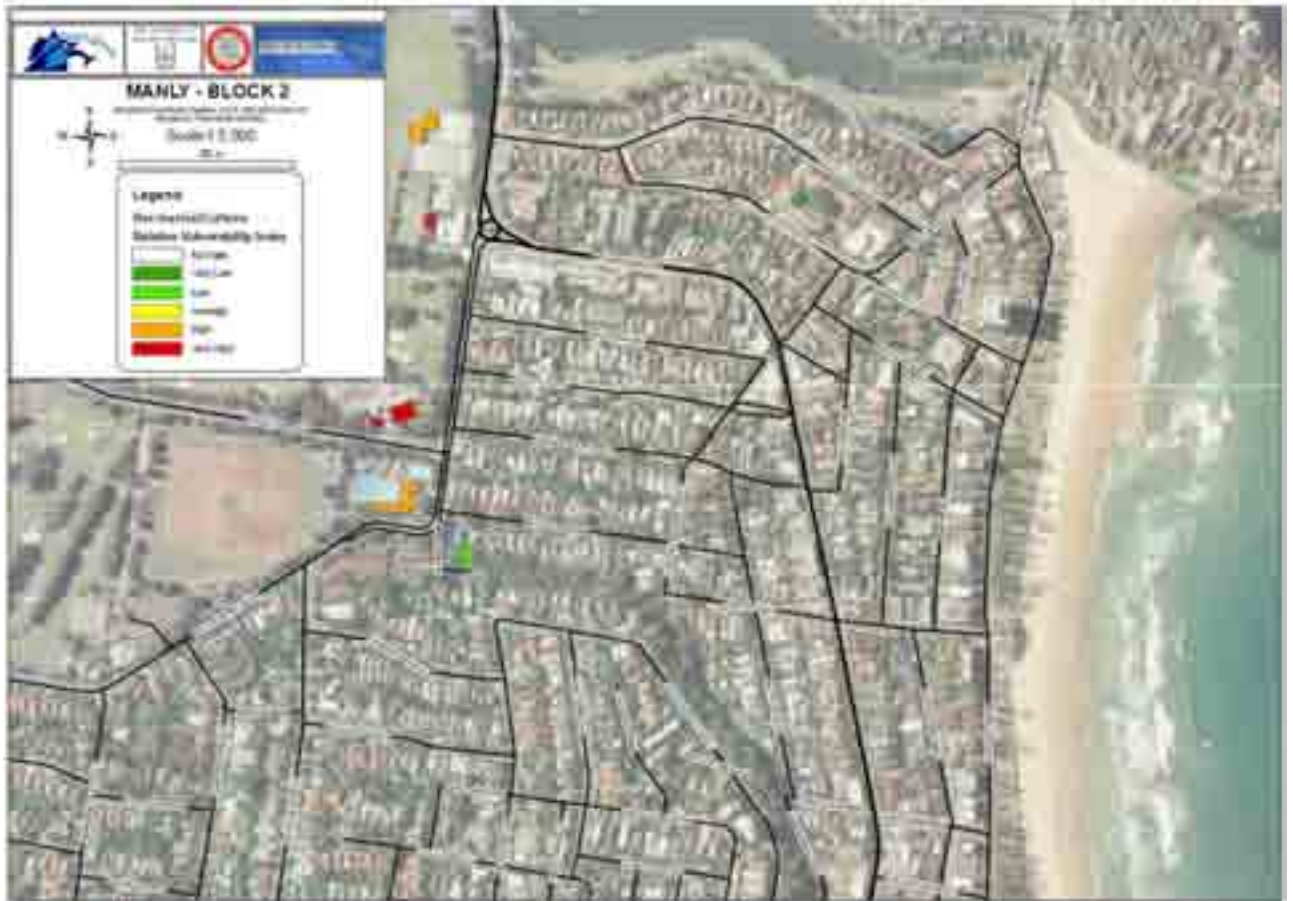
Figure 36. The vulnerability of recreational and cultural buildings in Block 2, Manly

Figure 36 displays the calculated RVI scores of the recreational and cultural buildings in Block 2. As can be seen, the majority of these buildings have been assessed as having “High” and “Very High” RVI scores.

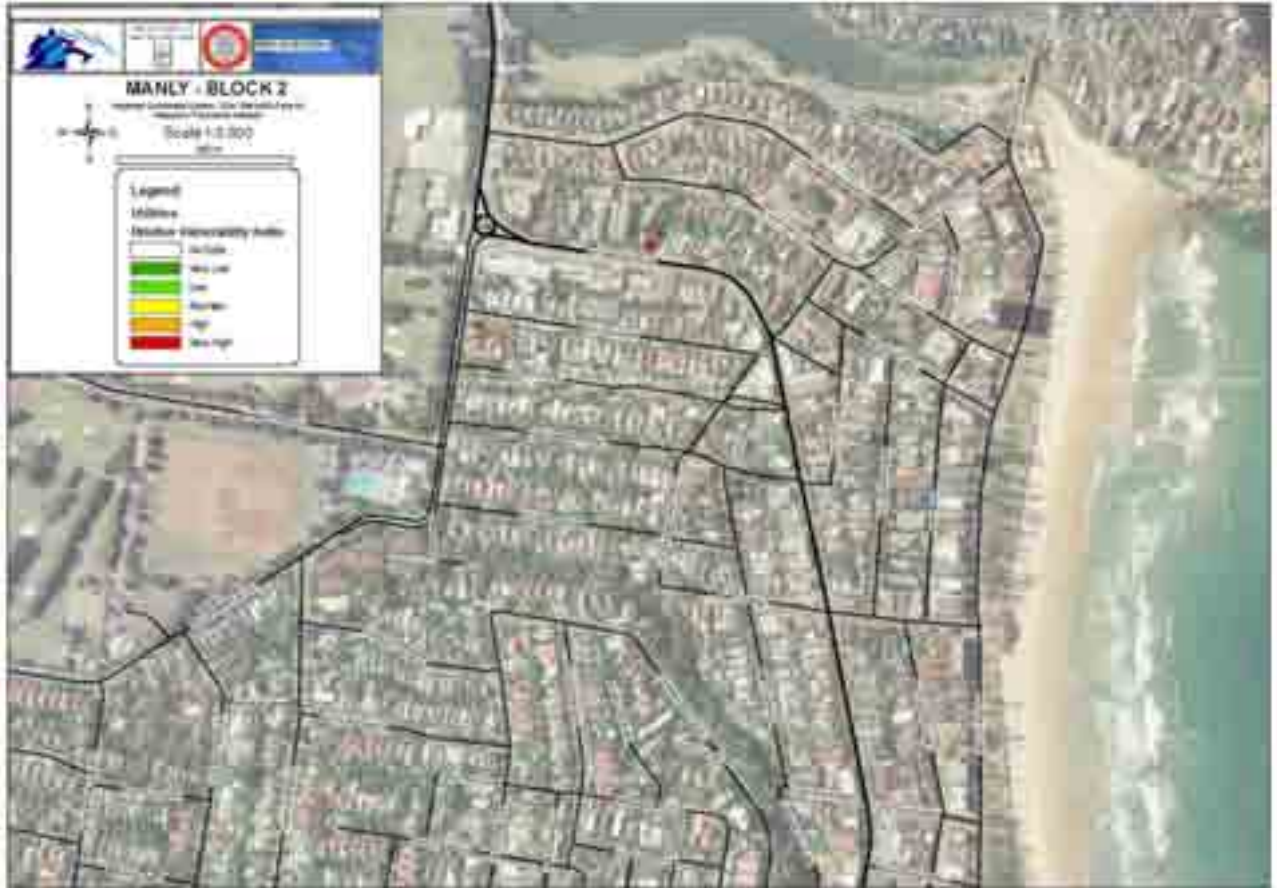
Figure 37. The vulnerability of utility buildings in Block 2, Manly

Figure 37 displays the calculated RVI scores of buildings belonging to the utilities of water, gas and electricity services in Block 2 located within the tsunami inundation zone. They have all been assessed as having “High” and “Very High” RVI scores in spite of being located some distance from the shore.

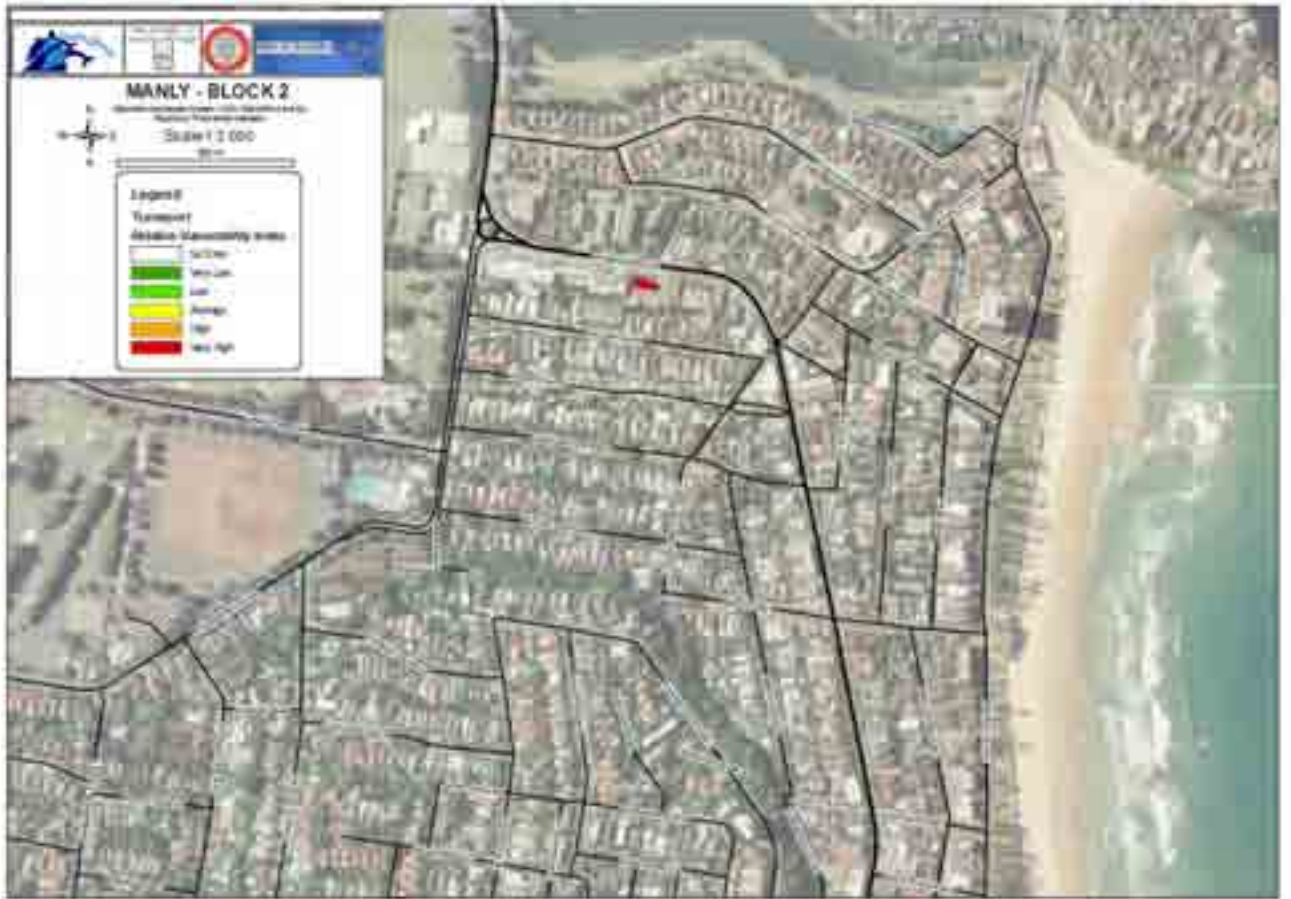
Figure 38. The vulnerability of the transport system building, Block 2, Manly

Figure 38 shows the calculated RVI score of the only transport system building located within the tsunami inundation zone of Block 2 (the RTA motor registry). It is classified as having a “Very High” RVI score.

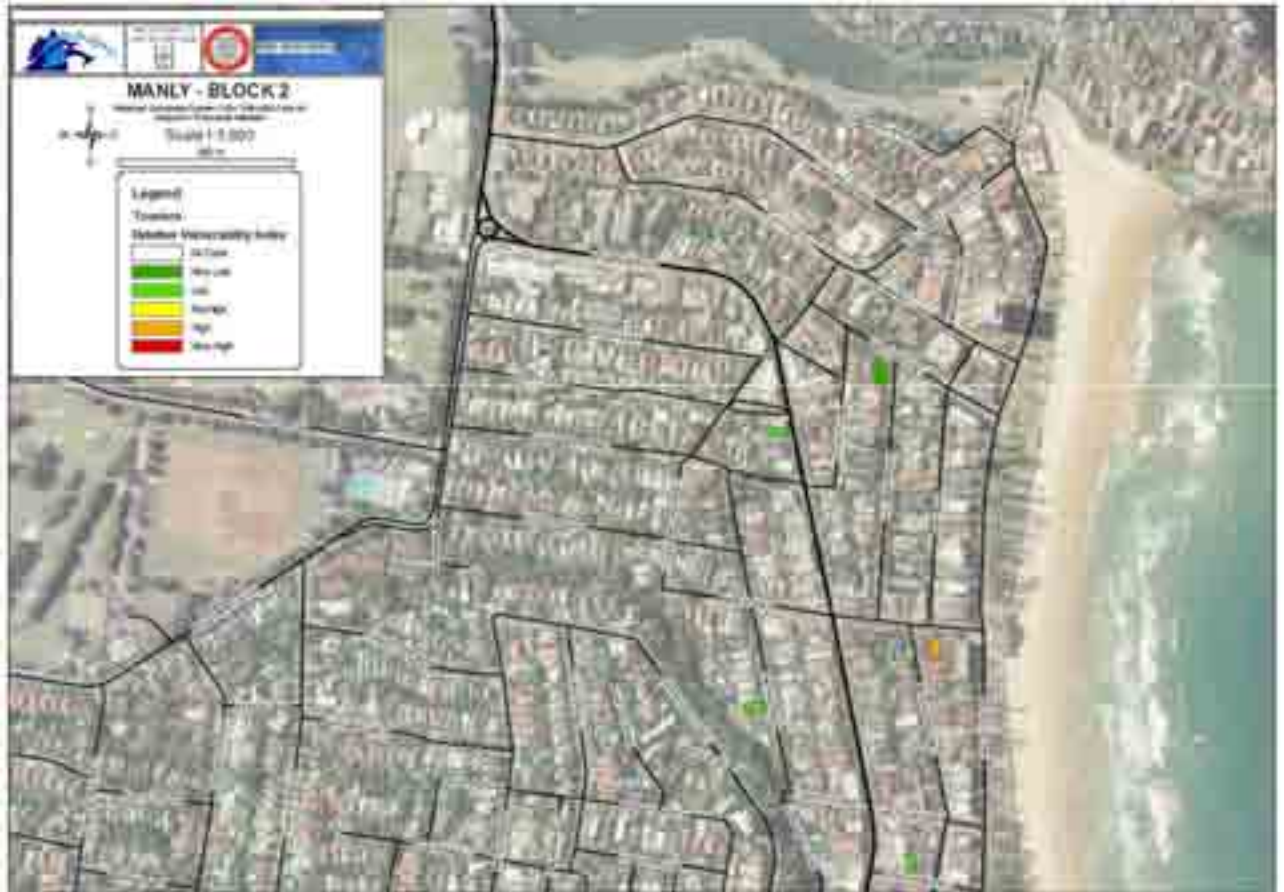
Figure 39. The vulnerability of tourism buildings in Block 2, Manly

Figure 39 shows the calculated RVI scores for and spatial distribution of those buildings associated with the tourism sector within Block 2. Of these, just one has been classified as having a “High” RVI score.

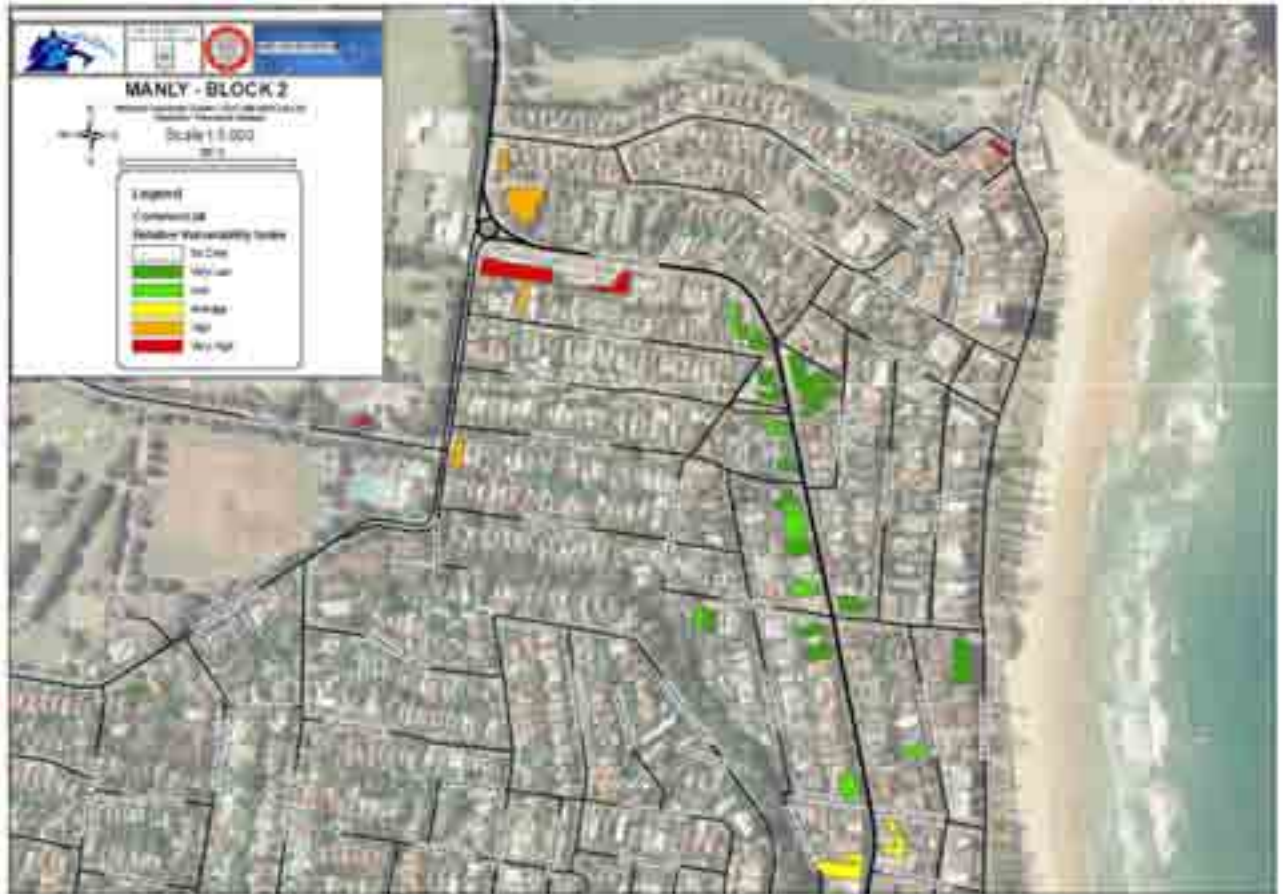
Figure 40. The final RVI scores of the commercial buildings Block 2, Manly

Figure 40 displays the spatial distribution and calculated RVI scores for the commercial buildings located within the tsunami inundation zone of Block 2. Most buildings have been assessed as having either “Low” or “Very Low” RVI scores. However, a few buildings have been assessed as having “Average”, “High” or “Very High” RVI scores.

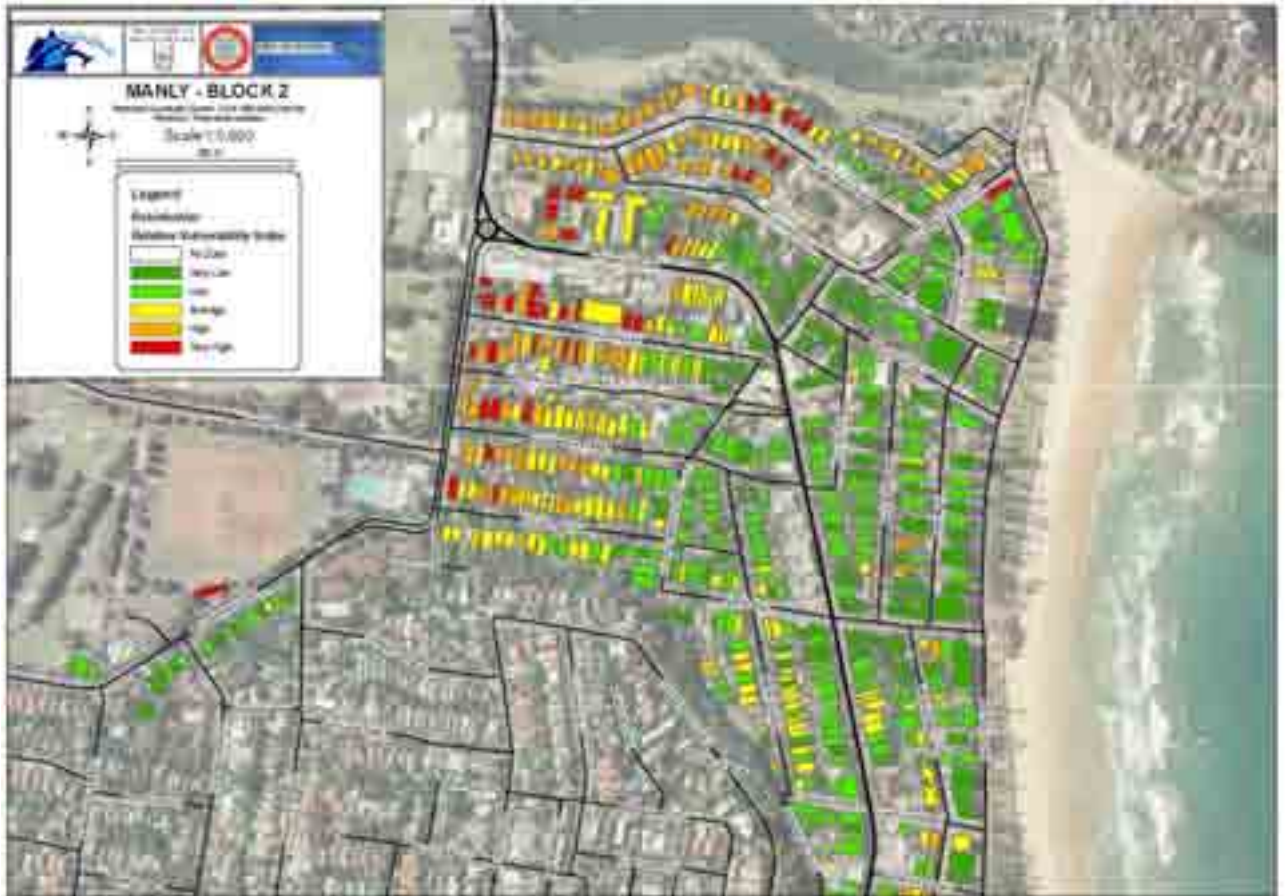
Figure 41. The RVI scores of residential buildings in Block 2, Manly

Located within the tsunami inundation zone of Block 2, Manly are a large number of residential structures. Their spatial distribution and calculated RVI scores are displayed in Figure 41. As an interesting observation, the majority of residential buildings located in the seaward sections of the study area are actually classified as having “Average”, “Low” and “Very Low” RVI scores even though they are ‘closer’ to the sea and initial point of inundation.

With regard to the residential buildings located in Block 2, Manly (Figure 41), it is apparent that most structures closer to the sea are in fact, assessed as having ‘lower’ RVI scores than those further inland. For many this will be counter intuitive but the lower vulnerability of these structures is because generally speaking, they are much newer than those located farther away from the shoreline, are in better condition and have been built to newer, higher standards and specifications.

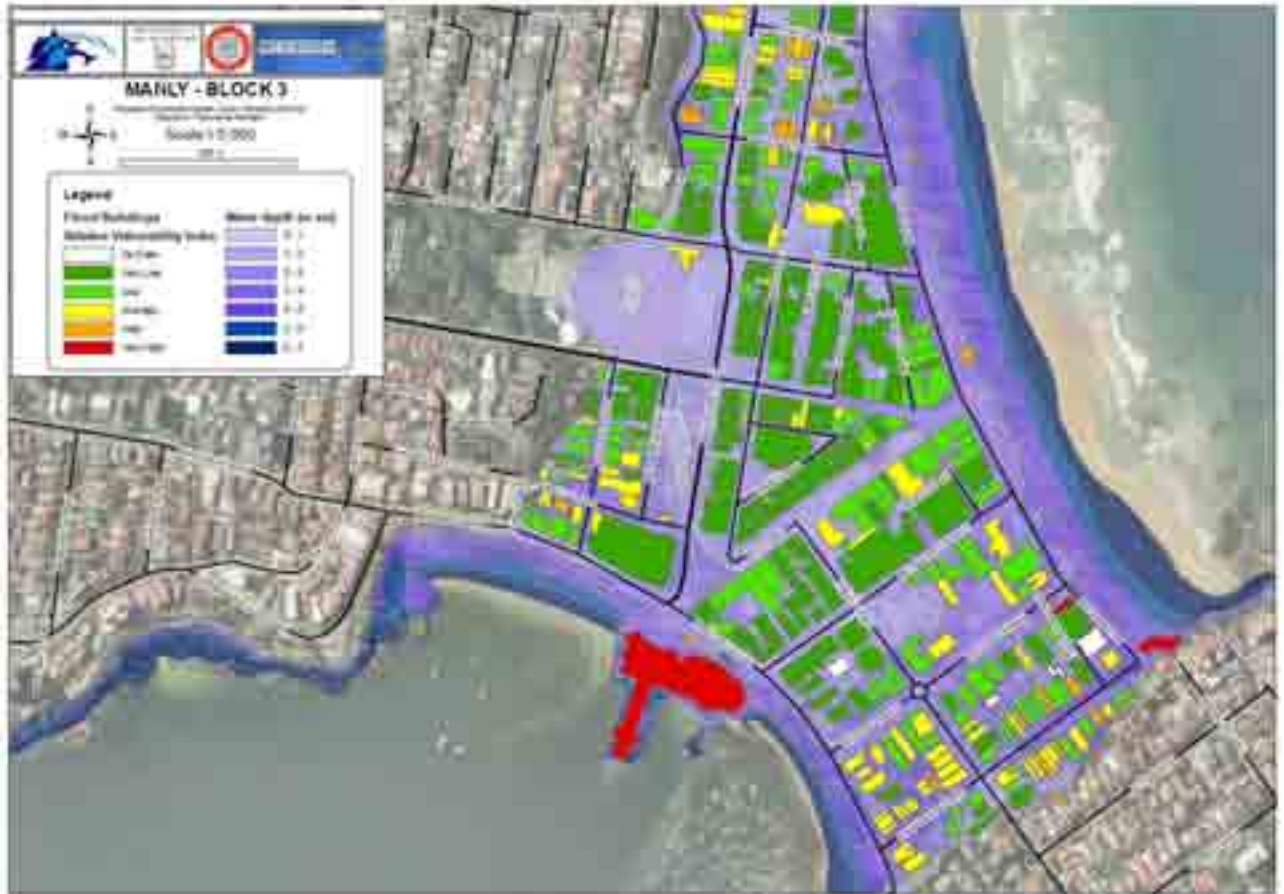
Figure 42. Tsunami inundation and RVI scores in Block 3, Manly

The area of Manly Block 3 inundated by the tsunami in our scenario is shown in Figure 42⁵.

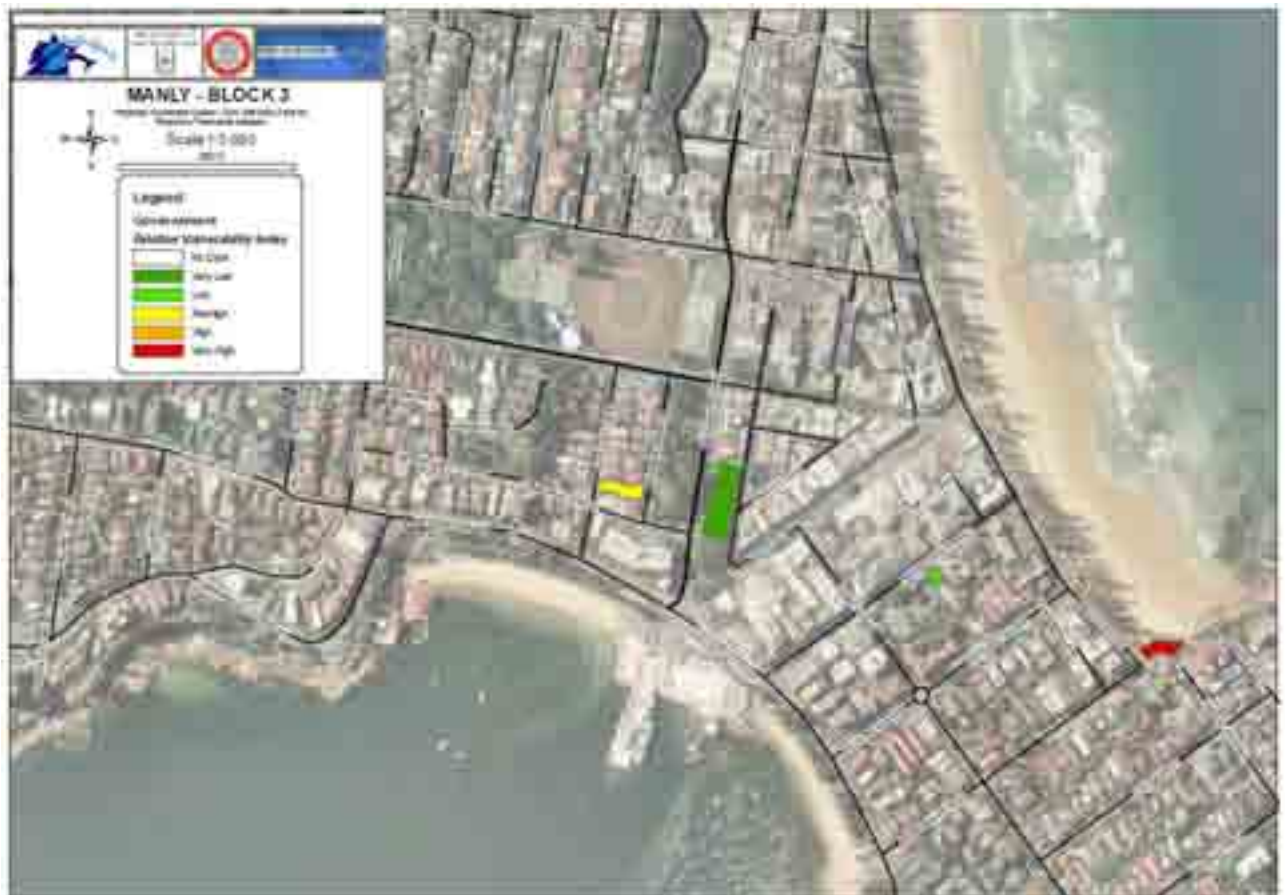
Figure 43. The distribution and final RVI scores of government buildings in Block 3, Manly

Figure 43 shows the calculated RVI scores and the spatial distribution of those local government buildings present within Block 3, Manly. Of these, just two are classified as having “Very High” RVI scores. One is the South Manly Surf Life Saving Club, and the other is a public seating structure on the promenade.

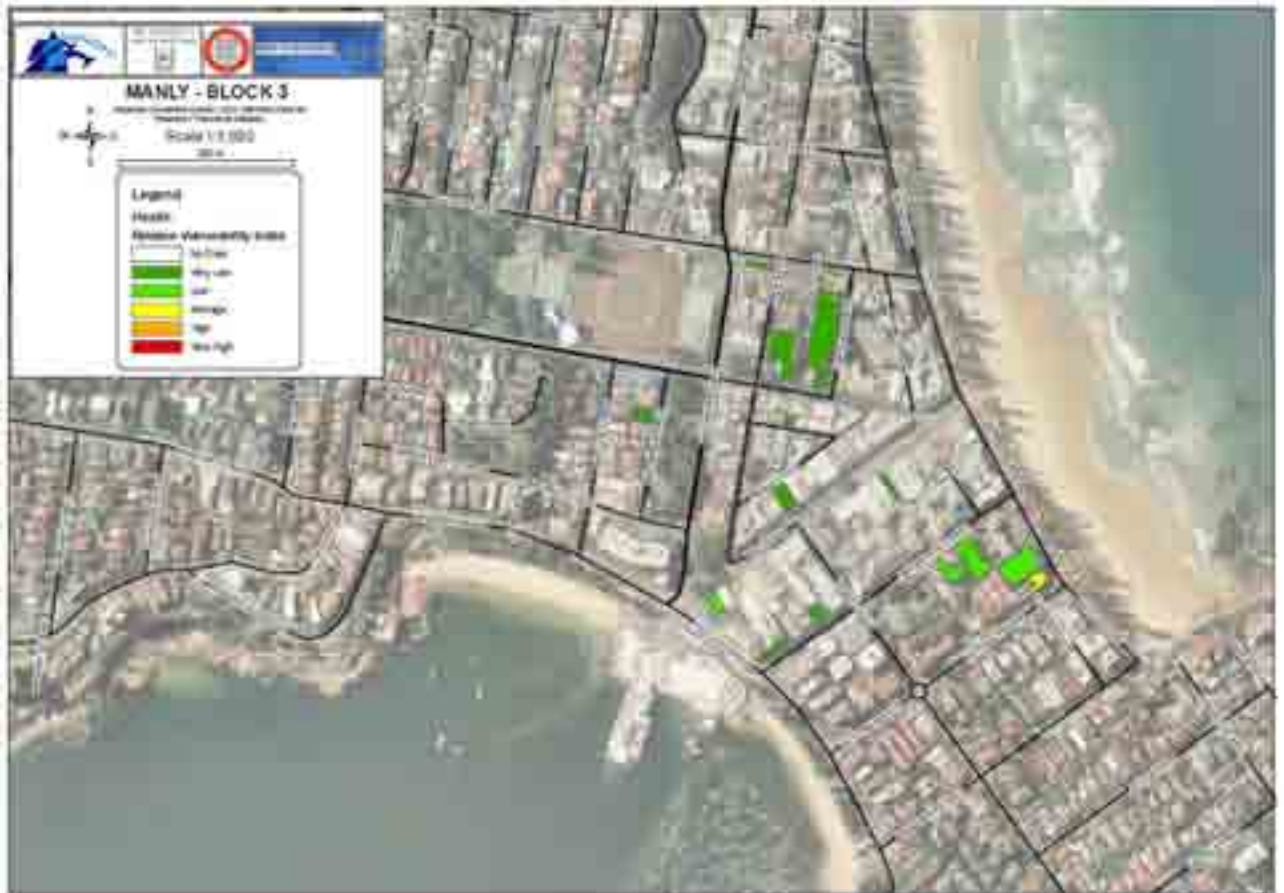
Figure 44. The RVI scores of health and medical services buildings in Block 3, Manly

Figure 44 displays the spatial distribution and calculated RVI scores of the health and medical services buildings located within the Block 3 area. Just one building has been classified as having an “Average” RVI score. The others have “Low” and “Very Low” RVI scores.

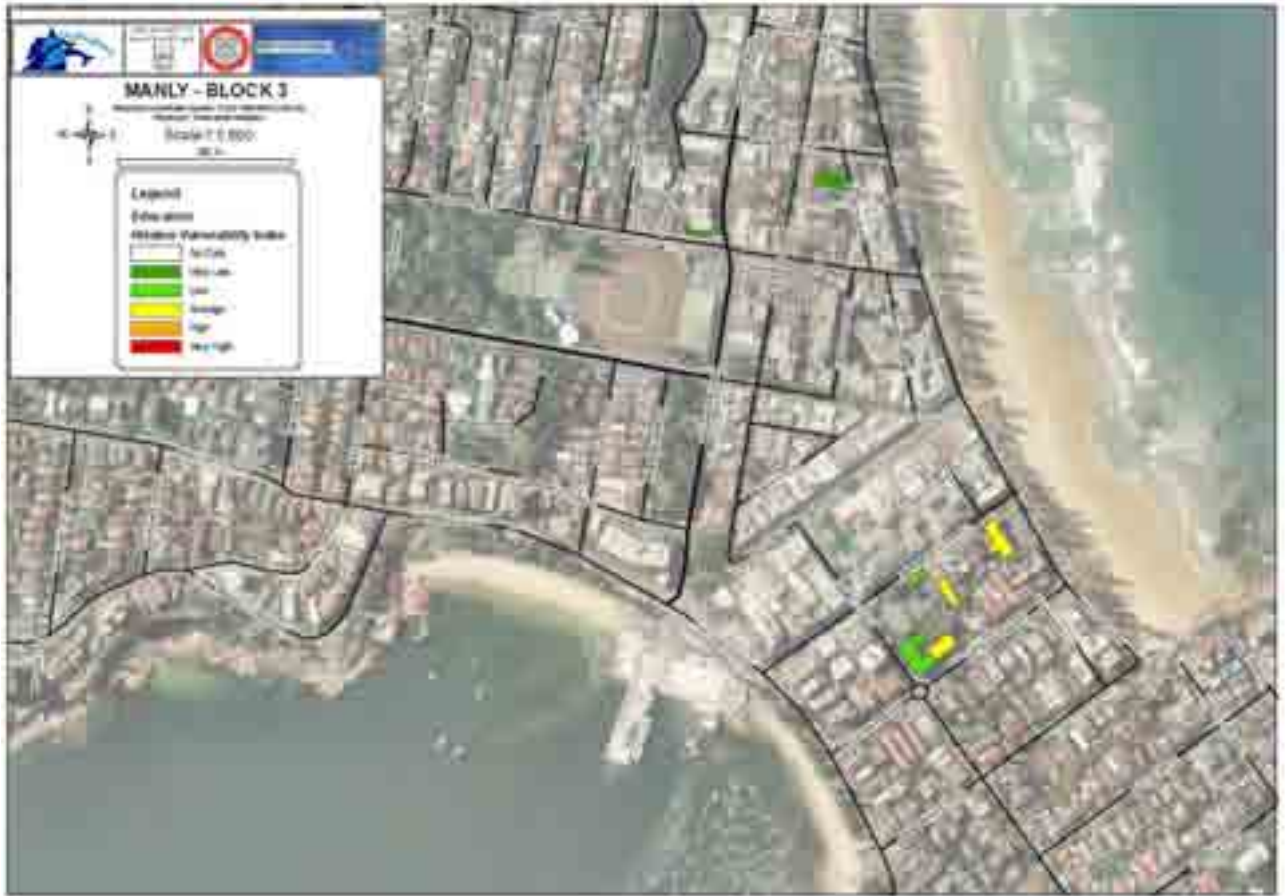
Figure 45. The RVI scores of health and medical services buildings in Block 3, Manly

Within the Block 3 area of Manly, just a handful of buildings are associated with the education sector. Figure 45 shows the calculated RVI scores for these buildings and their locations. It can be seen that three of them have been classified as having “Average” RVI scores.

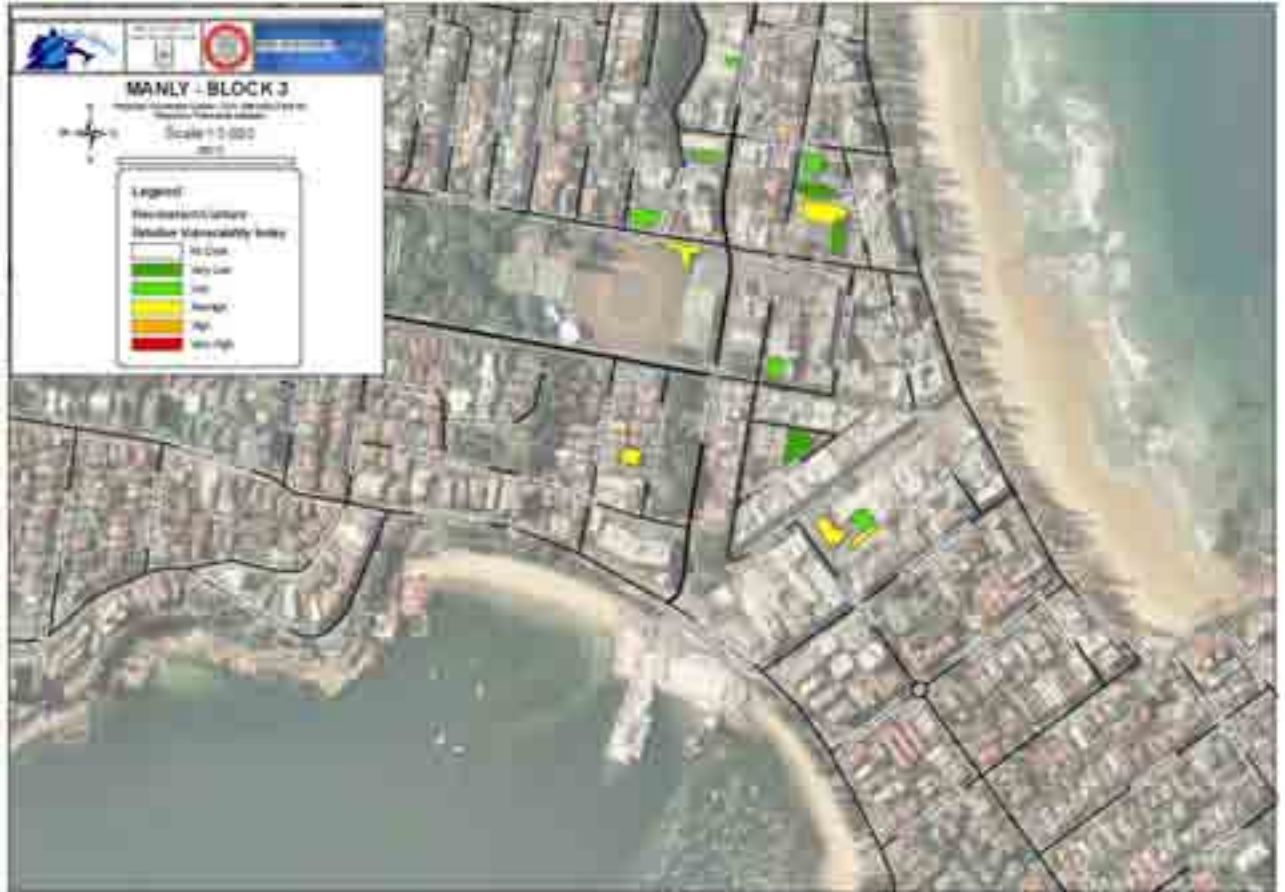
Figure 46. The vulnerability (RVI) scores of recreational and cultural buildings in Block 3, Manly

Within the Block 3 area of Manly, a relatively small number of buildings are associated with recreation and cultural activities. Figure 46 shows the calculated RVI scores of each of these buildings and their locations. One third of these buildings have been assessed as having “Average” RVI scores and the rest are classified as “Low” and “Very Low” RVI.

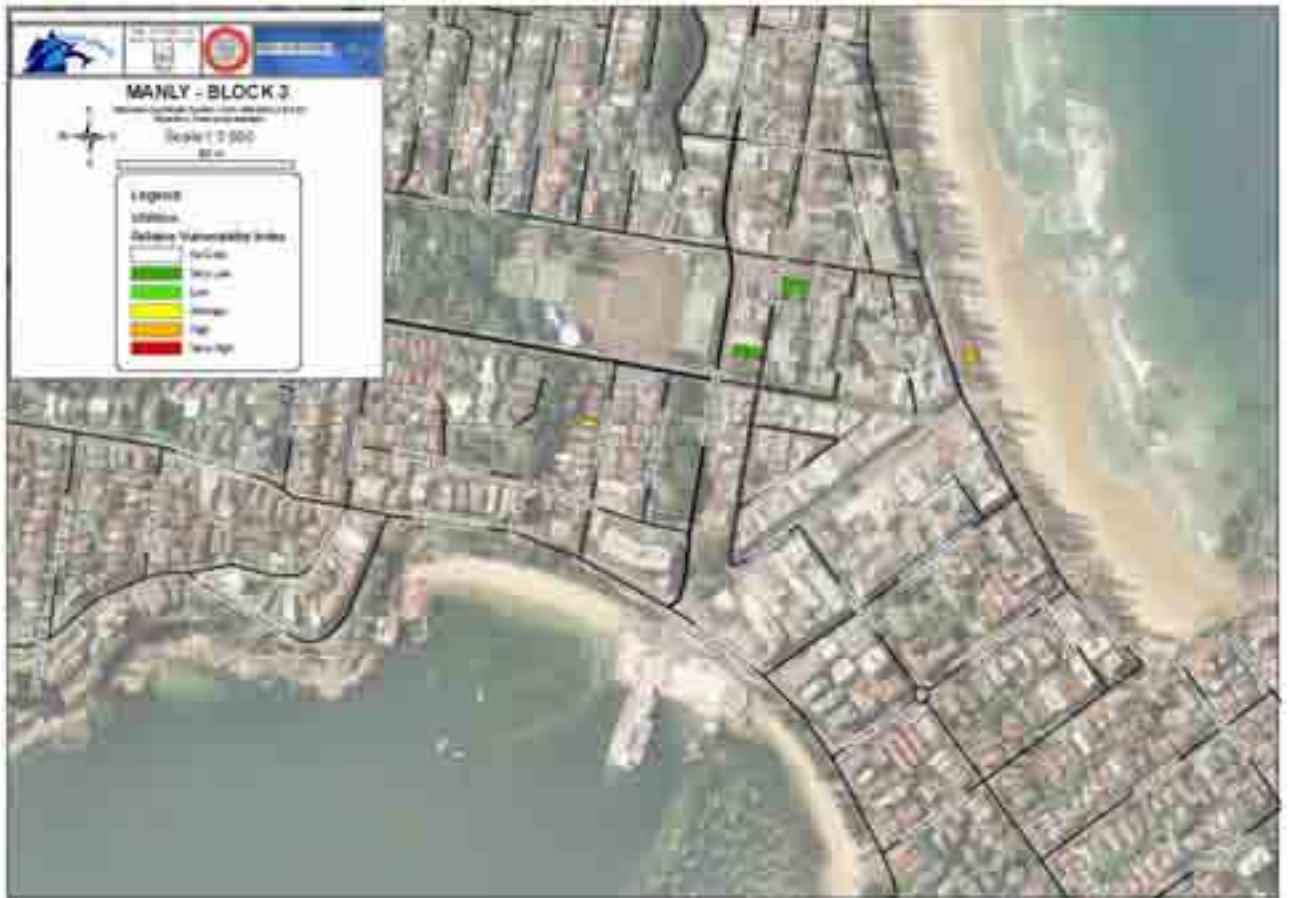
Figure 47. The RVI values of the utility buildings in Block 3, Manly

A very small number of individual buildings belonging to the utilities sector are present within the tsunami inundation zone of Block 3. The locations and RVI scores of these buildings are displayed in Figure 47. Of these, one building is classified as having a “High” RVI score. The remaining buildings have all been assessed as having lower RVI scores.

Figure 57 indicates that only a very small number of individual buildings associated with the utilities sector are located within the Manly Block 4 area (5 of them fall below the legend, but they are visible in Block 3, Figure 47). The visible building is an electric station and it has been classified as having an “Average” RVI score.

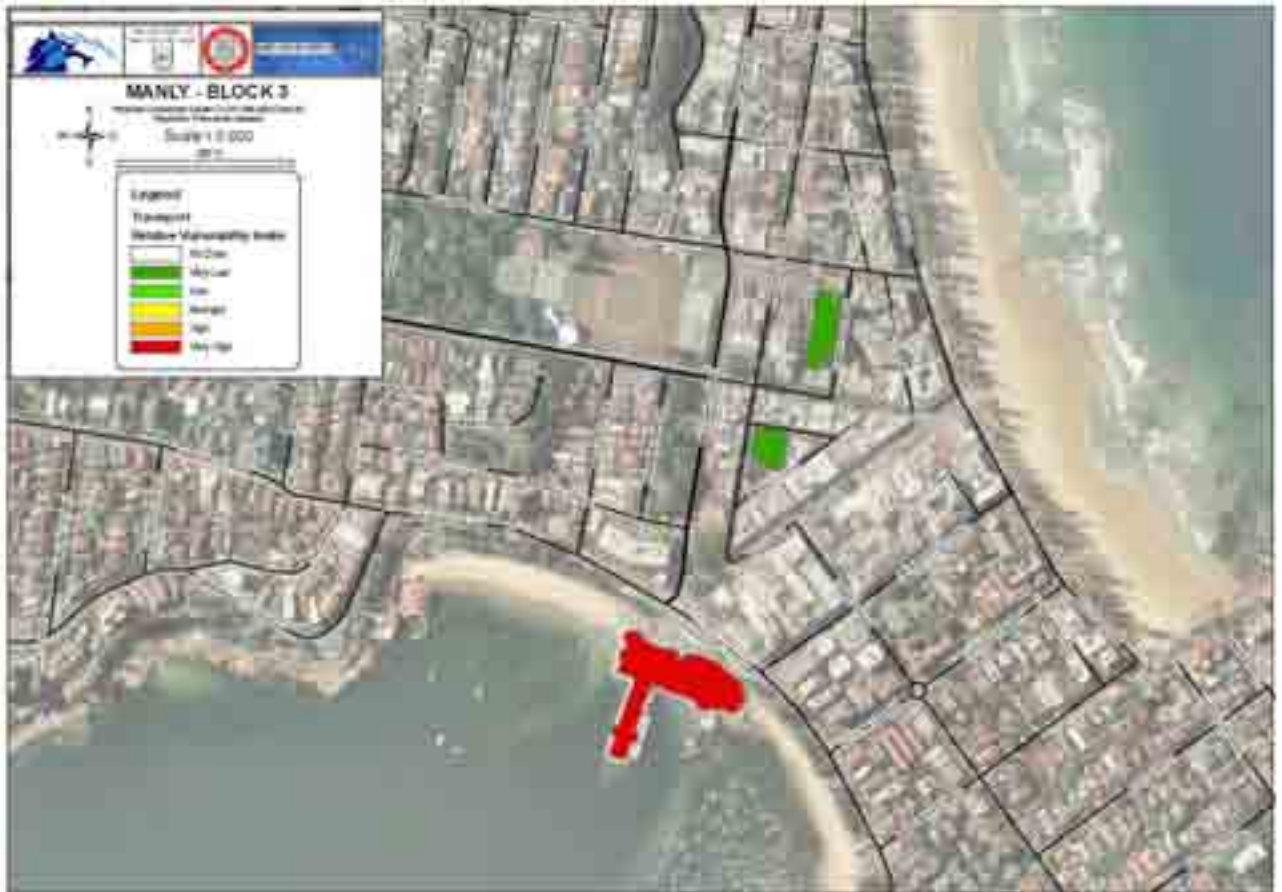
Figure 48. The vulnerability (RVI) scores of transport system buildings in Manly Block 3

Within the Block 3 study area of Manly, only a small number of buildings are related to the transport services sector. Of these, the most significant is Manly Wharf located on the harbour side of the inundation zone. Figure 48 displays the calculated RVI scores of these buildings and their exact locations. The only problematic building structure is Manly Wharf which has been classified as having a “Very High” RVI score.

Figure 58 shows the calculated RVI scores and spatial distribution of the extremely small number of transport related building structures located within the Block 4 area of Manly. One of them is located behind the legend, but it can be seen in Block 3, Figure 48). Just one building - Manly Wharf has been assessed as having a “Very High” RVI score.

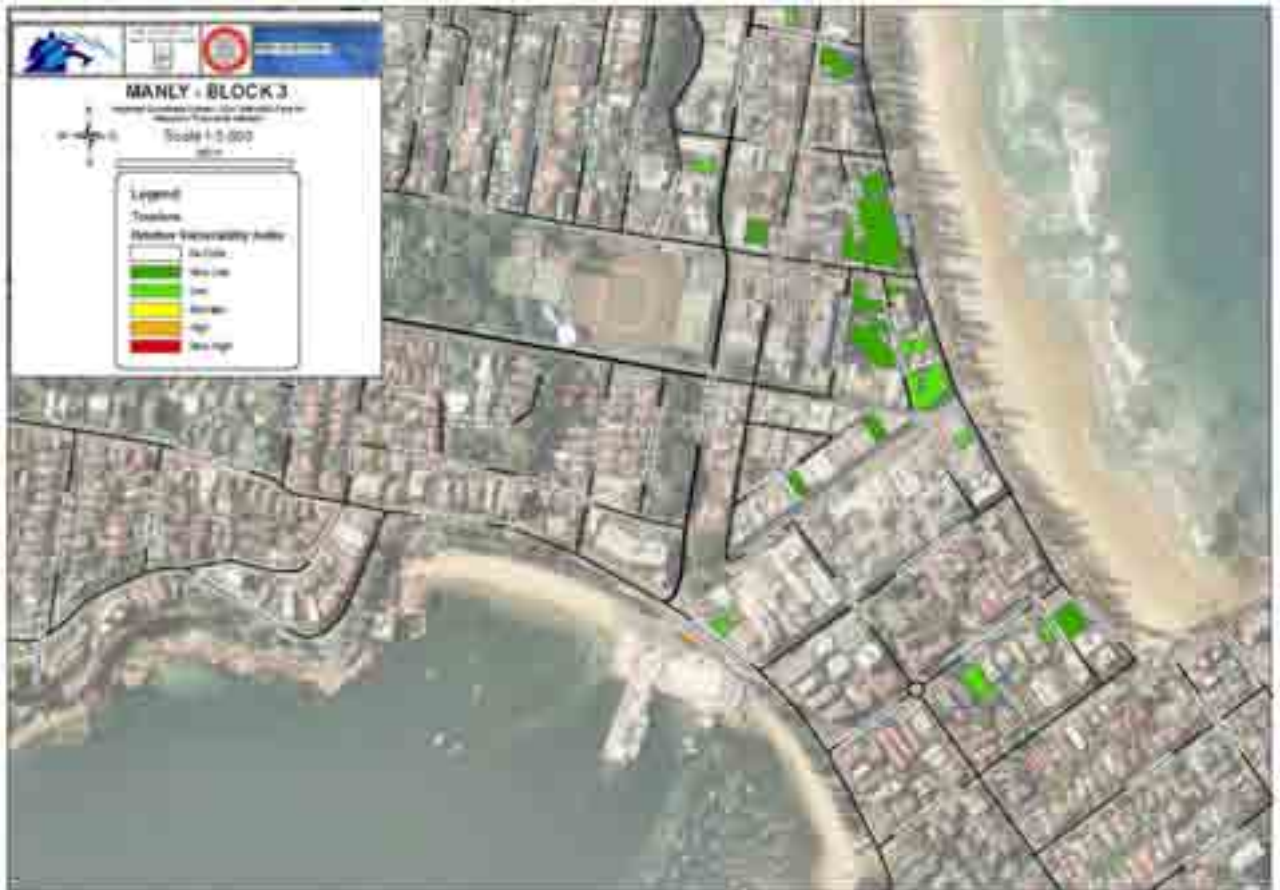
Figure 49. The RVI values for the tourism buildings located within Block 3, Manly

Manly is an iconic Australian tourism destination and this importance is reflected in the relatively large number of tourism related buildings located within the Block 3 area of Manly (Figure 49). Of these, just one (the Tourism Information Office outside Manly Wharf) has been classified as having a “High” RVI score. The remaining buildings have all been classified as having “Average” or lower RVI scores.

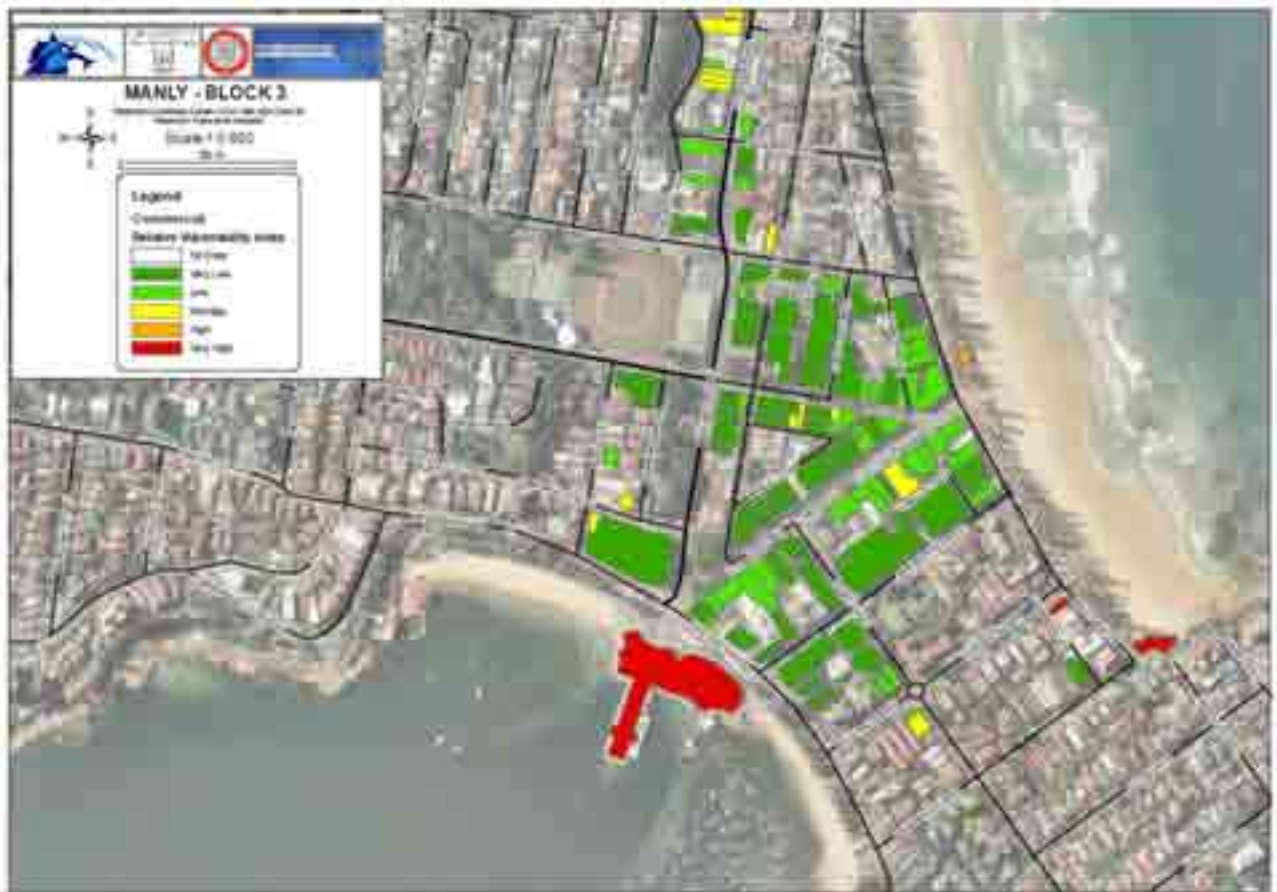
Figure 50. The vulnerability of commercial buildings in Manly Block 3 according to their RVI scores

Since Block 3 incorporates the commercial heart of Manly, it has the highest number of commercial building structures of any part of this study. Their distribution and calculated RVI scores are shown in Figure 50. It should be noted that Manly Wharf appears under this classification as well as the transport sector since individual commercial business operators are located within the wharf structure. These individual business operators have been joined together as a 'single' business within our analysis. Of all of the commercial buildings present in Block 3, just three have been classified as having "Very High" RVI scores and just one was classified as having a "High" RVI score. The remaining buildings have been assessed as having RVI scores of "Average" or lower.
