A METHOD FOR ASSESSING THE VULNERABILITY OF BUILDINGS TO CATASTROPHIC (TSUNAMI) MARINE FLOODING

August 2009

This report “A method for assessing the vulnerability of buildings to catastrophic (tsunami) marine flooding” was prepared for the Sydney Coastal Councils Group Incorporated by:

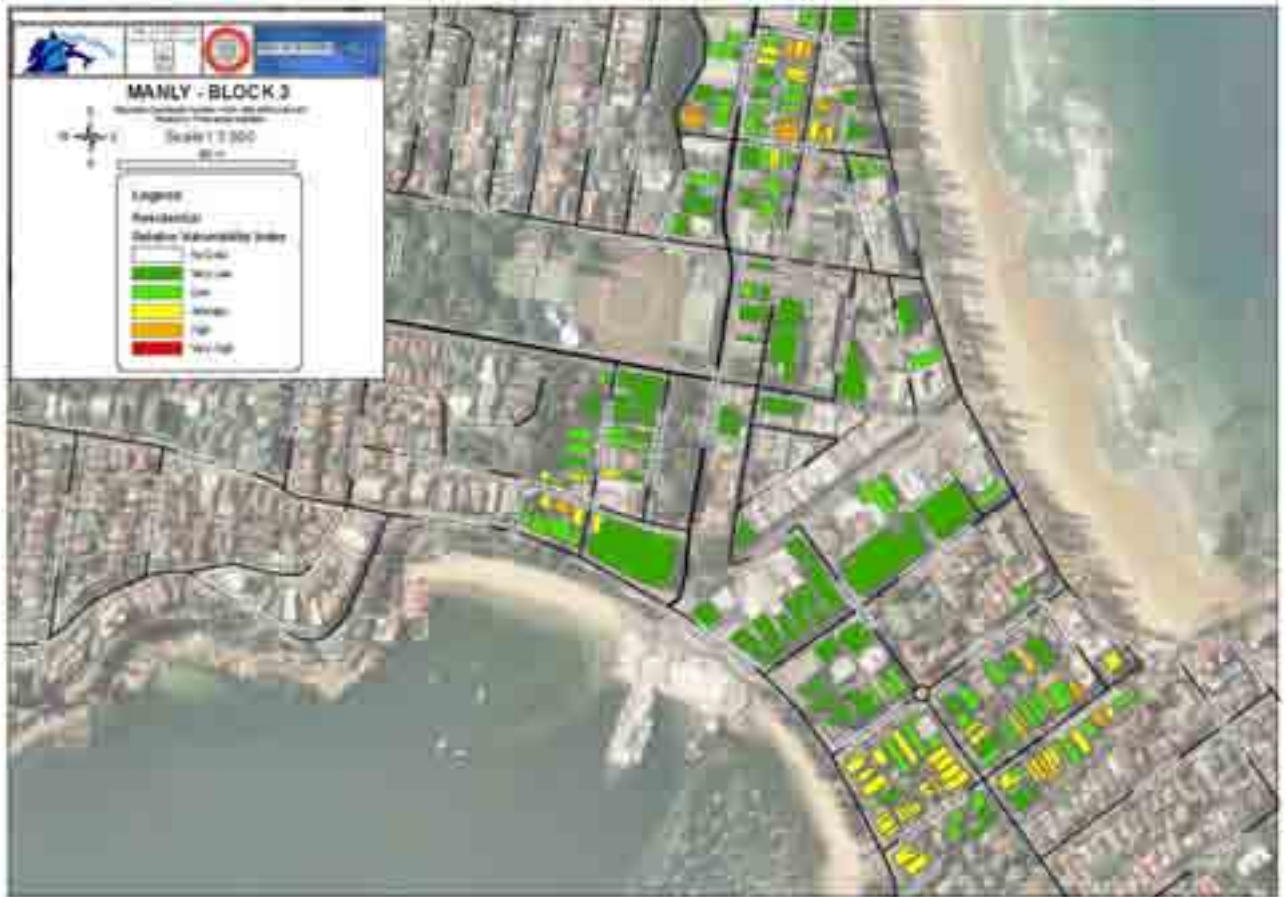
Figure 51. The RVI scores of residential buildings in Manly Block 3

There are a moderately large number of residential buildings within Block 3. Due to the nature and character of Manly, most residential structures in Block 3 are actually multi-dwelling, multi-story buildings rather than separate houses. The exact location and calculated RVI scores for each of these residential buildings is shown in Figure 51. The vast majority of these residential structures have been assessed as having “Average”, “Low” and “Very Low” RVI scores. Only a small number of buildings are assessed as having “High” RVI scores.

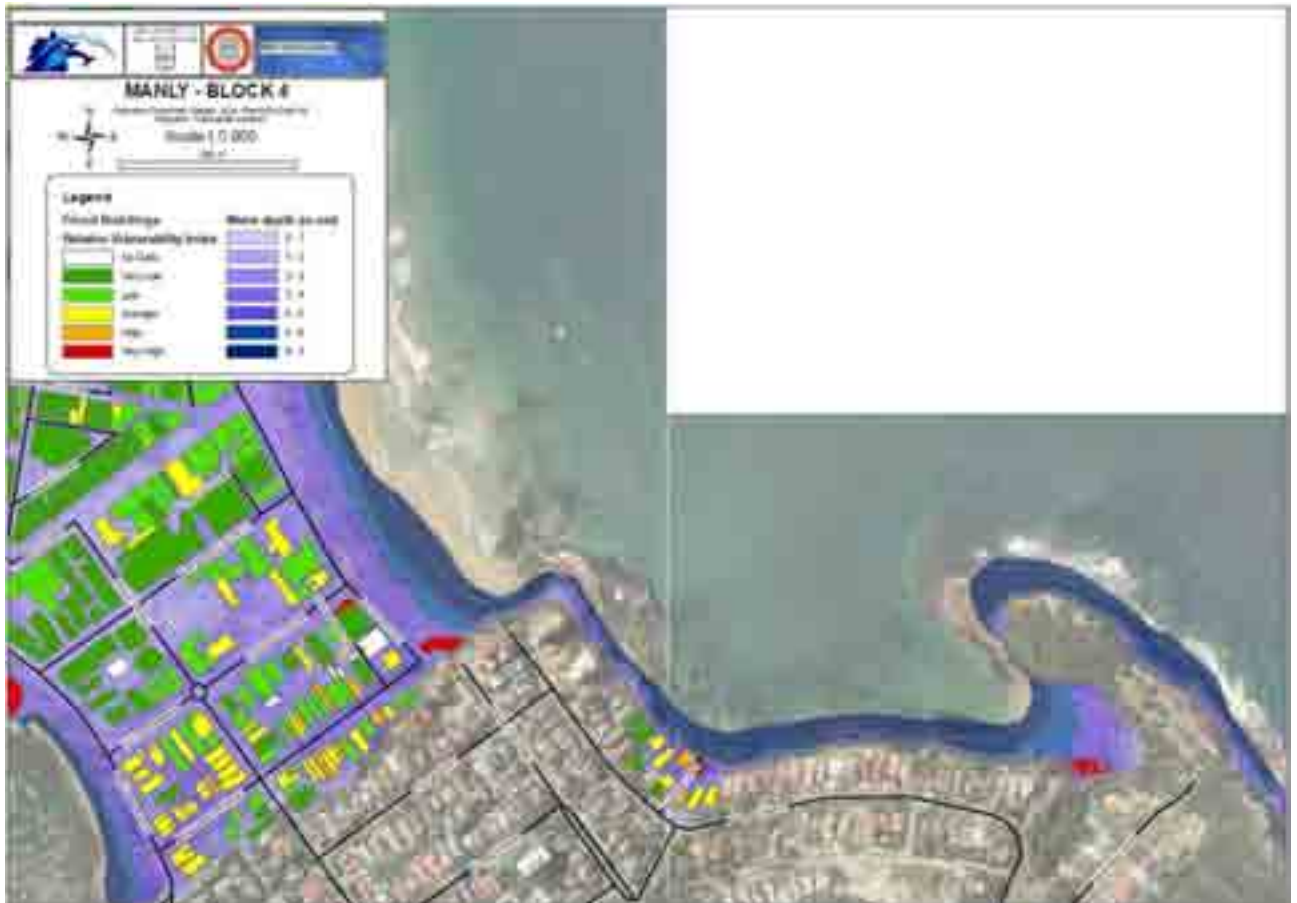
Figure 52. The inundation of Block 4, Manly

The total area of Block 4 inundated in our scenario is indicated in Figure 52.

Examination of Fig 52 indicates that a relatively large area of Block 4 would be inundated during our scenario – mostly towards the commercial centre of Manly (which was presented in Section 3.3.3). A moderately large number of buildings of all types would be ‘touched’ by flood water during this event. This represents the total ‘exposure’ to potential damage. Figure 52 also displays the calculated RVI scores of each of the buildings located within the inundation zone.

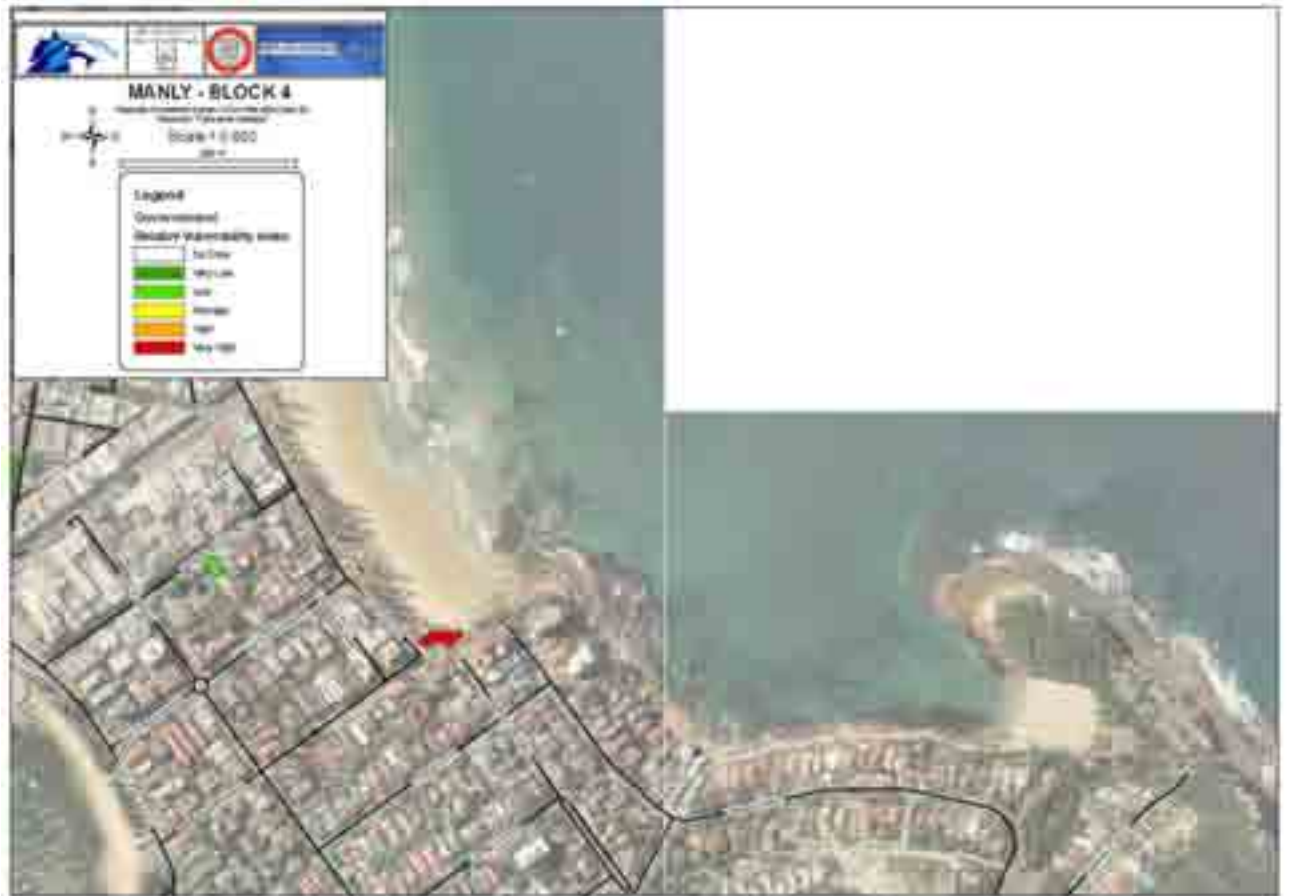
Figure 53. The distribution and final RVI scores of local government buildings in Manly Block

Figure 53 shows the calculated RVI scores of the small number of buildings in Manly Block 4 that are the responsibility of local government. Two of these buildings has been classified as having “Very High” RVI scores – the Manly Surf Life Saving Club (both dealt with by the analysis of Block 3 structures) at the southern end of Manly Beach and a shelter structure on the main South Steyne Promenade.

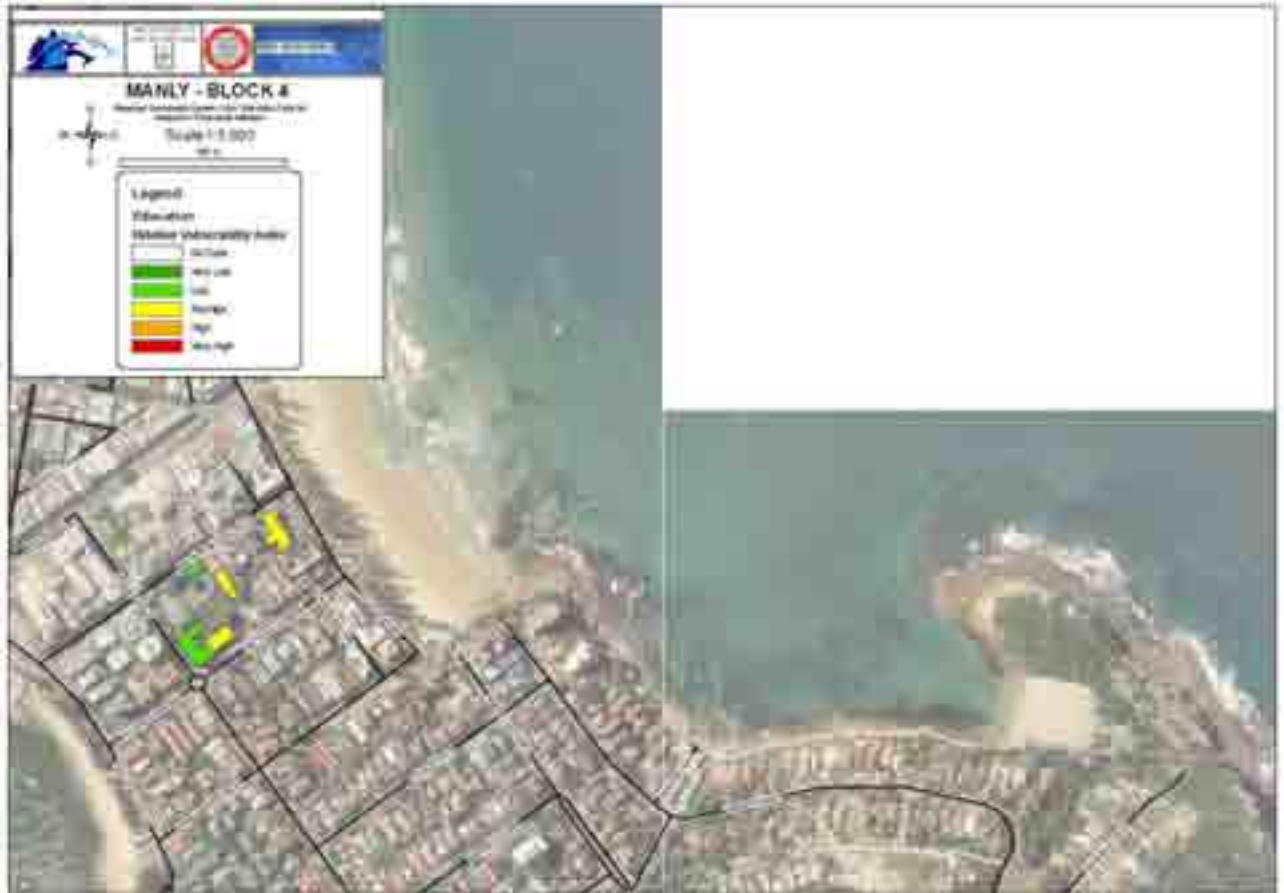
Figure 55. The vulnerability of the education buildings in the Manly Block 4 area

Figure 55 displays the distribution and calculated RVI scores of the small number of buildings within Block 4 that relate to the education sector. Three of these are classified as having “Average” RVI scores.

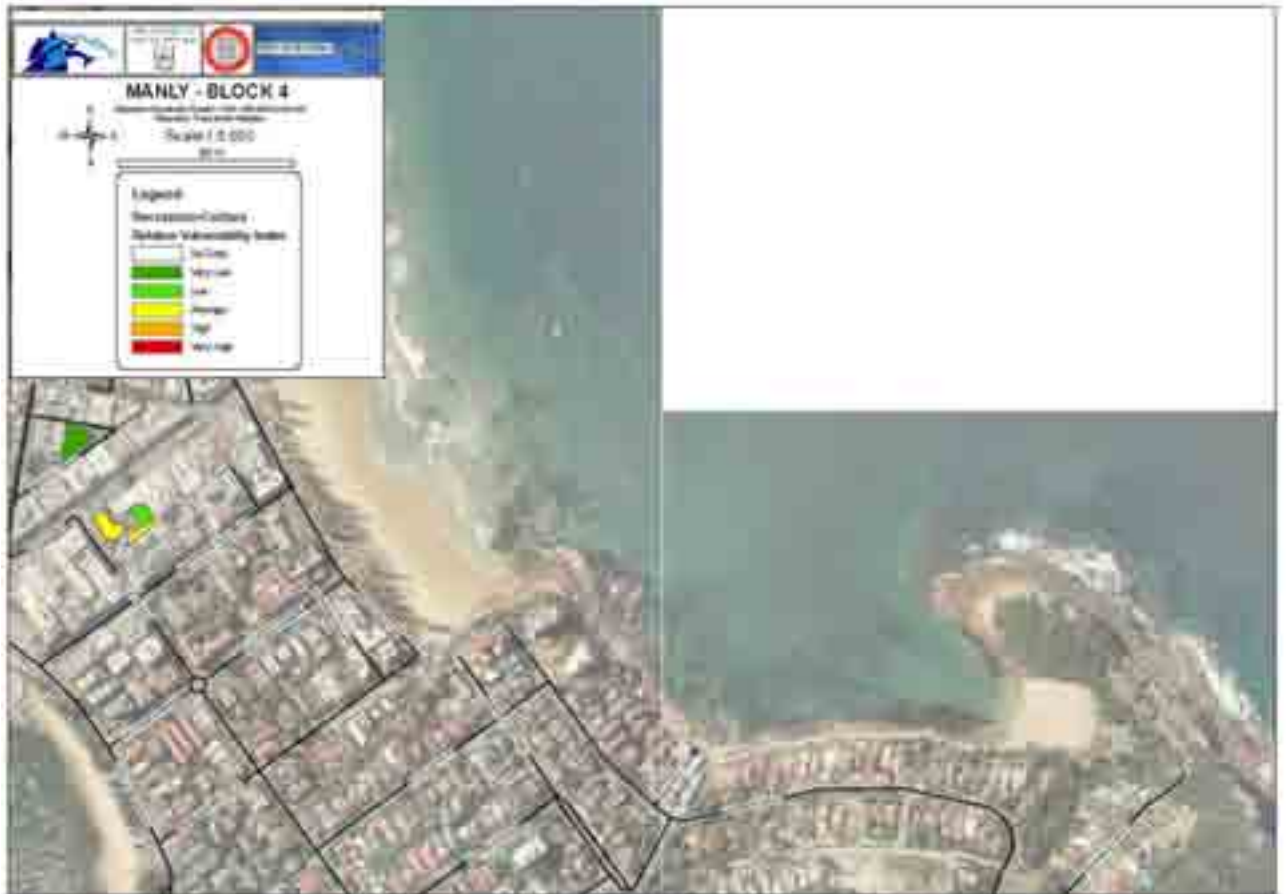
Figure 56. The vulnerability of recreational and cultural buildings in Manly Block 4

Figure 56 displays the calculated RVI scores and spatial distribution of the small number of recreational and cultural buildings in Manly Block 4. Of these, two are classified as having “Average” RVI scores.

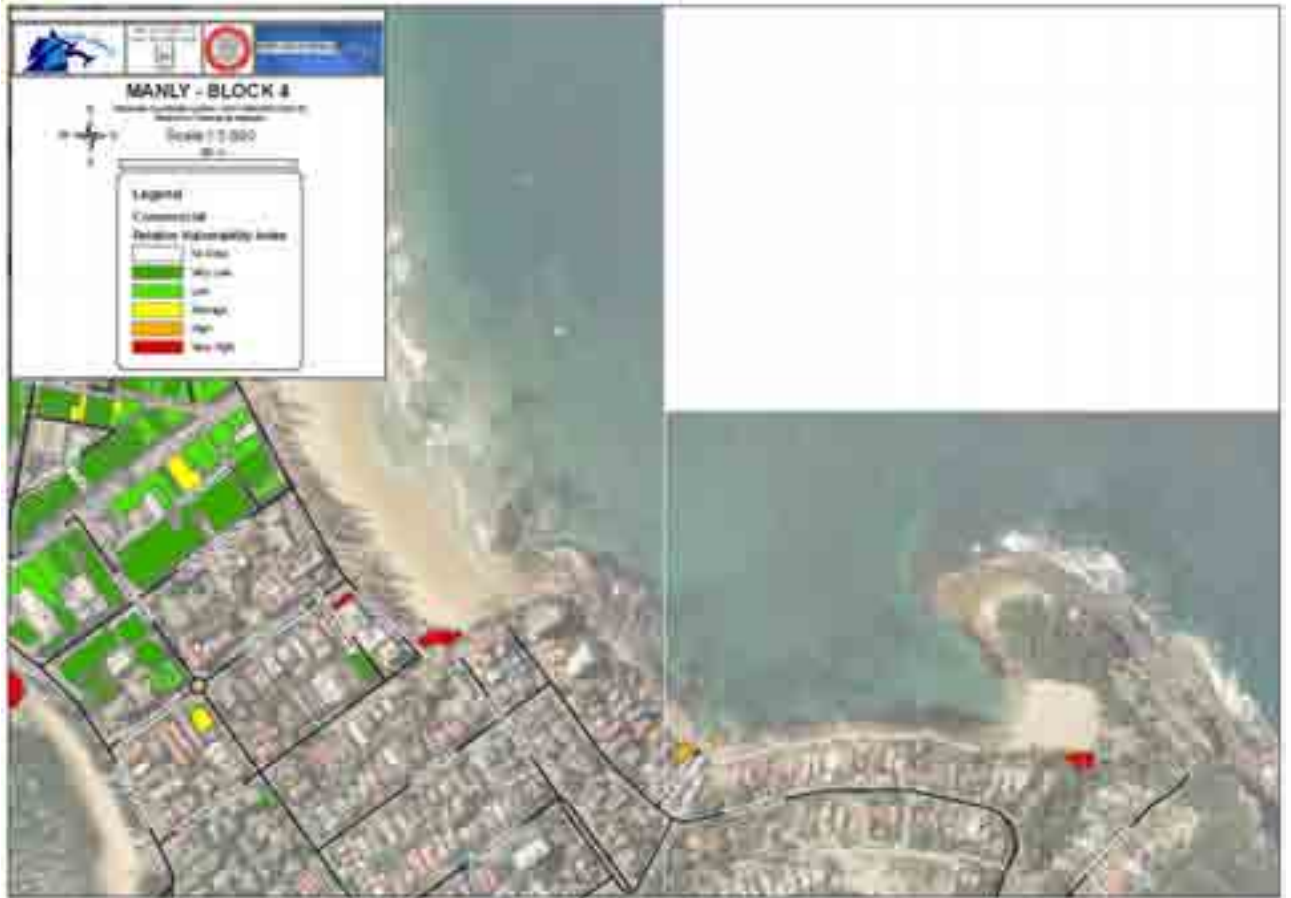
Figure 60. The distribution and RVI scores of commercial buildings in Manly Block 4

Figure 60 displays the calculated RVI scores and spatial distribution of the moderately large number of commercial buildings in Manly Block 4 located within the tsunami inundation zone. Only 7 of them have been assessed as having “High” and “Very High” RVI scores.

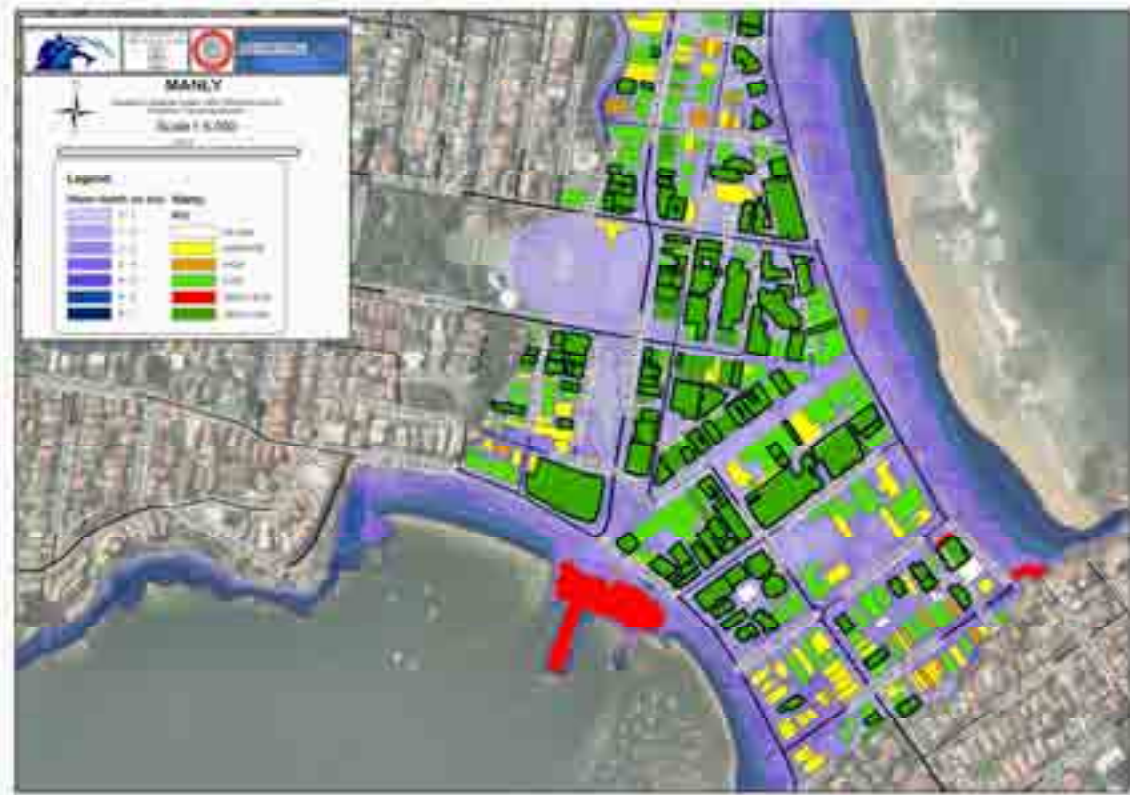
Figure 63. Buildings in Block 3 that are considered safe for evacuation are circled with black. They are considered safe because they have an assessed RVI score of “Very Low” and at least two of their floors would be above the expected flood level.
