Anti-fouling for NSW Coastal Pools and Platforms

The final report for a research project (Dec 2008 – Mar 2010) on new anti-fouling coatings and alternative cleaning methods to control the growth of algae on coastal pools and platforms

Tim Charlton, Rebecca Swanson and Peter Steinberg
Centre for Marine Bio-Innovation (University of New South Wales)

May 2010

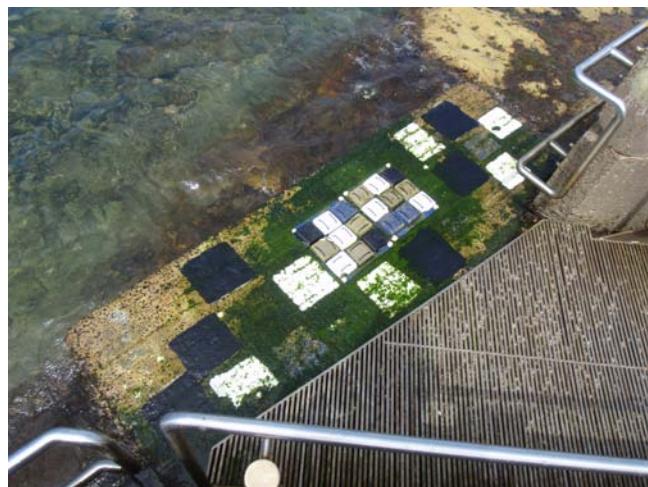
Figure A.1 The step at Clovelly Bay after 4 weeks of the final Trial. The coatings were applied to the concrete step (*in-situ*) and to small concrete blocks (off-site).

The White-X8 coating is recommended for a more extensive application to the Clovelly Bay steps. The White-X8 coating maintained effective anti-fouling for 4 weeks (Statistical analysis **Tables B.1, B.2, B.3**) and effective foul-release after 8 weeks after cleaning with medium pressure from a water ‘jet-blast’ (**Table A.1**).

Table A.1 The coating recommended for Clovelly steps: anti-foul and foul-release effectiveness. Adhesion of White-X8 to the blocks was better than the concrete step.

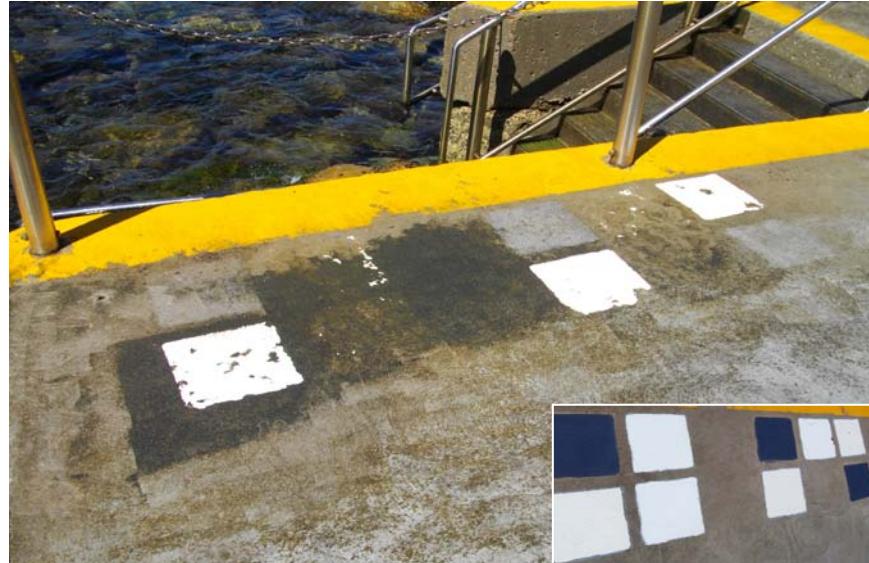
Figure A.2 Test area on the Clovelly promenade after 12 weeks. The surrounding area was cleaned 3 times with a high pressure water jet during the trial period. Inset: Test area at the start of the Trial.

- The White-X8 coating is recommended for the concrete promenade (**Table A.2**).

Table A.2 The coating recommended for the Clovelly promenade: anti-foul effectiveness. Adhesion of White-X8 coating may have been compromised due to poor weather conditions on the day of application.

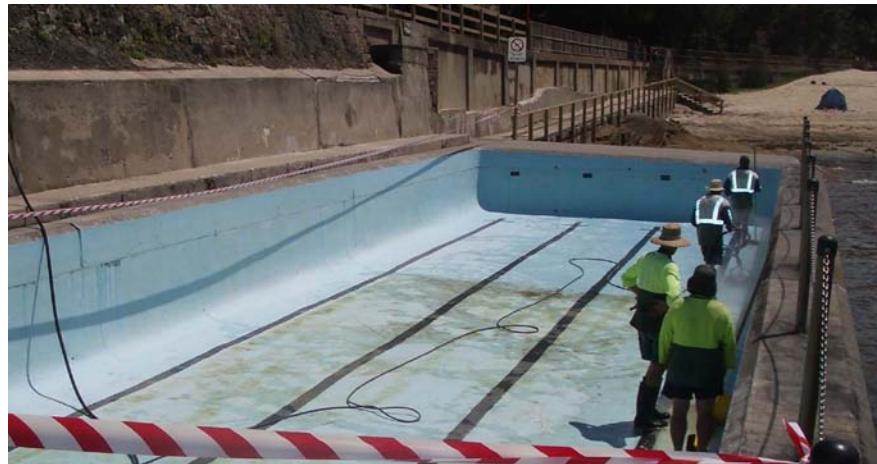
Figure A.3 Cleaning the Clovelly Bay Pool.

Clovelly Bay Pool was the only pool in the trial that was coated with pool paint (**Figure A.3**). A limited trial with a wax-based coating was conducted from Dec 08 to Feb 09. Most coatings were not tested due to the need to avoid damage to the existing paint.

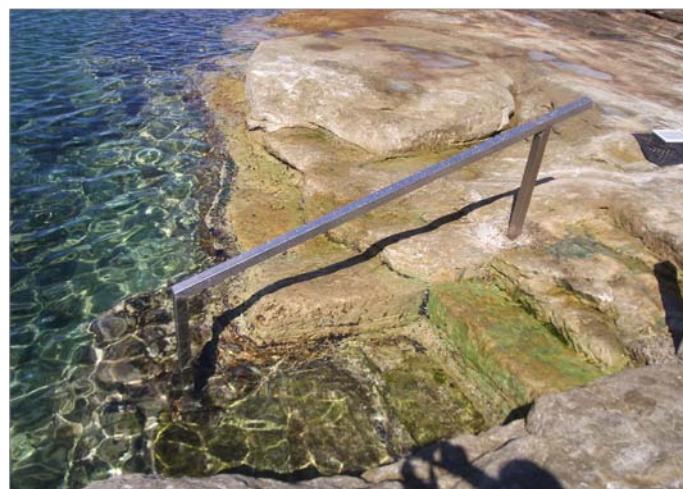
Figure A.4 Steps and rock platform at Mahons Pool.

- The area is in a relatively natural state and white paint on the rocky areas surrounding the pool may cause significant community dissent. It is recommended that alternative tints be sought for White-X8 and coating be restricted to areas of high traffic.
- This site is too exposed for the current version of the SW Mat coating. An alternative design with improved adhesion of the sand-wax material to the mat could provide an option for the steps that are underwater. This coating can be cleaned underwater and would reduce the need to empty the pool for cleaning.

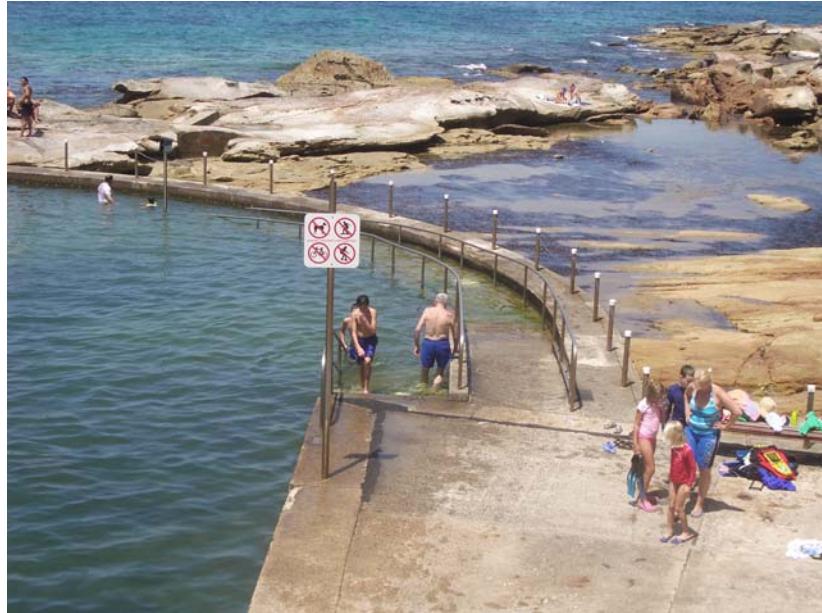
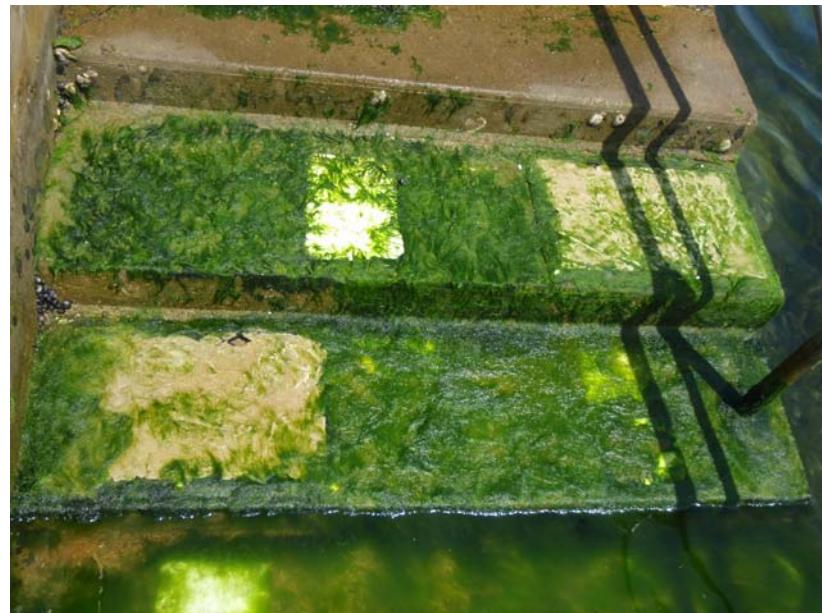
Figure A.5 A. The steps and ramp used for coating trials at Malabar Pool. B. The steps were exposed after 4 weeks of the trial to allow cleaning. Algal growth was rapid and the lack of wave action due to the location of the pool was likely to be a factor contributing to the algae growing relatively long strands.

Table A.3 The two coatings recommended for the steps and ramp at Malabar Rock Pool: anti-foul and foul-release effectiveness

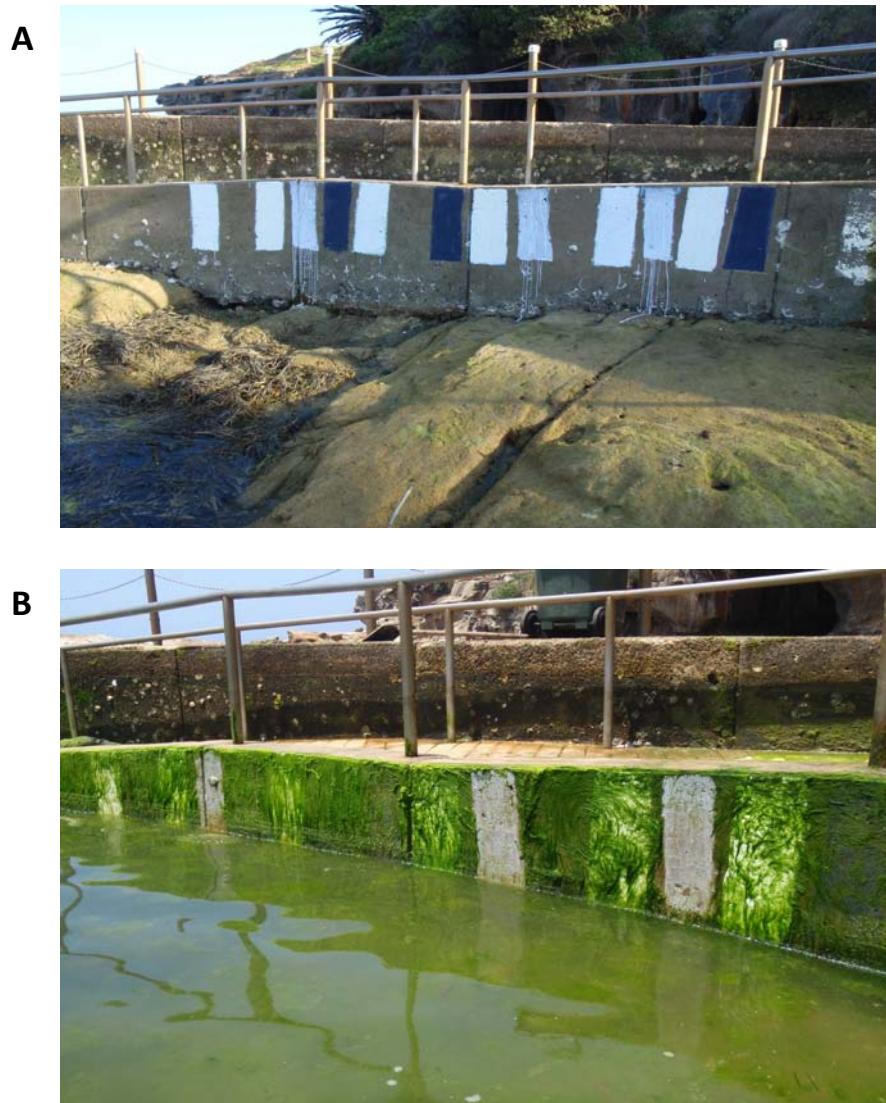
Figure A.6 The test panels on the wall of Malabar Rock Pool: A. Directly after application B. After 4 weeks of the coatings trial.

Table A.4 Anti-foul and foul-release effectiveness of the coatings on the wall of Malabar Rock Pool.
All coatings are recommended for further testing

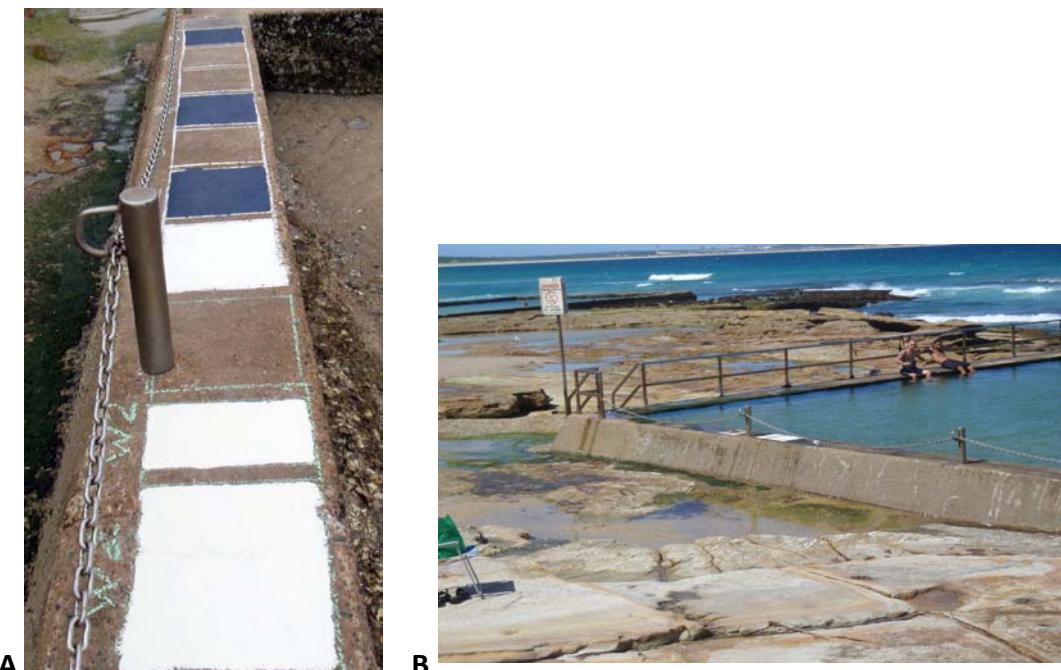
Figure A.8 A. Top of pool wall showing coatings after application **B.** Application site - NW corner of the Pool

- The top of the pool walls can be painted with white-X8 to dramatically reduce the growth of the very slippery brown algae which grows on the top of all pool walls. The NW edge may need to be cleaned more frequently to completely stop the growth of the green algae.

Table A.6 There was no fouling on the White-X8 panels on the top of the wall at Cronulla Rock Pool. The control panels (uncoated concrete) were heavily fouled with brown and green algae within 8 weeks

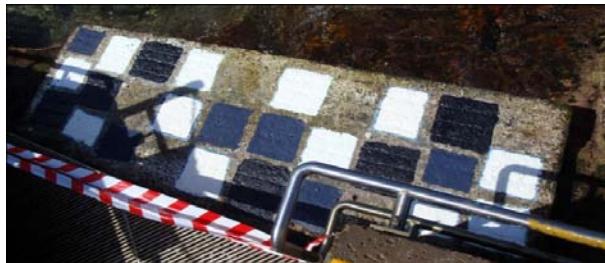
Photo 1 – Clovelly Step at 0 weeks. The direct application of 4 coatings (white-X8, black-Y3 and blue-Z3, white-X7 squares [flaked off in first week]) onto concrete step. The control squares are untreated concrete.

Four coatings were applied directly onto the concrete step (Photo 1). Two coatings, black-Y3 and white-X8, showed significant anti-fouling activity after 4 weeks (Photo 2; Table B.1,B.2). However, the antifouling effect of black-Y3 and white-X8 coatings was no longer significant at 6 weeks (Table B.3) and 8 weeks (Photo 3.).

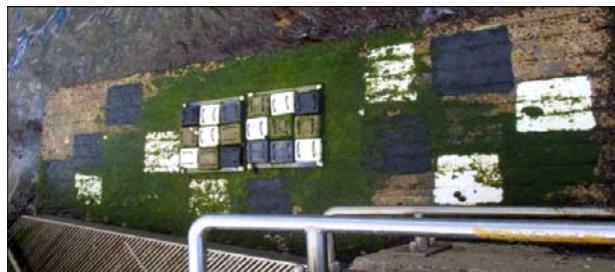
Photo 2 – Clovelly Step after 4 weeks. Black-Y3 squares showed 5–25% fouling cover while white-X8 (remaining white) squares showed 10–60% fouling cover. Most control squares (four of six) showed 100% fouling cover (now green) but two control squares had less than 10% fouling cover (Table B.1, B.2 for statistical analysis) Note: the tile experiment was added to the centre of this step after 1 week as white-X7 and blue-Z3 coatings painted here had peeled off by this time.

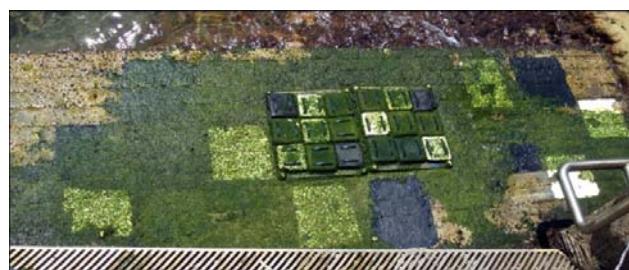
Photo 3 – Clovelly Step after 8 weeks. Most black-Y3 squares are heavily fouled (>75% cover) however two squares show less than 5% fouling cover. Most white-X8 squares are completely fouled but fouling cover is less dense than fouling cover on control (green/concrete) squares. Control squares are the same as at 5 weeks.

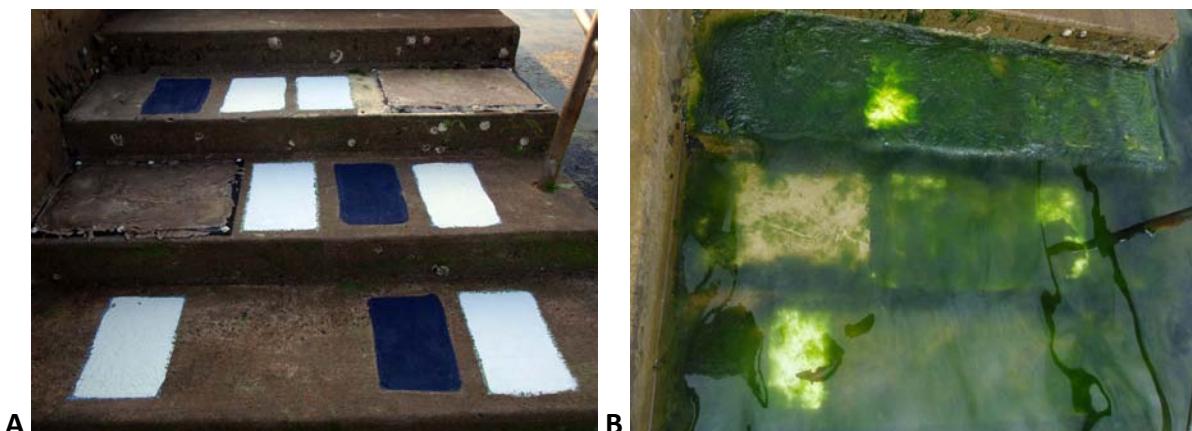
Photo 8 – Malabar Steps at 0 weeks (A) and 4 weeks (B). (A) The direct application of 3 coatings (white-X7, white-X8 and blue-Z3) and SW mats onto concrete step. (B) white-X8 (remaining white rectangles) and one SW mat (step 2) have less fouling cover than adjacent control areas (green).

Three coatings were applied directly onto the concrete steps in the pool. SW mats, made with anti-fouling wax/sand, were also fixed to steps. One coating, white-X8, and the SW mats, showed antifouling activity after 4 weeks (Photo 8B) however the effect was not statistically significant (Table B.4).

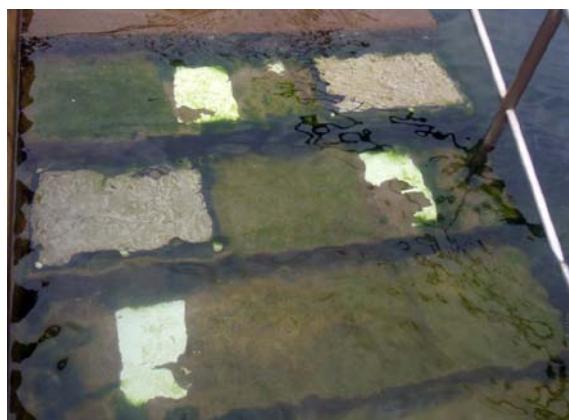
Photo 10 – Steps at 6 weeks. Algae have grown back on concrete areas cleaned 2 weeks earlier by jet-blaster and there is less algal growth on SW mats and white-X8 coating than at 4 weeks (see Photo 9). Recent 'big seas' appear to have 'self-cleaned' SW mats and white- X8 coating on steps (compare with Photo 9B).
