State of the beaches 2018-2019

Statewide summary and how to read this report

Beachwatch

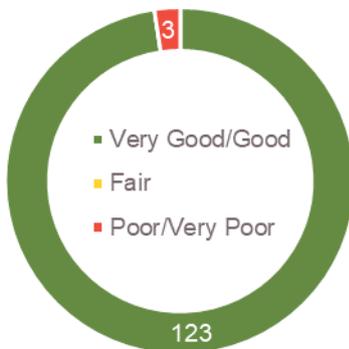
Beach Suitability Grades for monitored ocean beaches in NSW

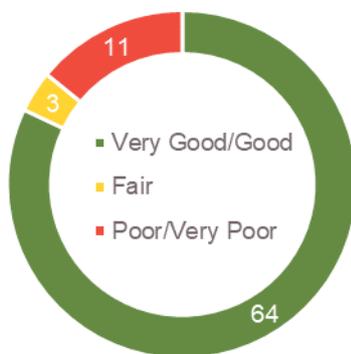
Beach Suitability Grades for monitored estuarine beaches in NSW

Sixty-four (82%) of the 78 estuarine swimming sites were graded as Very Good or Good. This is a slight improvement in performance from 2017–2018 when 81% of estuarine beaches were graded as Very Good or Good. While water quality at these sites was suitable for swimming most of the time, it was occasionally impacted by stormwater pollution following rainfall. These estuarine swimming sites are generally located in the well-flushed sections of the estuaries or had few potential sources of faecal contamination.

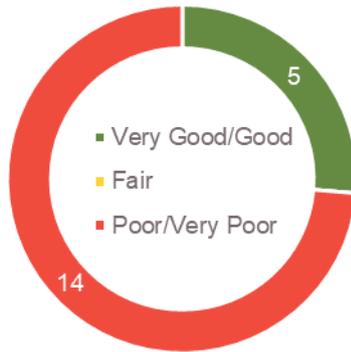
Beach Suitability Grades for monitored lake/lagoon swimming sites in NSW

Five (26%) of the 19 lake and lagoon swimming sites were graded as Very Good or Good. While this is a decline in performance from the previous year, it largely reflects the withdrawal of a number of lake swimming sites from the monitoring program. Thirteen swimming sites located in Lake Macquarie in the Hunter, of which eight were graded Good in 2017–2018, are no longer monitored under the Beachwatch Partnership Program.

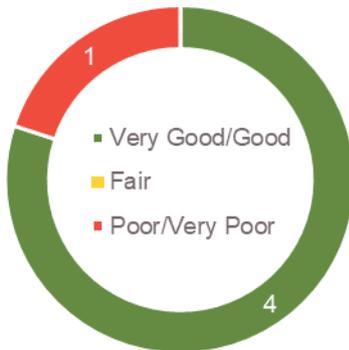
Beach Suitability Grades for monitored ocean baths in NSW

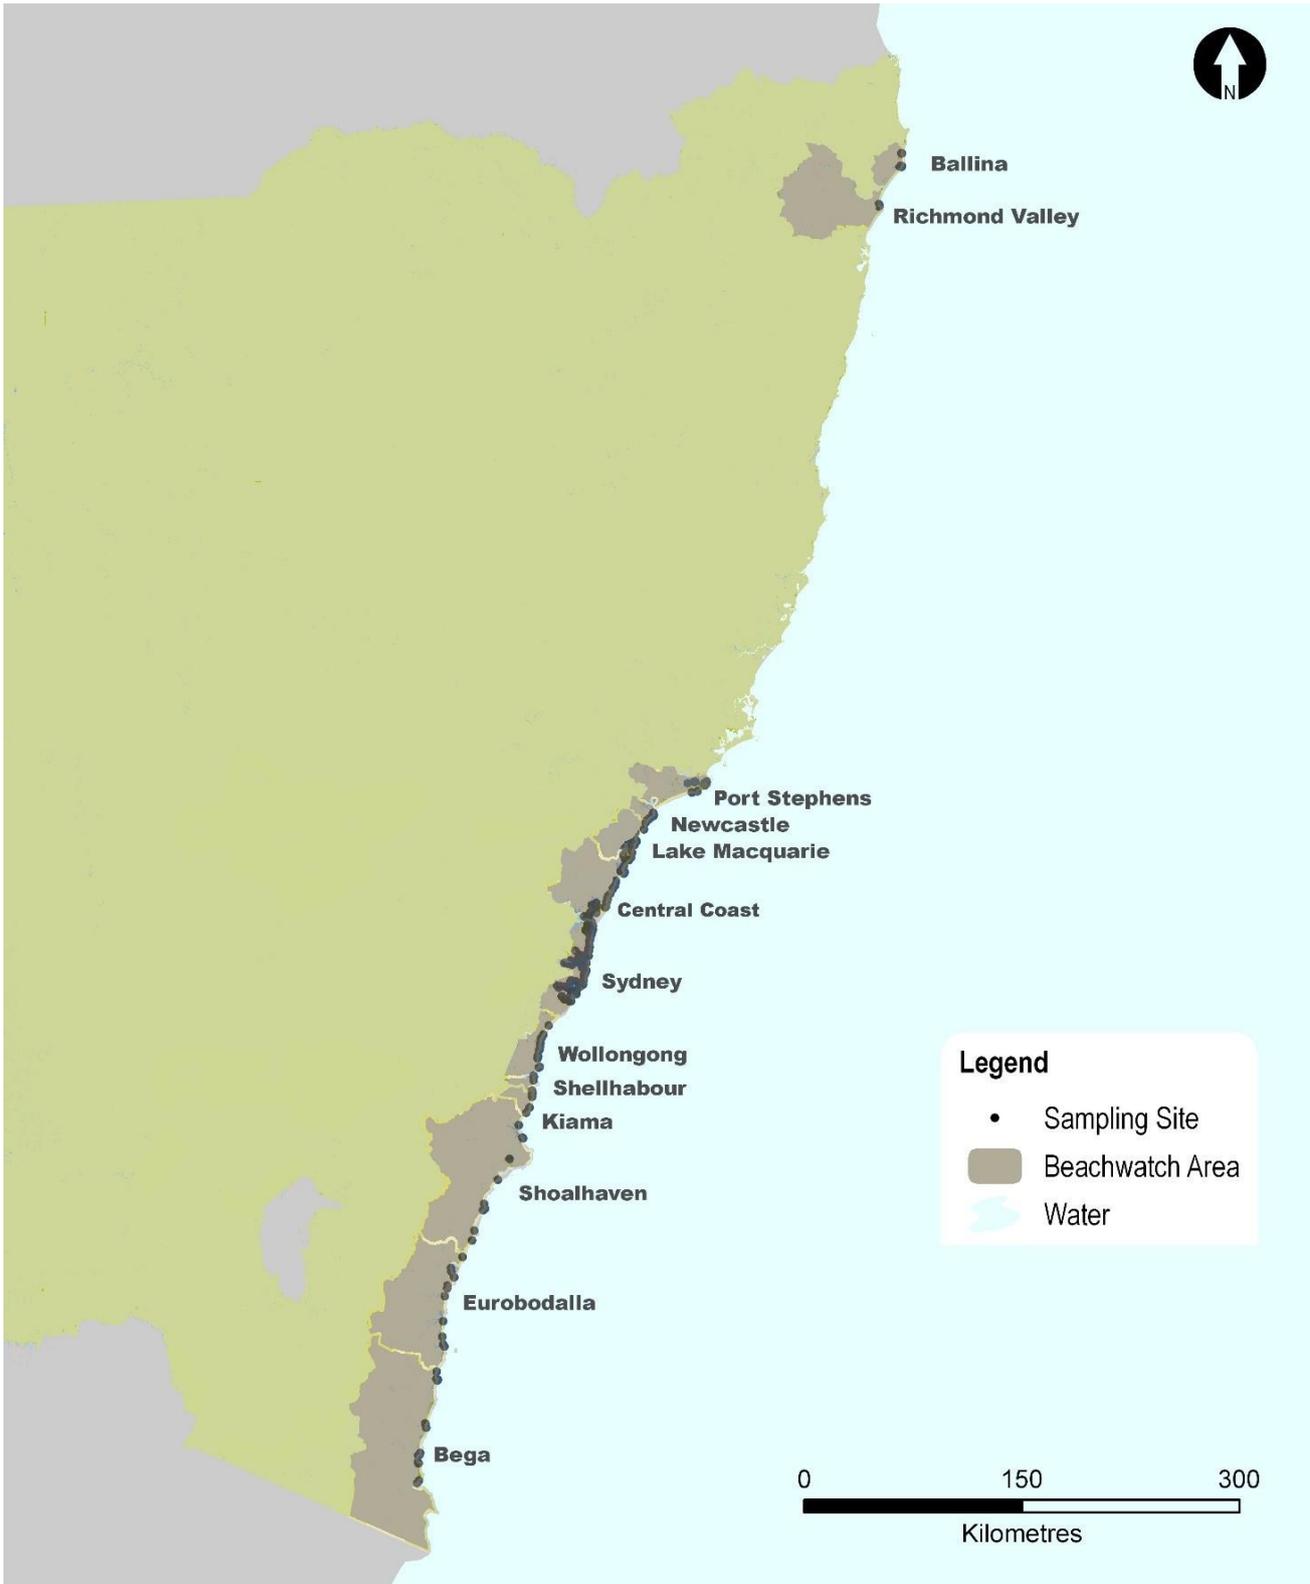
Sampling sites and areas monitored in New South Wales under the Beachwatch programs

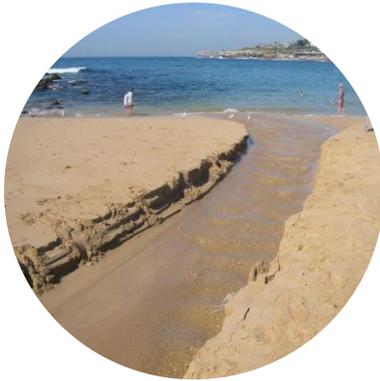
Stormwater at Coogee Beach
Photo: Beachwatch/EES, DPIE

Stormwater in urban areas often contains sewage from leakages, overflows or sewer chokes when the sewerage system fails.

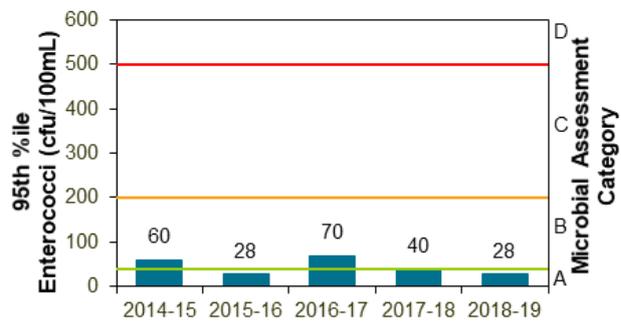
Microbial Assessment Category (MAC) chart

On each beach page, the MACs for the last five years are displayed on a simple bar chart. The MAC for the current year is based on enterococci data collected during the assessment period. The bars are labelled with the 95th percentile value for each year and the thresholds dividing the A, B, C and D categories are marked in green, amber and red for reference.

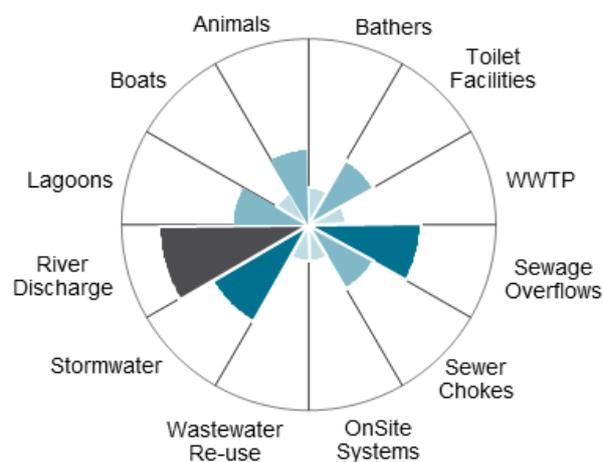
Sanitary Inspection Category (SIC) chart

The results of the sanitary inspection for each swimming location are presented in a radar pie chart. The chart shows the likelihood that each identified pollution source will contribute to faecal contamination at a swimming site, as indicated by the size and colour of the segment, ranging from very low (lightest colour) to very high (darkest colour) as shown below. The sum of these contributions is the overall likelihood, or Sanitary Inspection Category.

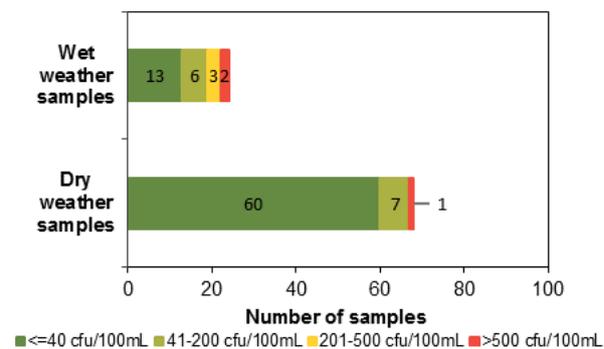
Wet and dry weather water quality chart

Enterococci levels in wet and dry weather conditions are presented for each swimming location as a bar graph. All data collected during the assessment period is included in the analysis. Dry weather is defined as no rainfall recorded in the previous 24 hours. Each bar is colour coded to show the number of enterococci results up to 40cfu/100mL, between 41 and 200cfu/100mL, between 201 and 500cfu/100mL and greater than 500cfu/100mL. These categories reflect the Microbial Assessment Category thresholds and are coloured on the graph as dark green, light green, amber and red respectively.

It is expected that swimming sites with lower levels of flushing show some elevated bacterial results in dry weather samples (no rainfall in the previous 24 hours) due to the longer time needed to recover from a rainfall event. At some estuarine and lake/lagoon swimming locations the impacts of stormwater pollution on beach water quality may be detected up to three days after rainfall.

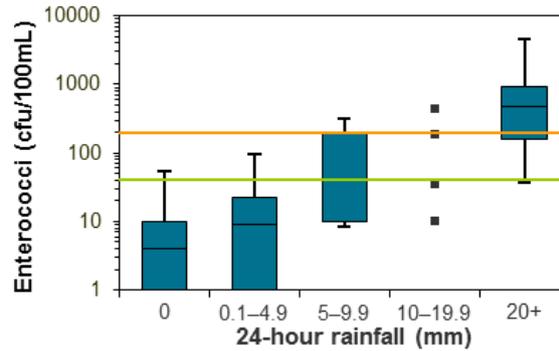
Water quality in response to rainfall

Trends in enterococci levels in response to rainfall are shown using a box plot. For reference, enterococci levels of 40cfu/100mL and 200cfu/100mL are indicated with a green and orange line, respectively. The 40cfu/100mL level is referred to as the 'safe swimming limit'. The enterococci data were obtained from the last five years of monitoring. Rainfall data were obtained from rain gauges situated close to the sample site and are 24-hour totals to 9am on the day of sampling. If there are fewer than five enterococci data points in a rainfall category, individual data points are presented instead of a box plot. At sites where many results are below the detection limit (1cfu/100mL), only the upper portion of the box plots will be visible.

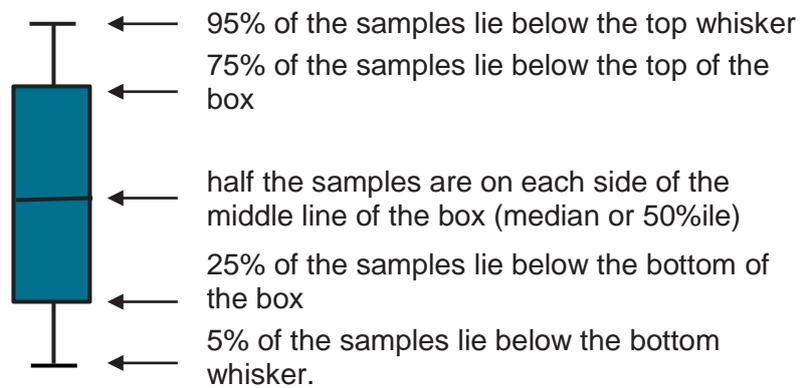
Each part of the box plot represents a significant percentile value of the sample population:

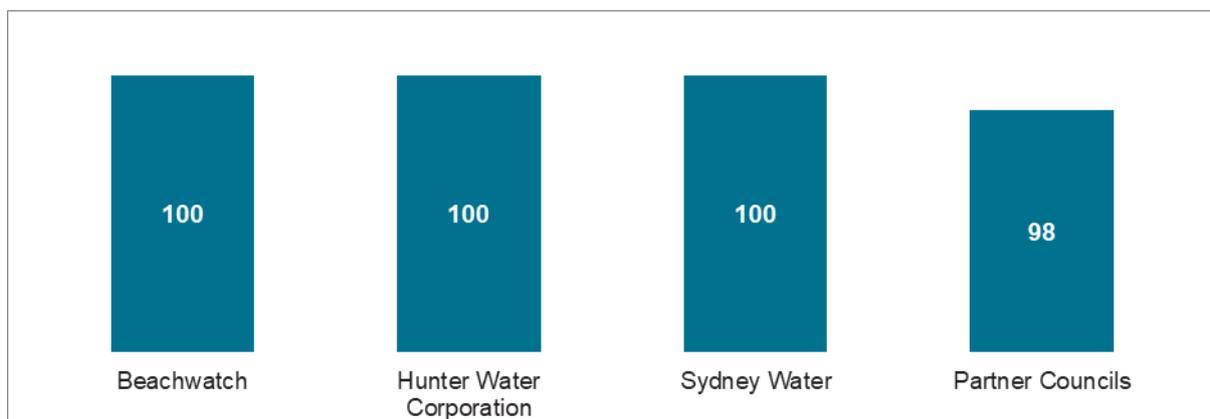
Figure 1 Percentage compliance with Beachwatch sampling protocols in 2018–2019

Sample collection by Beachwatch, Hunter Water and Sydney Water complied well with established sampling protocols, with a compliance of 100%. Councils in the Beachwatch Partnership Program achieved an overall compliance of 98% with Beachwatch sampling protocols.

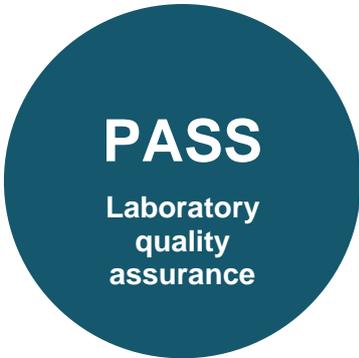
Due to the inherent variability of bacterial levels in environmental samples, duplicate results that are within 0.3 log-units of each other (equivalent to a halving or doubling of density on a linear scale) are considered to be acceptable. The majority of duplicate samples were within the acceptable limits; however, some enterococci results were outside this range, with most of these at very low bacterial densities that were below the safe swimming limit. Where values were outside this range, the site result was more often higher than the replicate, indicating that results were rarely underestimated.

Figure 2 Distribution of duplicate enterococci (cfu/100mL) results for the contracted laboratory, May 2018 to April 2019

To assess the reliability of laboratory data, Beachwatch sends duplicate water samples to our contracted microbiological laboratory, which is accredited by the National Association of Testing Authorities (NATA). Duplicate samples are collected from the same site at the same time and the laboratory is unaware that the samples are collected from a single location. The results are expected to be similar.

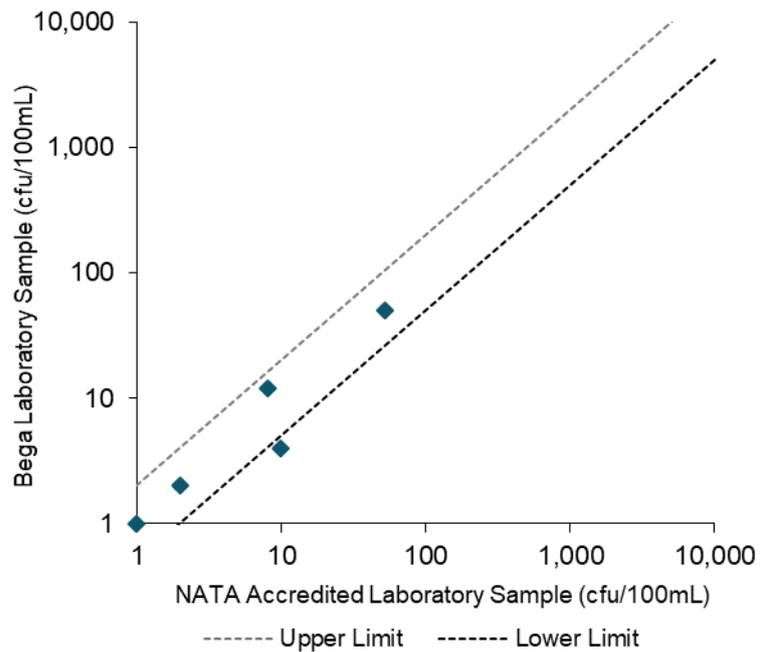
Figure 3 Distribution of duplicate enterococci (cfu/100mL) results for Bega and NATA accredited laboratories

Bega Valley Shire Council collected duplicate samples on three occasions during the summer season. Bega laboratory analysed one sample while the duplicate was sent to a NATA accredited laboratory for testing. Comparison of results showed five of the six samples were within the acceptable limits. Bega laboratory reported one result outside the lower limit, and slightly lower than the bacterial count reported by the NATA accredited laboratory (Figure 3); however, this outlier is well below the safe swimming limit. Bega laboratory microbial analysis has continued to show much improvement in performance over the last three years, and confidence can be placed in data reported for council's swimming sites.

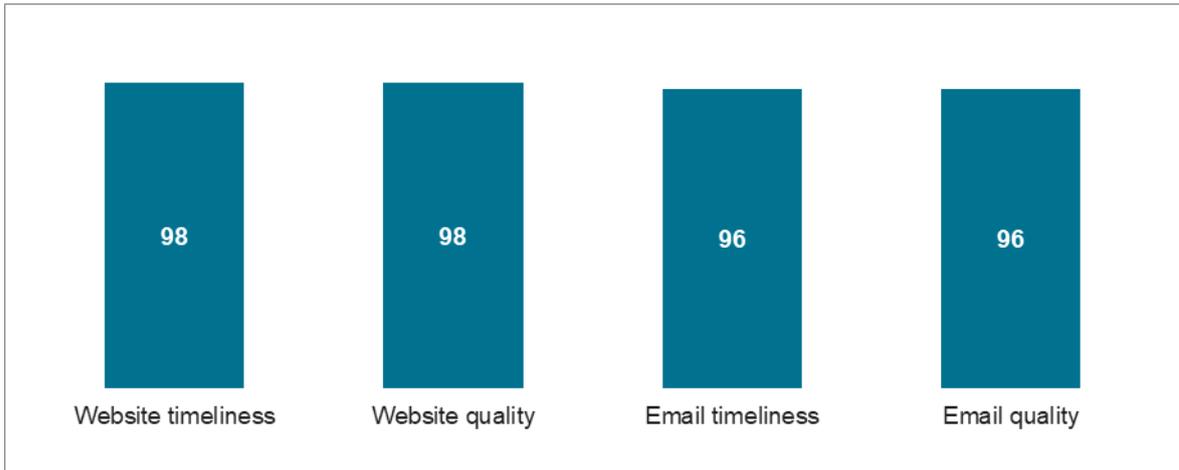
Figure 4 Percentage compliance with beach pollution forecast reporting protocols in 2018–2019

Minor quality non-compliance included some minor punctuation, and incorrect pollution scenarios for some sites on some occasions. The timeliness of forecasts was impacted on a couple of occasions and was usually caused by technical problems with the Beachwatch website or email provider.
