# Assessment and Decision Frameworks for Seawall Structures

Appendix  
E

## Case Study Bilgola

## Appendix E Case Study – Bilgola Beach

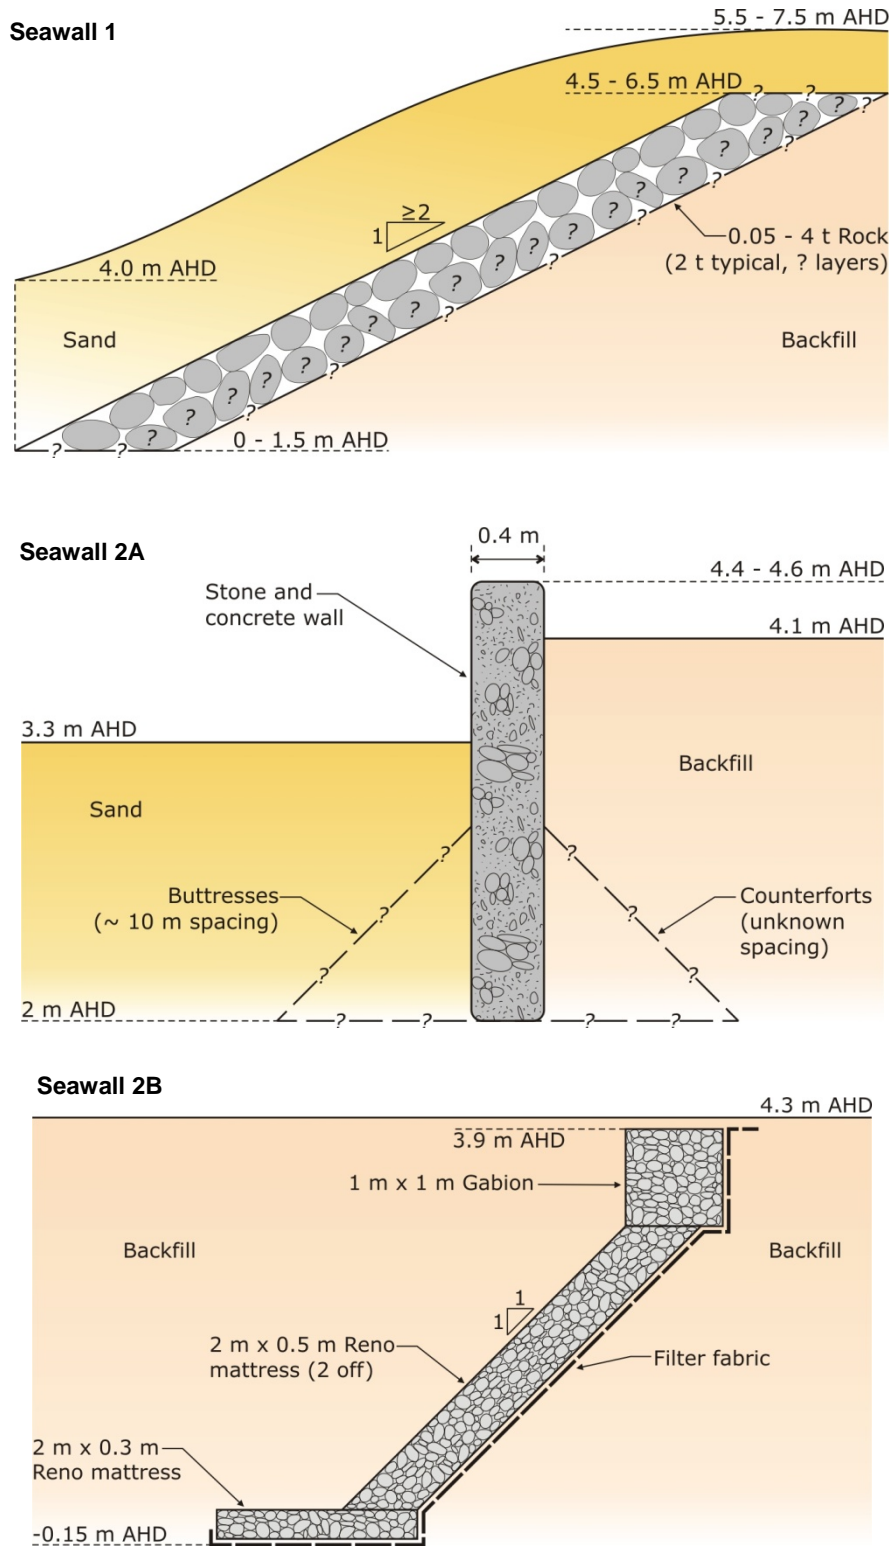
Figure 2.6 Bilgola Beach Seawall Cross-sections (1, 2A and 2B)

Representative design cross-sections were prepared for the seawall structures assessed and are presented in Figures 2.6 (Seawalls 1, 2A and 2B) and 2.7 (Seawall 3). The sections were based on the review of all relevant documents including council records and technical drawings, consultant reports, geotechnical investigations and topographic surveys. Structure details and information that could not be verified are clearly identified in the cross-section figures.

Seawall 1 is located seaward of seven private properties in Allen Avenue. As a result of the 1966 storms, several houses were at risk of being undermined, and WRL recommended that a sloping rock seawall be constructed in addition to beach nourishment (Foster and Hattersley, 1966). In 1967, the recommendations had not yet been implemented and, with coastal storms threatening properties seaward of Allen Avenue, emergency rock protection was installed. The crest level of these works was approximately 2.5 m AHD (the toe level was unknown), with a face slope of 1V:3.0H and constructed from a single layer of 50kg rocks with unknown composition (likely sandstone or basalt) (Foster, 1990). No secondary armour or geotextile underlayer was used. It is not known if outflanking protection was included in the emergency works. It is noted that the 'as-built' emergency seawall was not in accordance with WRL's design which included a gravel graded filter blanket and a toe level of -1.4 m AHD.

However, during the storms in May and June 1974, the wall was severely overtopped and several houses were threatened by wave action and inundation. The house at 9 Allen Avenue was badly damaged due to the combined effects of gale force winds and wave overtopping and was demolished (PWD, 1985). A swimming pool at 11 Allen Avenue was also destroyed during these storms, with some of its debris distributed within the seawall. Immediately following this storm, emergency coastal protection works consisting of timber poles (7 Allen Avenue) and sandbags (1 Allen Avenue) were also added to the damaged seawall. More extensive emergency protection works were undertaken in two stages later in 1974 using existing rock from the 1967 works and imported 2.0t basalt rock (Foster 1990). Again, no secondary armour or geotextile underlayer was used, and it is not known if outflanking protection was included in these additional emergency works.

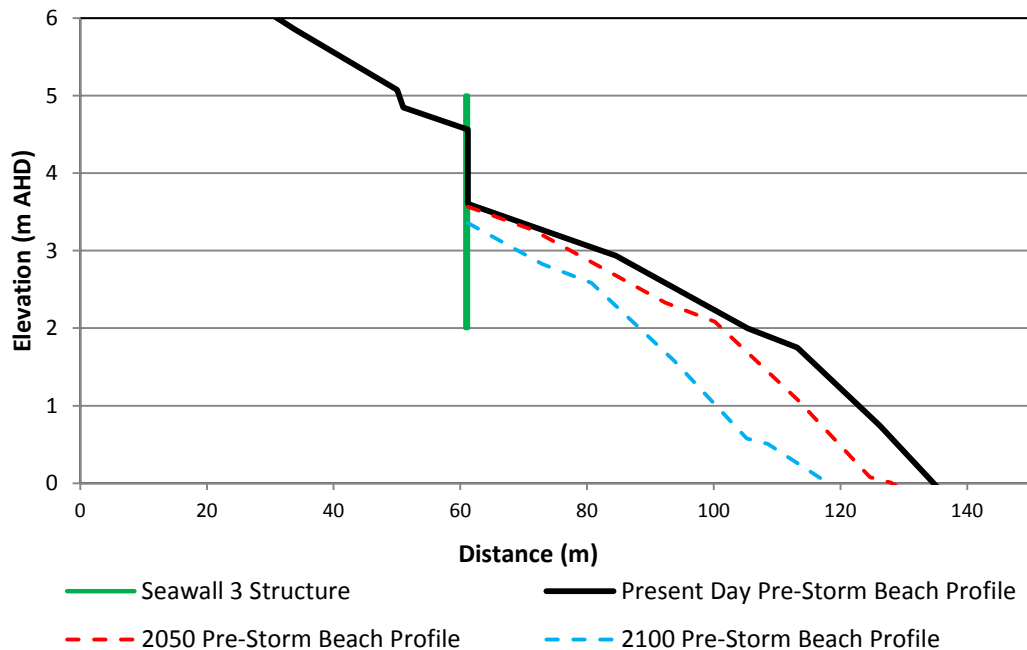
**Figure 2.13 Example SBEACH Erosion Modelling Input for Seawall 3**

Where the adjusted profile intersected with the face of each seawall (for non-buried structures), the profile landward of the seawall remained unchanged for the analysis. An example of SBEACH model input to determine the scour levels for Seawall 3 (photogrammetry profile 1) for present-day, 2050 and 2100 conditions is shown in Figure 2.13.

While obviously influencing beach recession, sea level rise will also exacerbate the process of erosion on sandy beaches. Further to any reduction in pre-storm sand levels at the toe of the seawalls from recession due to sea level rise (no underlying recession was assumed), increased still water levels will also allow higher waves to impact the structures and generate deeper scour compared to present day conditions. Accordingly, the risk of seawall instability due to undermining will increase over time. Table 2.23 summarises estimates of scour levels for 2050 and 2100.
