Antifouling Technologies for Coastal Pools and Platforms

Final Report on Field Trial (March-June 2009)

Written by Dr Rebecca Swanson

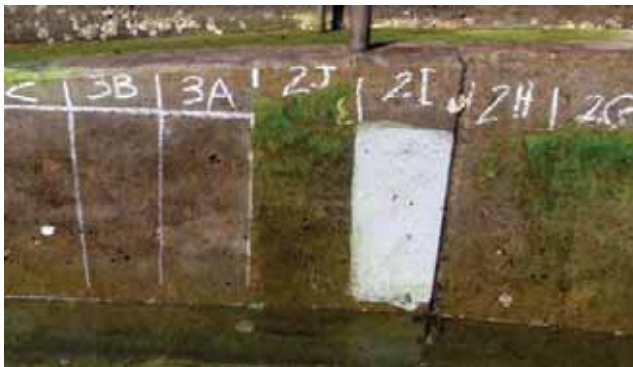
Photo 1 – Direct Application

A section of the direct application experiment at Malabar Rock Pool

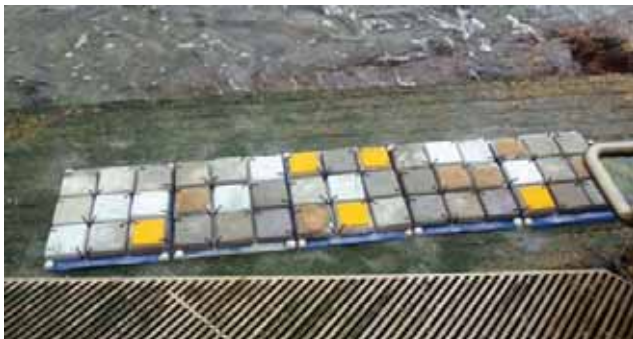
Photo 2 – Block experiment

The block experiment deployed on concrete step in Clovelly Bay

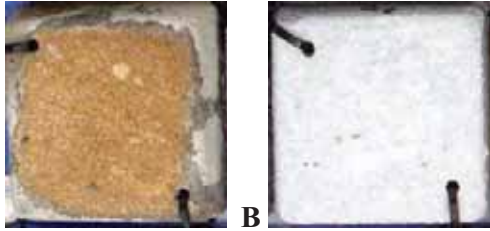
Photo 3 – Top view of wax-based blocks

W1 (A) with wax-sand inlayed into concrete block and W2 (B) with wax-based formulation rubbed onto blocks already painted with non-slip paint.

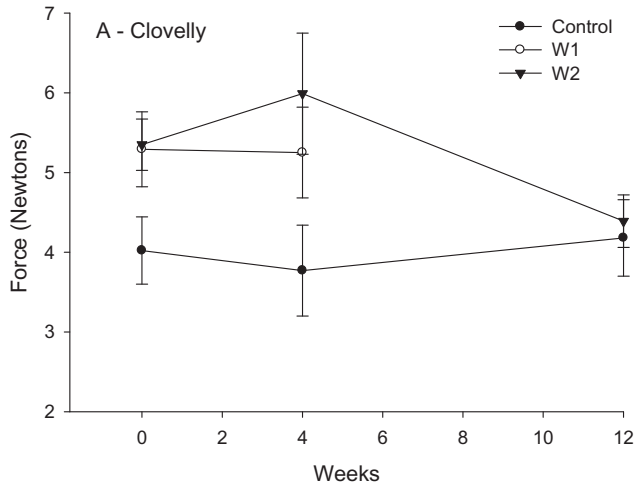
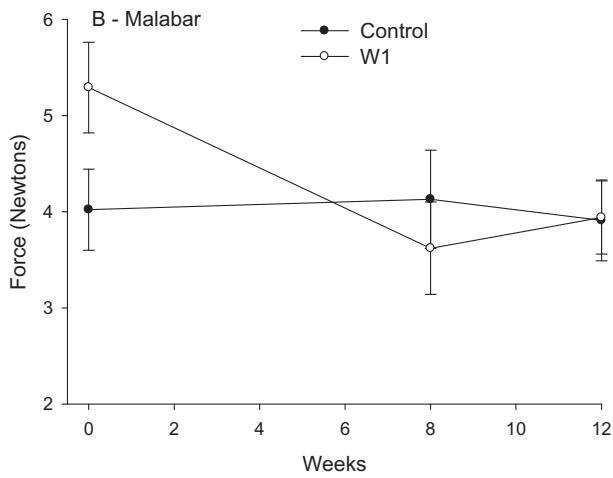
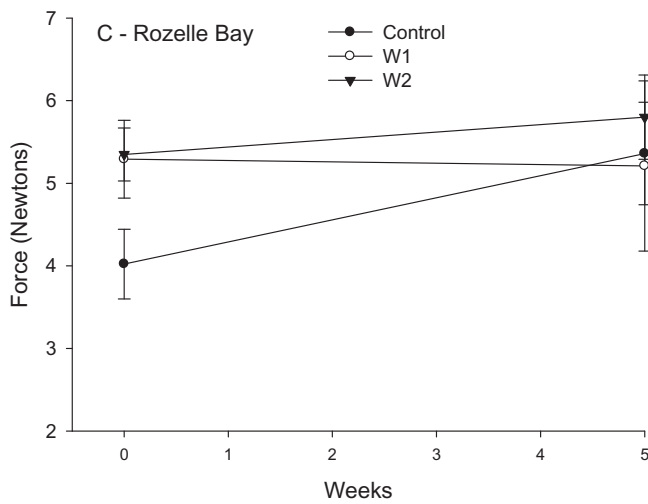
Figure 1 – ‘Slip test’ data for W1 and W2 blocks from Clovelly (A), Malabar (B) and Rozelle Bay (C) experiments based on force gauge readings (lower force readings indicate increased ‘slippery-ness’).

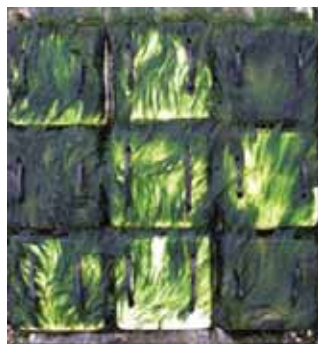
Photo 22 – Malabar Rock Pool Step

- X1 and control blocks showed a low level of fouling by green dots and short filaments of the green alga *Ulva sp.* after 2 weeks
- X1 blocks were moderately-heavily fouled at 5 weeks while control blocks were heavily fouled
- X1 blocks were heavily fouled at 8-9 weeks but to a lesser degree than control blocks (Photo 22)

Test board after 9 weeks showing 3 blocks with X1 or X2 coatings and 3 control blocks (see diagram below for block I.D.)

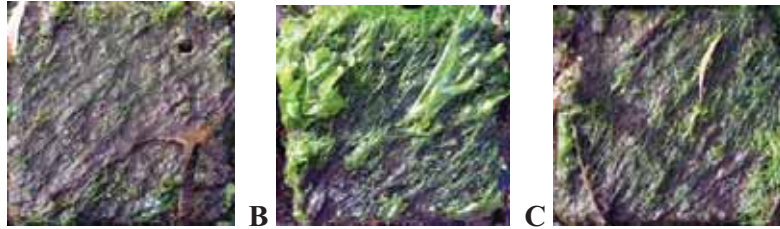
Photo 23 – Rozelle Bay Marina

- X1 and control blocks showed very little (<5% algal cover) fouling at 2 weeks
- X1 blocks showed medium-high level of fouling at 4 weeks by brown (predominantly) and green filamentous algae (*Ulva sp.*)
- Control blocks showed low-medium level of fouling at 4 weeks
- X1 blocks were heavily fouled by brown filamentous algae and *Ulva sp.* (filamentous and lettuce-like growth form) at 8 weeks (Photo 23B)
- Control blocks were moderately-heavily fouled by algae at 8 weeks (Photo 23A)

A control block (A), X1 block (B) and X2 block (C) after 8 weeks

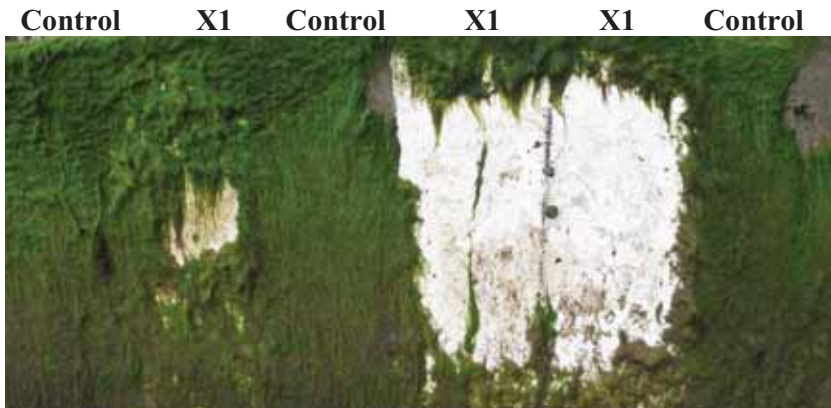
Photo 25 – Malabar Rock Pool Wall

- X1 panels (2/3) remain largely without fouling at 5 weeks while adjacent control panels were heavily fouled. One X1 panel was heavily fouled but this panel was completely surrounded by heavy fouling therefore edge effects may have increased degree of fouling in this panel (Photo 24)
- Similar results for X1 and control panels were observed at 9 and 12 weeks (Photos 25, 26)

X1 and control panels at 9 weeks (pool empty)

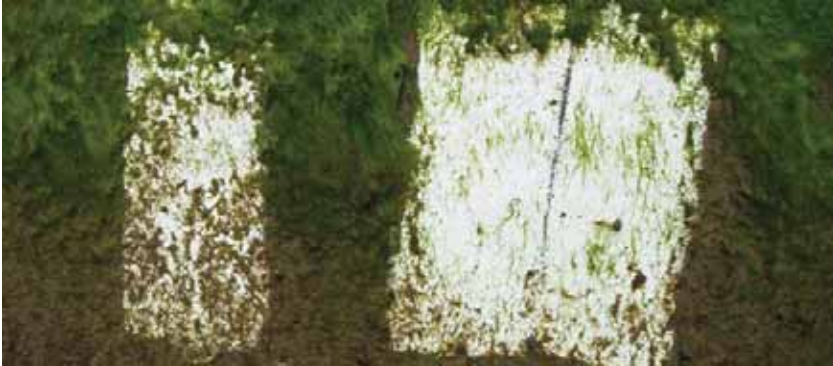
Photo 26 – Malabar Rock Pool Wall
X1 and control panels at 12 weeks (pool empty)

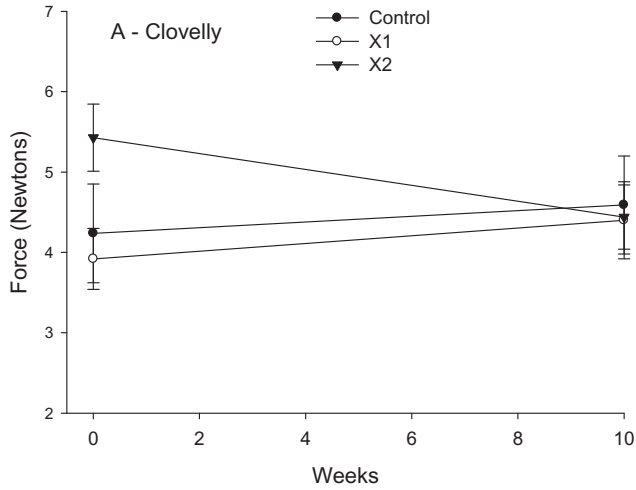
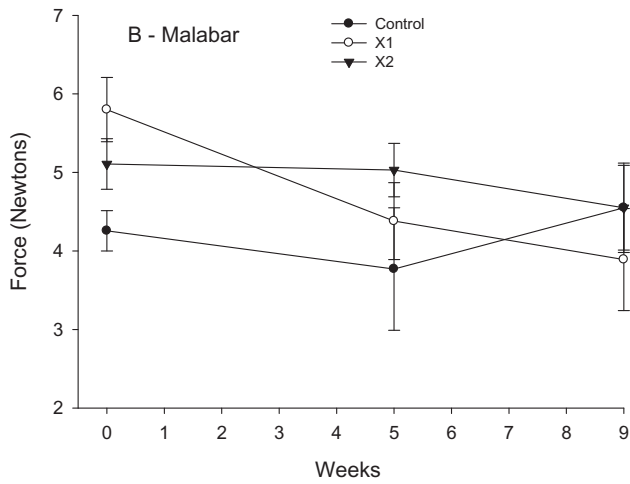
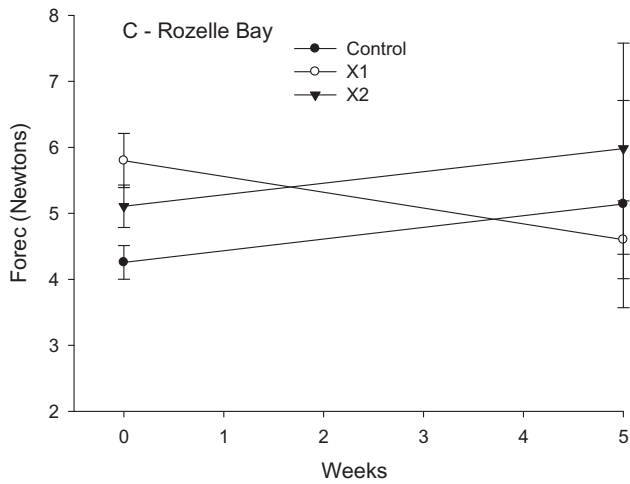
X1 blocks from Clovelly showed no difference in slip tests between clean and fouled X1 blocks (Figure 2A). X1 blocks from Malabar (Figure 2B) and Rozelle Bay (Figure 2C) became more slippery as they got fouled, as indicated by less force required on average to drag sled across fouled blocks.

Figure 2 – ‘Slip test’ data for X1 and X2 blocks from Clovelly (A), Malabar (B) and Rozelle Bay (C) experiments based on force gauge readings (lower force readings indicate increased ‘slippery-ness’).

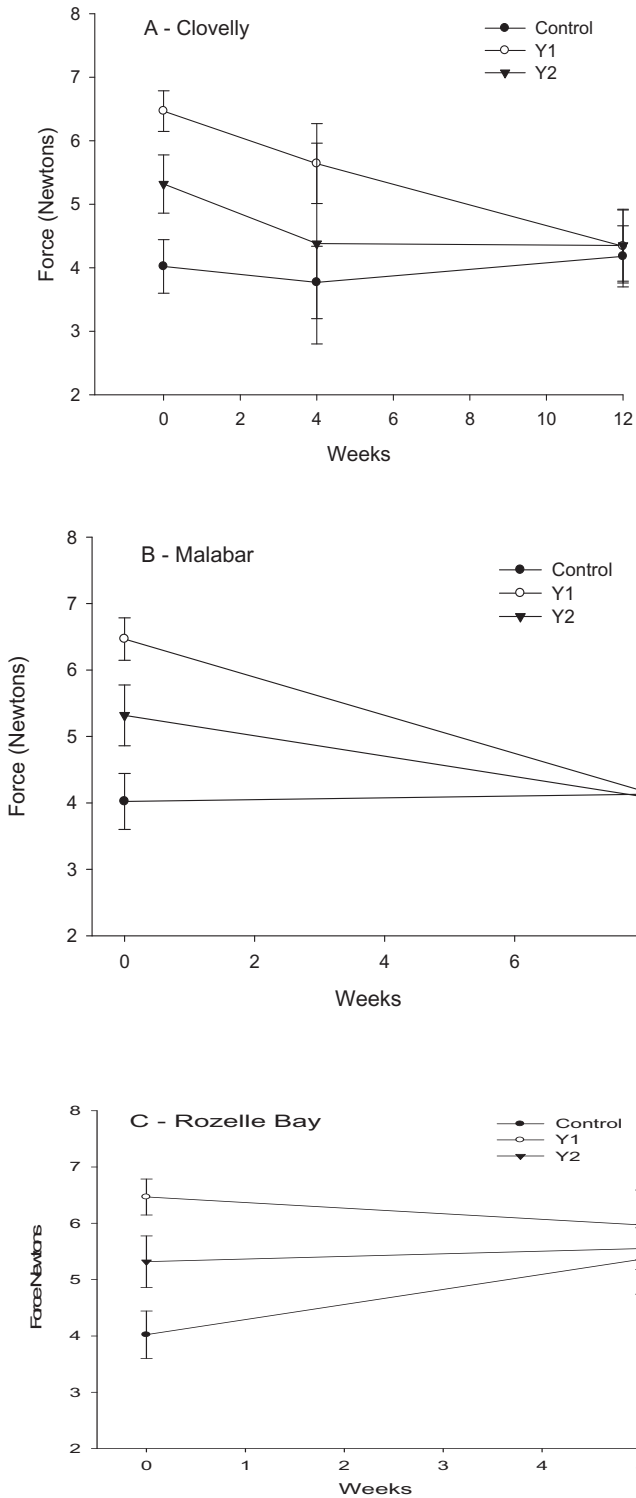
Y1 blocks from Clovelly and Malabar became more slippery as they got fouled, as indicated by less force required on average to drag sled across fouled blocks (Figure 3A, B). The exception was Rozelle Bay, where there was no change in measurements between un-fouled and fouled blocks (Figure 3C). Any slippery effect of fouling algae on these blocks was negated by the presence of hard worms in the fouling community (i.e., hard worms increased friction which in turn increased the force required on average to drag sled across heavily fouled blocks).

Y2 blocks from Clovelly and Malabar became more slippery as they got fouled, as indicated by less force required on average to drag sled across fouled blocks (Figure 3A, B). The exception was Rozelle Bay, where there was no change in measurements between un-fouled and fouled blocks (Figure 3C). Any slippery effect of fouling algae on these blocks was negated by the presence of hard worms in the fouling community (i.e., hard worms increased friction which in turn increased the force required on average to drag sled across heavily fouled blocks).

Figure 3 – ‘Slip test’ data for X1 and X2 blocks from Clovelly (A), Malabar (B) and Rozelle Bay (C) experiments based on force gauge readings (lower force readings indicate increased ‘slippery-ness’).

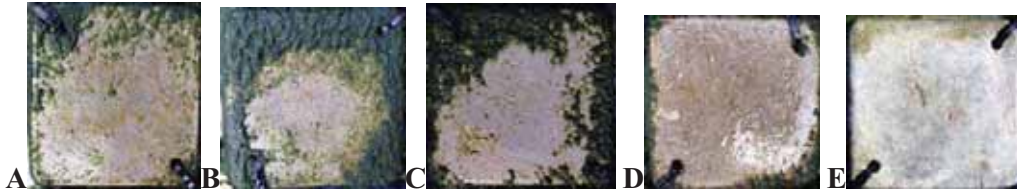
Photo 38 – Clovelly Bay Step

The least fouled block for each coating; Z1A (A), Z1B (B), Z2A (C), Z2B (D) and a control block (E) after 4 weeks

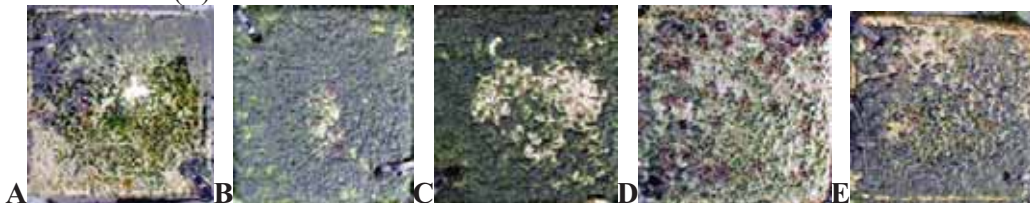
Photo 39 – Clovelly Bay Step

The least fouled block for each coating; Z1A (A), Z1B (B), Z2A (C), Z2B (D) and a control block (E) after 6 weeks

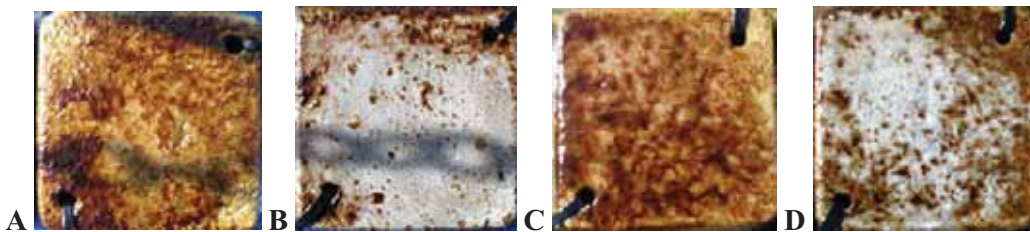
Photo 40 – Clovelly Bay Promenade

Z blocks at 11 weeks; Z1A (A), Z1B (B), Z2A (C) and a control block (D). Similar levels of fouling were observed at 12 weeks.

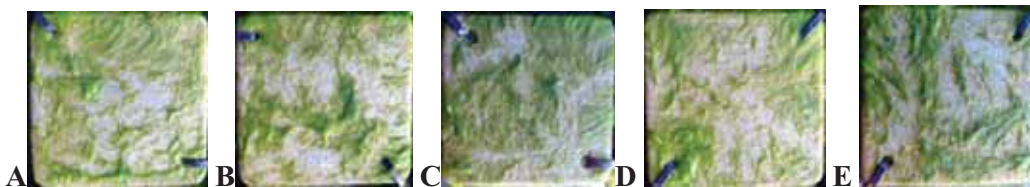
Photo 41 – Malabar Rock Pool

The least fouled block for each coating; Z1A (A), Z1B (B), Z2A (C), Z2B (D) and a control block (E) after 3 weeks

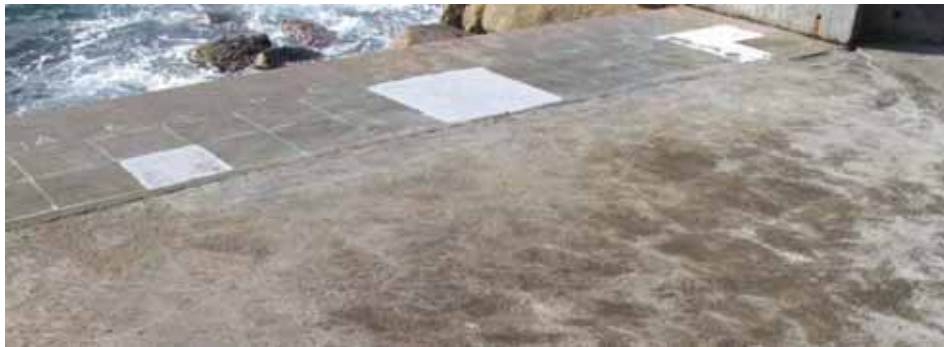
Photo 44 – Clovelly Promenade

The direct application experiment after 12 weeks. Area is low foul area compared to surrounds (foreground).

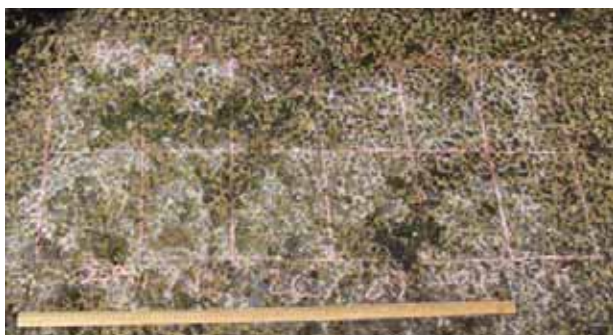
Photo 45 – Malabar Boat Ramp

Direct application experiment testing coatings from BASF

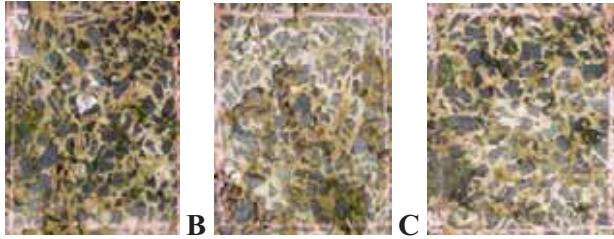
Representative test squares at 3 weeks, Z1 (A), Z2 (B) and control (C), showing no difference between test squares (A, B) and control squares (C)

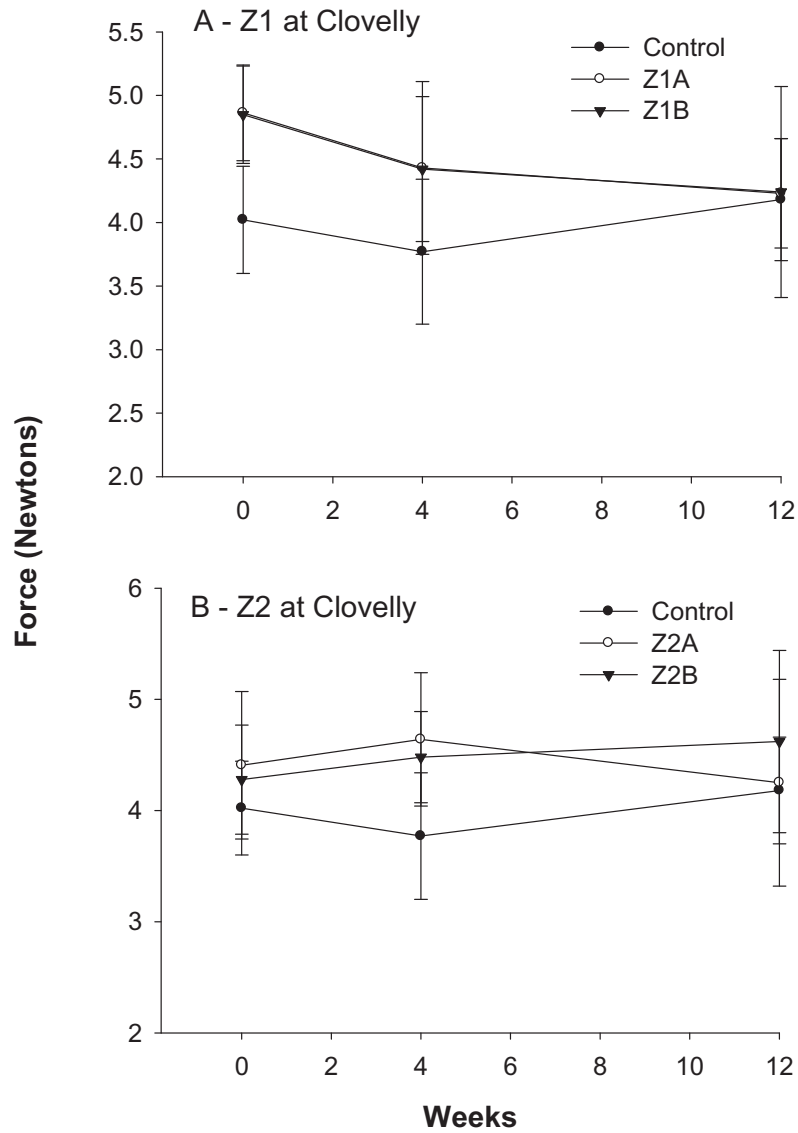
Figure 5A-B – ‘Slip test’ data for Z1 (A) and Z2 blocks (B) from Clovelly experiments based on force gauge readings (lower force readings indicate increased ‘slippery-ness’).

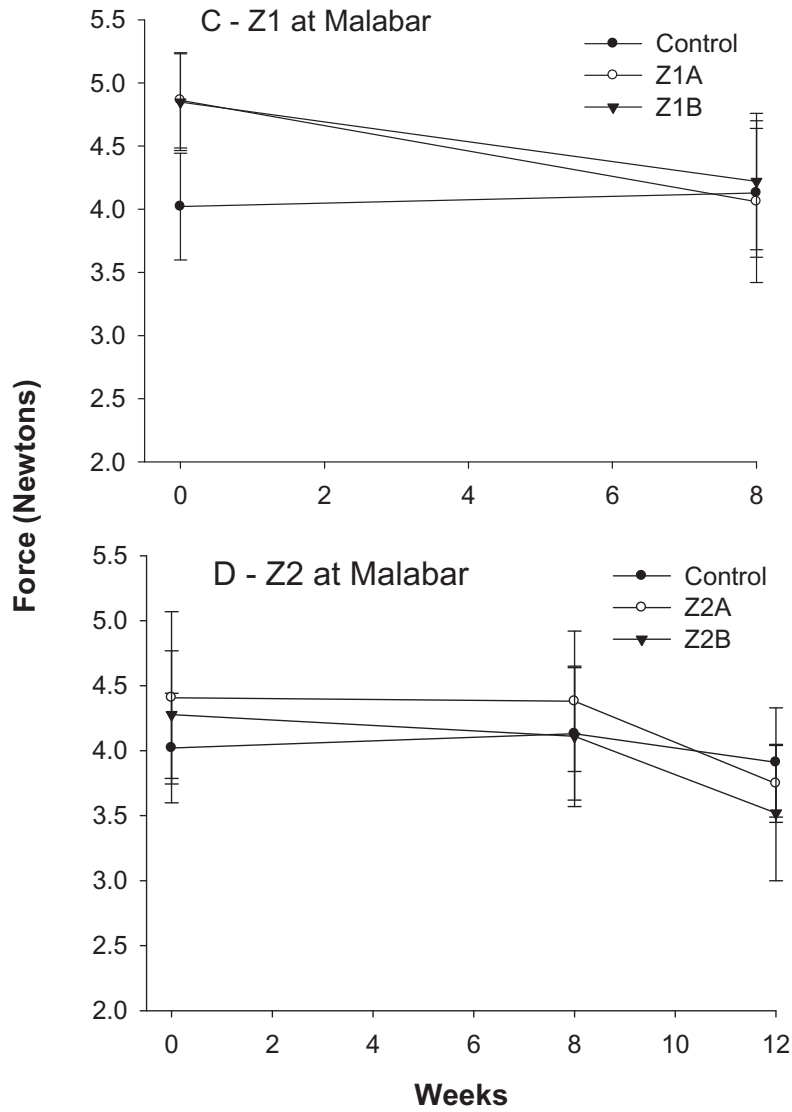
Figure 5C-D – ‘Slip test’ data for Z1 (C) and Z2 blocks (D) from Malabar experiments based on force gauge readings (lower force readings indicate increased ‘slippery-ness’).

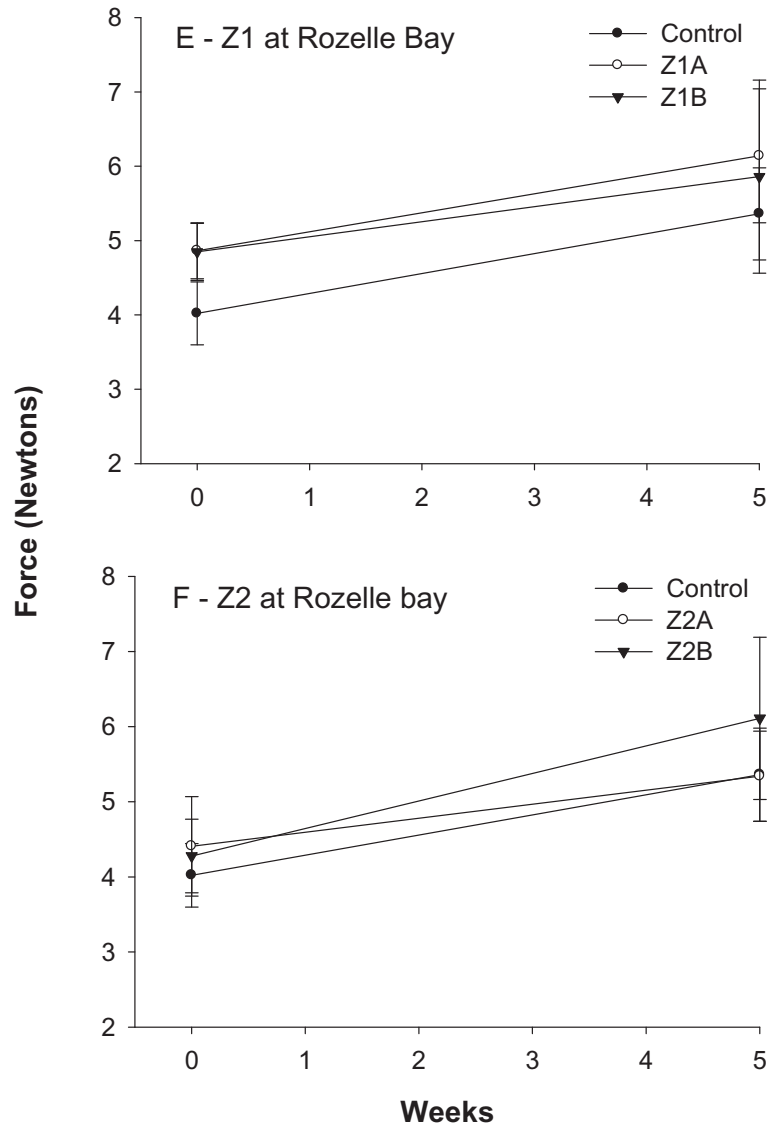
Figure 5E-F – ‘Slip test’ data for Z1 (A) and Z2 blocks (B) from Rozelle Bay experiments based on force gauge readings (lower force readings indicate increased ‘slippery-ness’).
