# Assessment and Decision Frameworks for Seawall Structures

Appendix  
B

## Geotechnical Considerations

This Appendix was prepared by Worley Parsons in conjunction with Pells Sullivan Meynink for this Report titled *Assessment and Decision Frameworks for Seawall Structures*. The purpose of the information in this Appendix was to provide an overview of seawall performance and likely modes of geotechnical failure, particularly under a changing climate. The focus is on small structures and addresses specific questions from a geotechnical engineering viewpoint. The authors of the Appendix were A.F. Nielsen and A. Salim. It has not been published elsewhere.

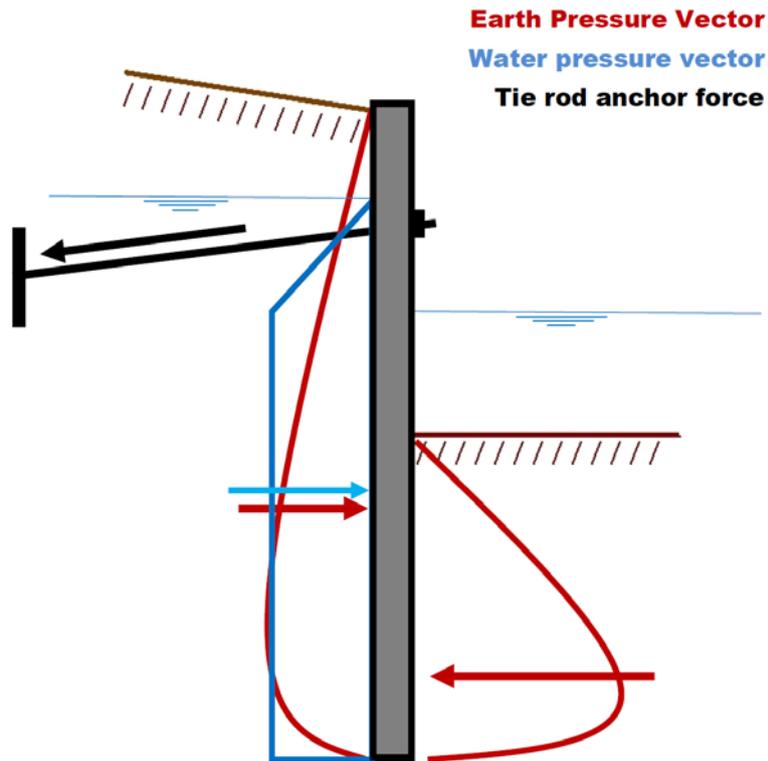
The loading on an anchored bulkhead wall is depicted on the schema in Figure 1.

Figure 1 Earth pressure and hydrostatic loading schema for an anchored bulkhead

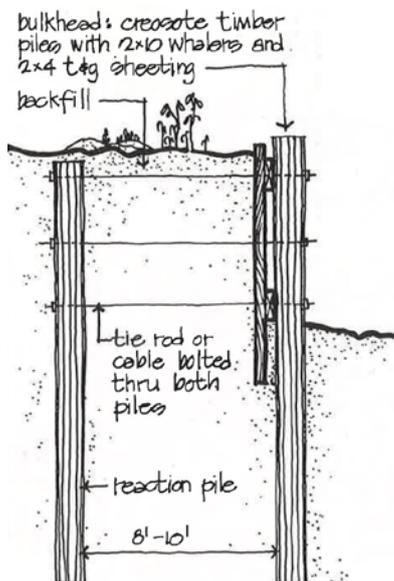
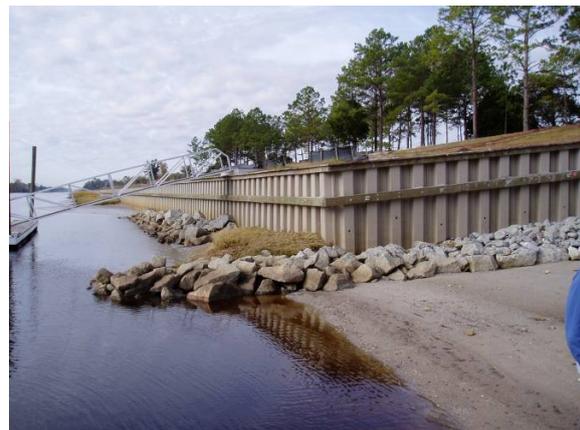
Anchored bulkheads are used in ports where, commonly, they comprise heavy steel sections. However, much lighter steel, timber, vinyl and fibre reinforced plastic sections are found often around estuary foreshores. This type of wall can be used in newly reclaimed land or open areas where the installation of tie rods is not limited by site constraints.

Figure 2 Anchored bulkhead wall

Left: Sand-fill anchored timber bulkhead wall schema (source: Dames & Moore 1980)

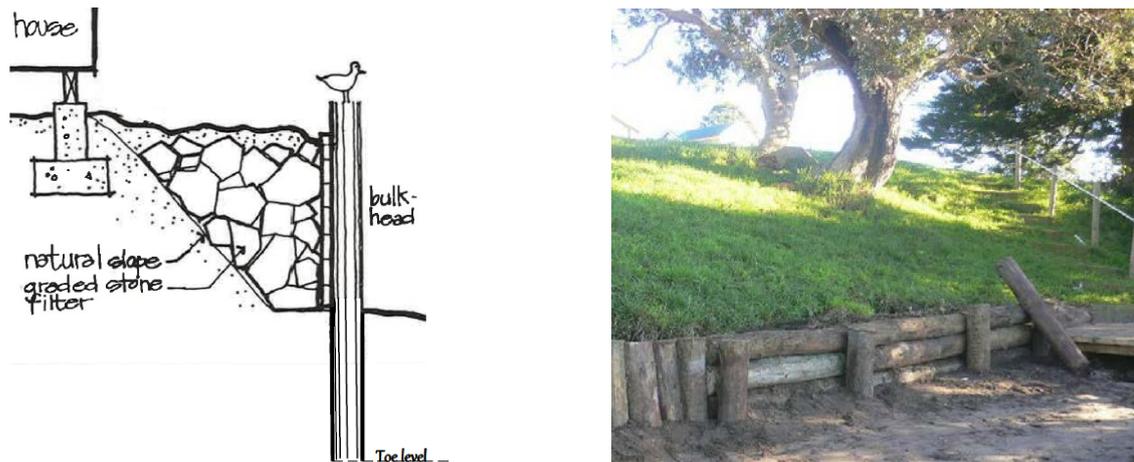
Where the retained height is small, bulkhead walls can be free standing without anchoring tiebacks. Free-standing bulkhead walls are used also in areas restricted by landward constraints, such as trees. In areas with geotechnical constraints such as soft soils, bulkhead walls can gain support by deeper toe penetration rather than significant increase in width and footprint. Ideally, the backfill comprises free draining material such as rock-fill. If the backfill is sand or soil then care must be taken to ensure that there is no leakage of the backfill through the interstices of the wall structure, which could result in the loss of the retained material and the formation of dangerous sinkholes behind the wall.

**Figure 3 Free-standing bulkhead wall**

Left: Free-standing rock-fill timber bulkhead wall schema (source: Dames & Moore 1980)  
 Right: Free-standing timber Log bulkhead wall (Source: Deborah Lam)

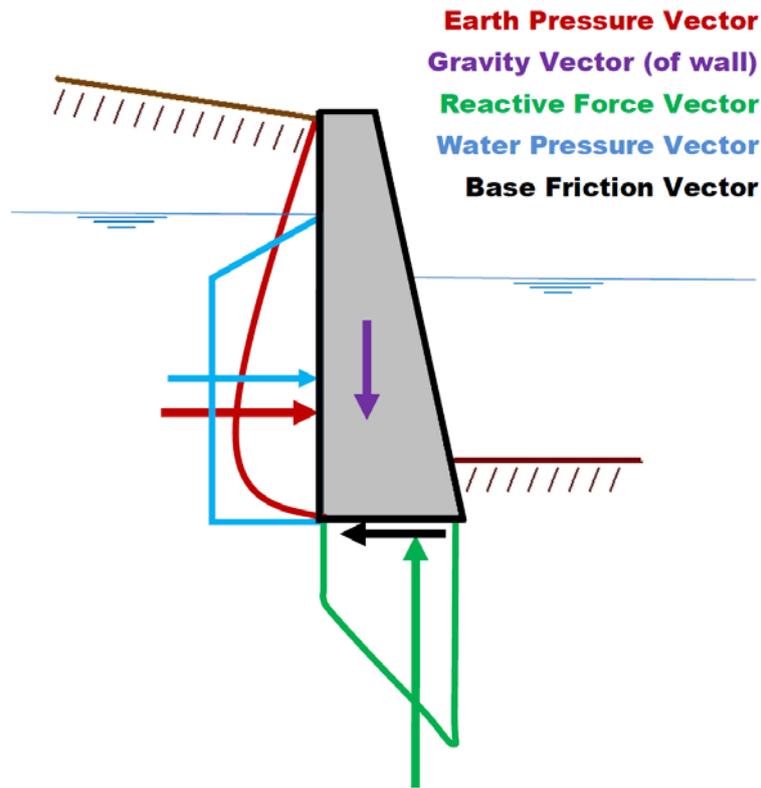
The loading on a gravity wall is depicted on the schema in Figure 4.

Figure 4 Earth pressure and hydrostatic loading schema for a gravity wall

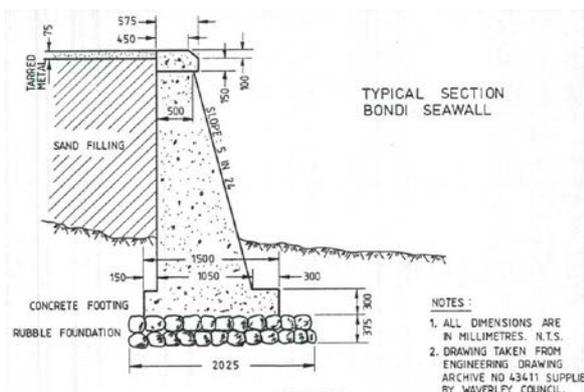
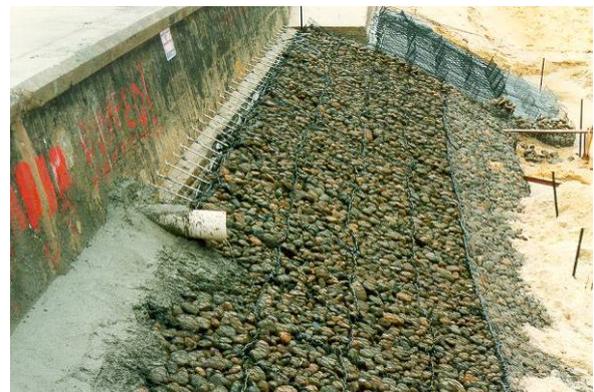
Figure 5 Mass gravity seawall

Left: Reproduction of Historical Design Drawings of Bondi and Bronte Seawalls (Source: PWD, 1988)  
 Right: Bondi seawall with Reno-mat toe protection being installed (Source: Lex Nielsen)

Flexible sloping rock mattress revetments consist of woven mesh units that are connected together and filled with rock. They are used, commonly, in the rehabilitation and protection of riverine environments and have been used also in beachfront environments, for example, at Bondi (see Figure 5) and Wollongong (Figure 13). The wire fabric is susceptible to damage, vandalism and corrosion.

- constructing 'falling toe' scour blankets for mass gravity seawalls, such as shown in Figure 5 (right)
- extending toe protection for flexible revetments by increasing the extent and mass of the toe armour
- increasing armour size on flexible sloping revetments by placing an additional layer of larger units, building upon what is there already
- increasing revetment crest levels by placing armour on top or by constructing a wave deflector wall.

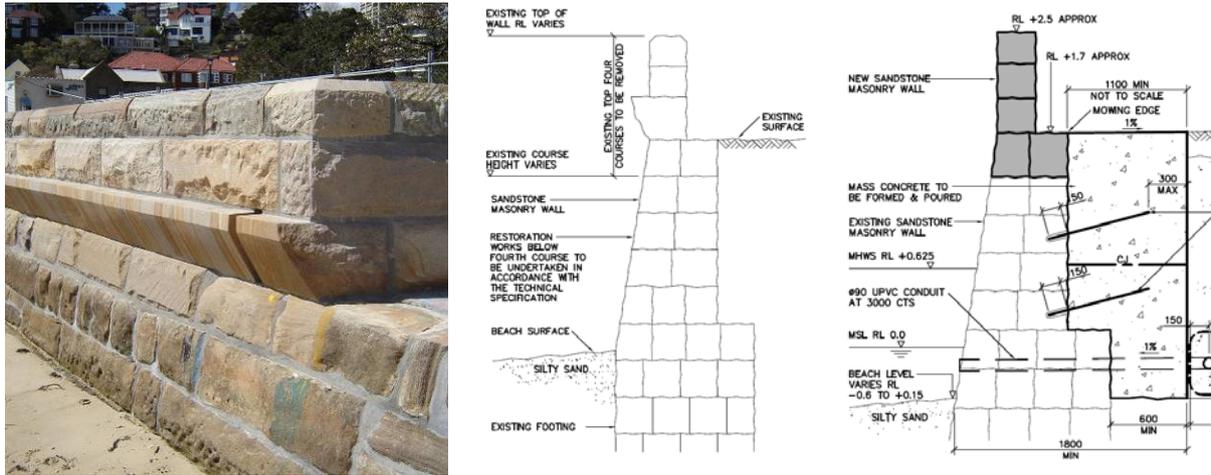
**Figure 6 Blockwork gravity seawall**

Left: Sandstone blockwork seawall; Centre: Original design; Right: Remedial design (Source Woollahra Council)

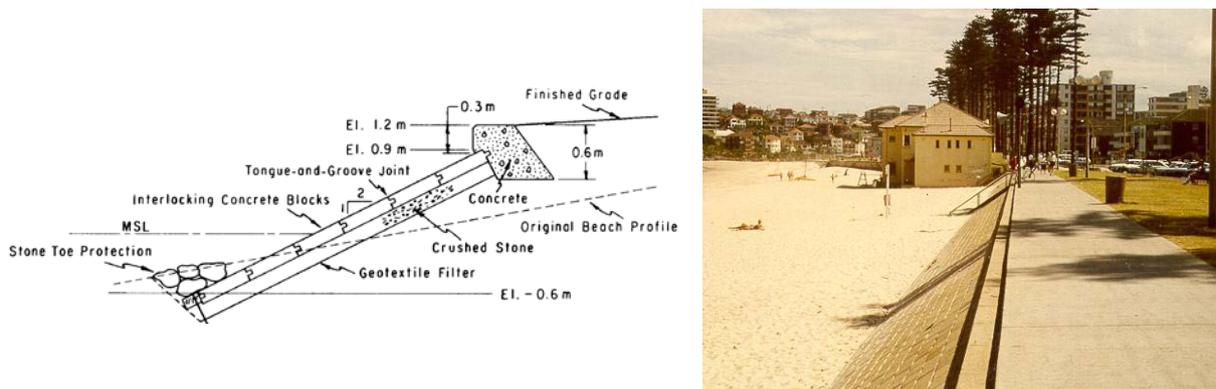
Rigid sloping revetments are popular on promenades, especially where there is very heavy pedestrian traffic, such as on main tourist beaches. The facing can be a concrete slab or interlocked bricks, concrete or rock blocks. These revetments have the advantage of being relatively thin, comprising components that can be transported readily to site. Stairs can be incorporated into sloping revetments with minimal protrusion seaward and landward of the revetment, allowing unobstructed access along pathways and foreshore. However, generally they are unable to accommodate settlement or adjustment of the underlying materials.

**Figure 7 Rigid sloping revetment**

Left: Typical design for an interlocking concrete slab revetment (source: USACE 2011); Right: Promenade and seawall

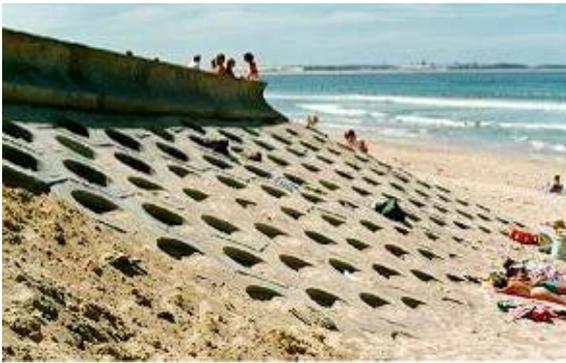
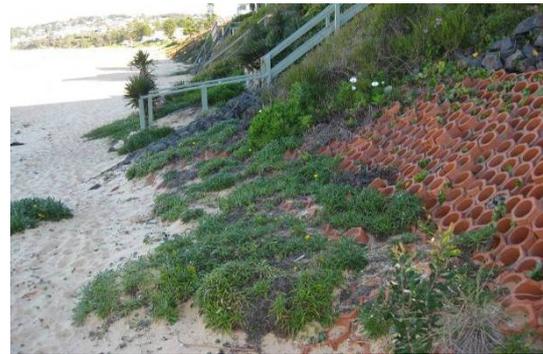
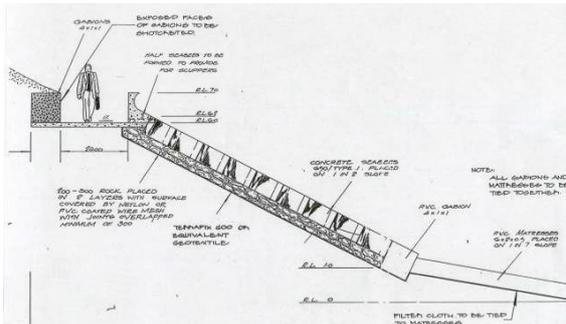
Sloping revetments can be classified also as semi-rigid where they comprise units that can tolerate some movement or displacement without total collapse. Pattern-placed unit revetment can dissipate wave energy at the back of beaches and along the foreshore. Pattern-placed units, such as Seabees (Figure 8), can be more stable than randomly placed units, such as rock or concrete cubes, which can result in the use of lighter individual units and, hence, smaller volumes. These revetments can be useful where site constraints limit the use of randomly placed units or where architectural preference is for a regular smooth finished appearance. The size of the armour unit depends on the adopted design conditions and smaller scale versions of the Seabee revetment can be found in front of residential development (Figure 8 right).

Top left: Seabee seawall Prince Street Cronulla

Top right: Small scale Seabee revetment on Wamberal Beach in the Gosford Shire (source: Lex Nielsen)

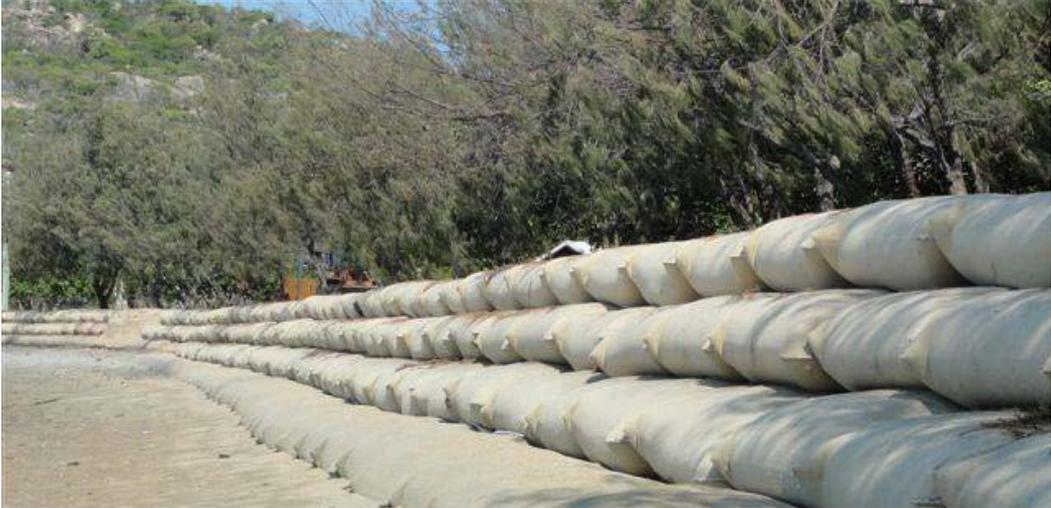
Flexible near-vertical mass gravity structures can comprise various materials including sandbags, rock boulders and gabion units. These near-vertical mass gravity structures have a smaller footprint than sloping structures and can be effective in reducing the encroachment of a seawall structure into a waterway, particularly in low wave energy environments.

**Figure 9 Sandbag gravity seawall**  
(source: Geofabrics Australasia)

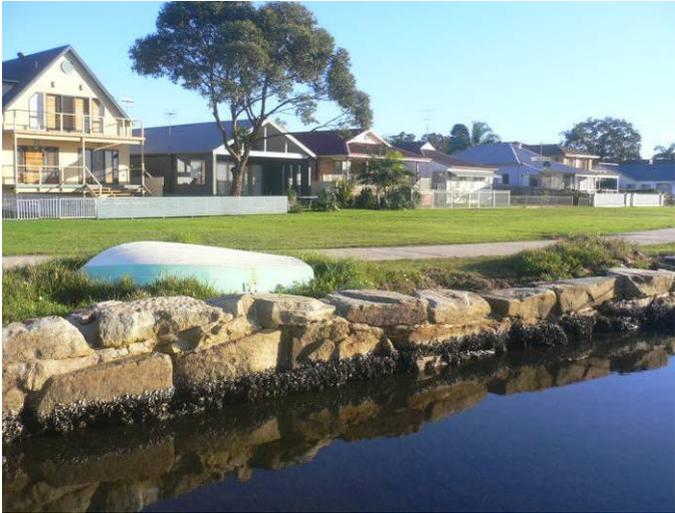
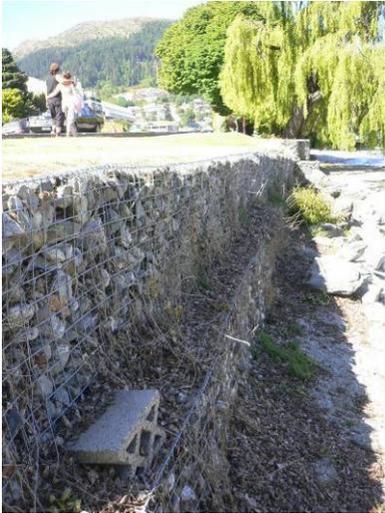
**Figure 10 Flexible near-vertical mass gravity seawall**  
Left: Rock boulder gravity seawall; Right: Gabion gravity seawall (Source: Deborah Lam)

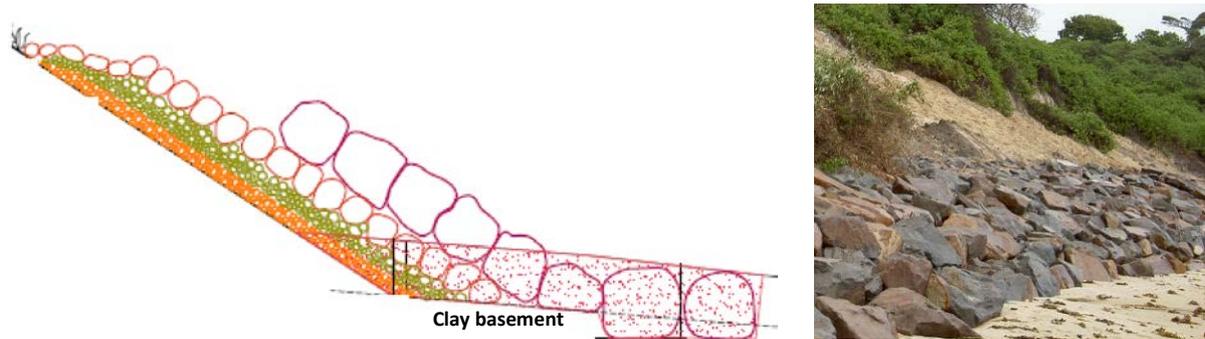
Flexible sloping rock rubble revetments can be designed for a variety of coastal environments from low to high wave energy. Rock rubble revetments can comprise armour layers, underlayers, filter layers (including geotextiles) and a core. The design of rock rubble revetments will be controlled by the size, shape and quality of rock available from nearby quarries. Flexible revetments often can tolerate a significant degree of displacement and shifting. Typically, the design conditions permit the movement of some 10% of the armour units and 2% damage during the design event.

**Figure 11 Rock rubble revetment**

Left: idealised design section (Source Wyong Shire Council); Right: As built (Source Lex Nielsen)

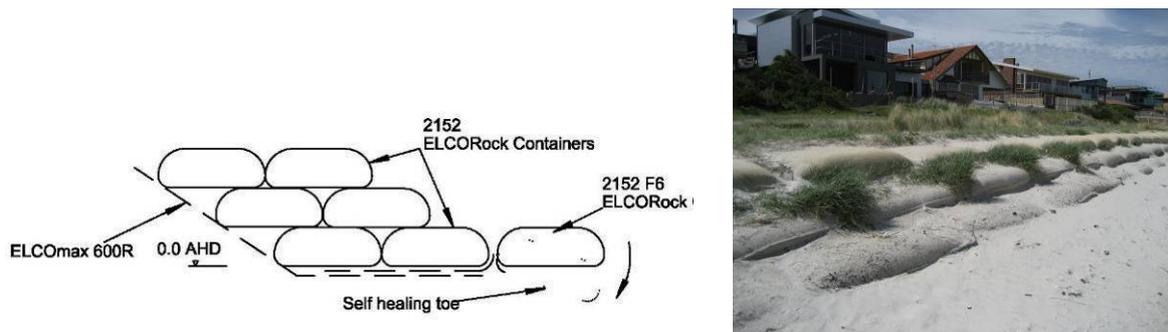
Sloping sandbag revetments are being used increasingly for revetments on beachfronts. It is a developing technology and guidelines for their design and construction are provided by the geotextile manufacturers. Generally, the service life of sandbag revetments is limited as they are prone to damage by vandalism.

**Figure 12 Sandbag revetment**

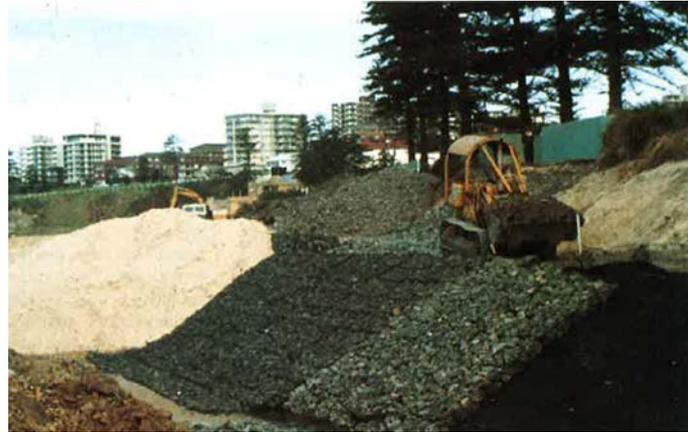
**Figure 13 Sloping Reno-mattress dune revetment under construction**

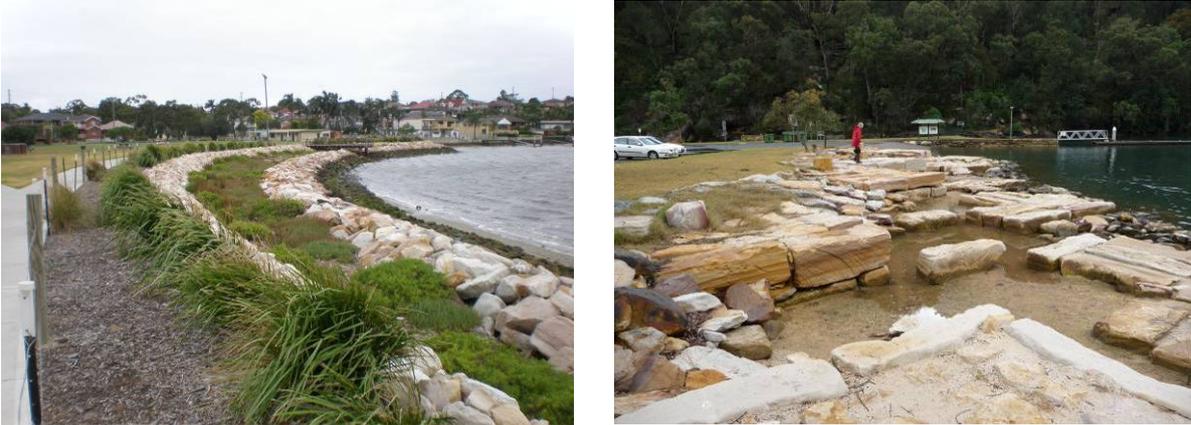
- cavities or pools that retain water
- no cement between blocks to provide crevices
- using rough or textural surfaces
- addition of boulders at the toe.

**Figure 14 Environmentally friendly seawalls**

Left: Step-type seawall with saltmarsh; Right: Estuary bank protection (Source WorleyParsons)

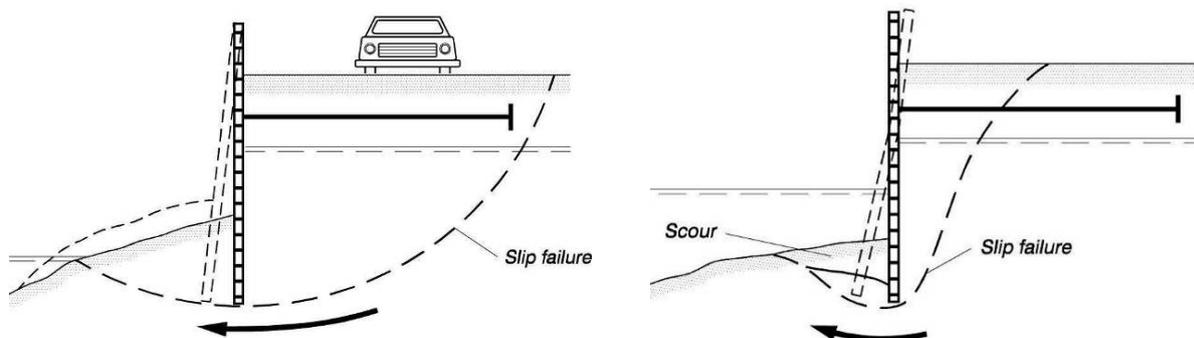
Rotational slip failure occurs when the disturbing forces of the soil pressure, groundwater pressure and pressures induced by surface loads exceed the resisting shear stresses in the soil mass. This may occur when the surface loads are increased beyond those for which the structure was designed, such as by increasing the development on a lot (adding a dwelling, putting on a second storey or a swimming pool, adding fill to increase ground levels), when an earth tremor causes liquefaction of the soil mass, thereby reducing the shear strength of the soil, or when toe scour occurs, reducing the resisting passive pressure from the soil in front of the wall. This may cause subsequent rotation of the wall or 'kick out' at the toe.

**Figure 15 Rotational slip failure of an anchored bulkhead due to increased live load (left) and toe scour (right)**

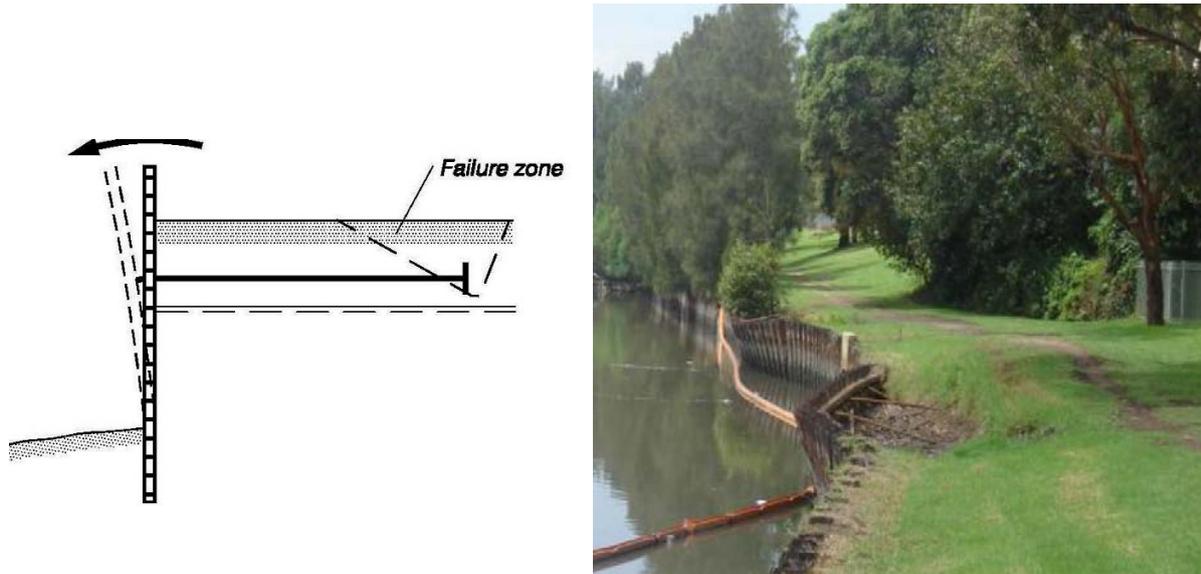
Excess loads from increasing the active soil pressure by developing behind the wall, from increasing groundwater pressure due to poor drainage or wave overtopping, or as a result of an under-designed anchor could lead to anchor pull-out and wall collapse (Figure 16).

**Figure 16 Wall failure by anchor pull-out or tie rod failure**

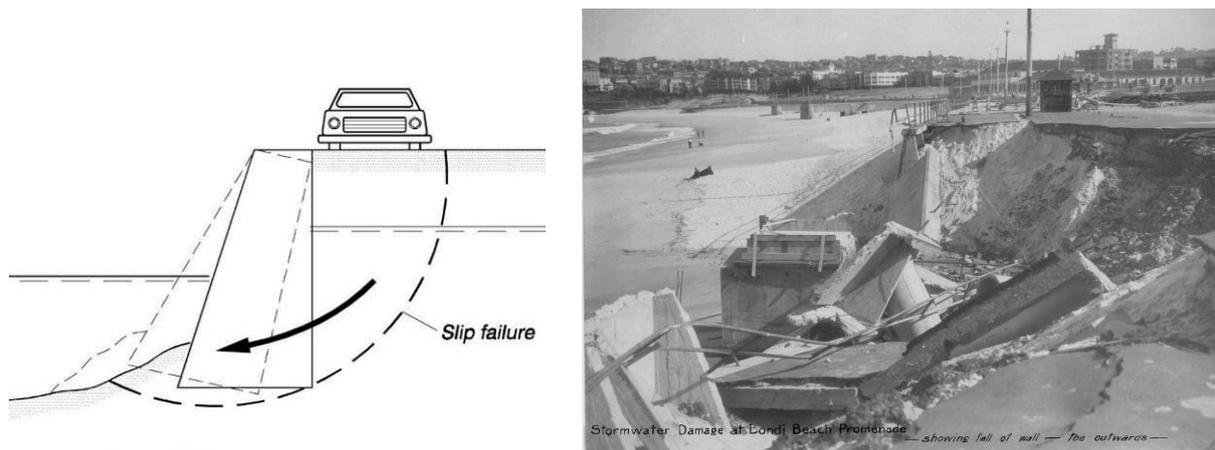
As with anchored bulkheads, gravity seawalls can experience rotational slip failure. This can occur if the disturbing forces are increased, say, by development behind the wall, rises in groundwater levels or the resisting forces are reduced, say, as a result of toe scour. As illustrated in Figure 17, the counterfort seawall at North Bondi Beach failed with the toe moving outwards following scour of the beach sand in front of it.

**Figure 17 Rotation slip failure of counterfort gravity seawall resulting from toe erosion**

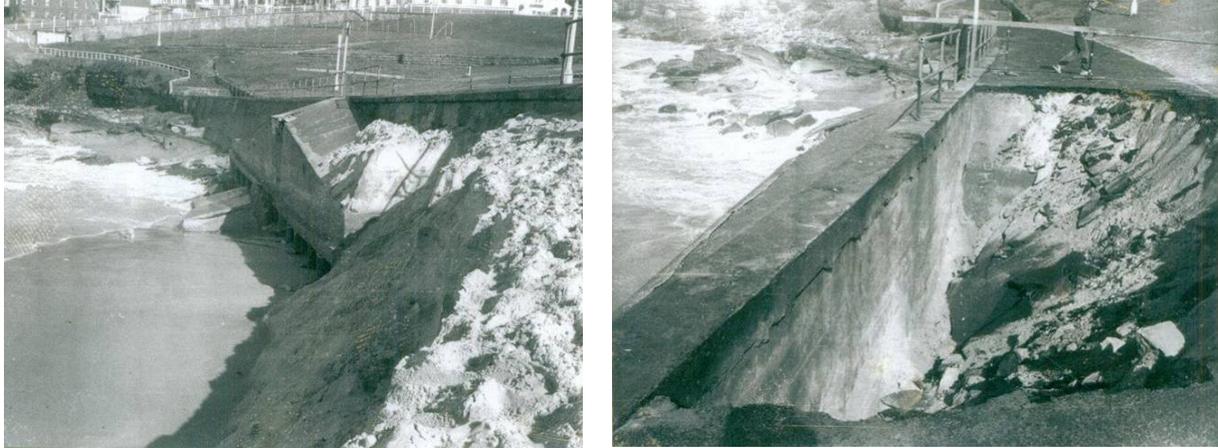
Some seawalls may not collapse when the sand in front of the footing is scoured and the footing undermined. However, this can result in the loss of backfill, as shown in Figure 18.

**Figure 18 Loss of backfill of mass gravity seawall at South Bondi Beach 13 June 1974 as a result of toe scour and undermining of the footing**

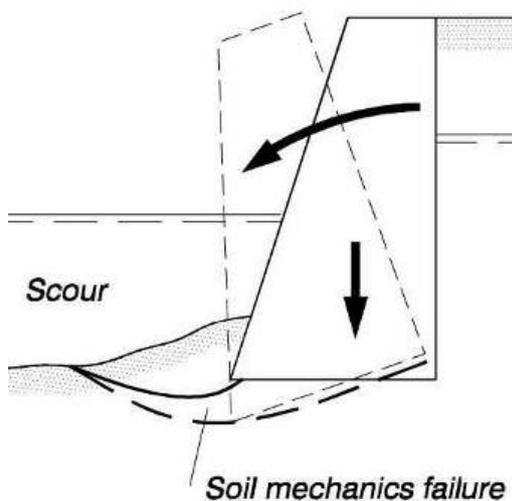
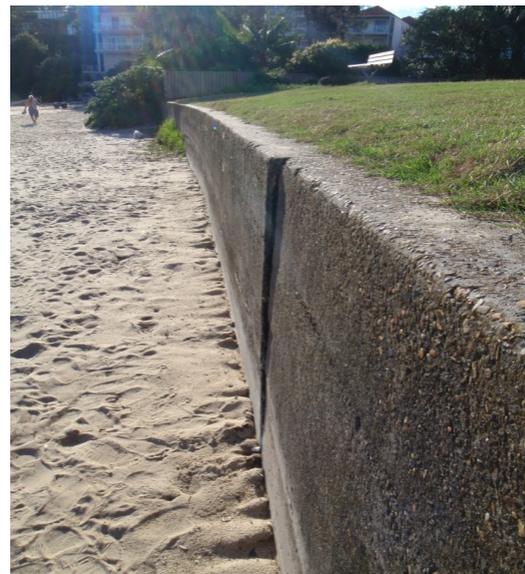
In mass gravity structures, toe bearing failure can occur when foundation load exceeds the bearing capacity of the soil (Figure 19). Excessive settlement and overturning can occur where there is insufficient drainage, noting that hydrostatic pressure typically is some five times greater than soil pressure, or where there is toe scour, which can undermine the wall or reduce the bearing capacity due to loss of overburden pressure.

**Figure 19 Toe bearing failure schema and plate showing incipient failure**

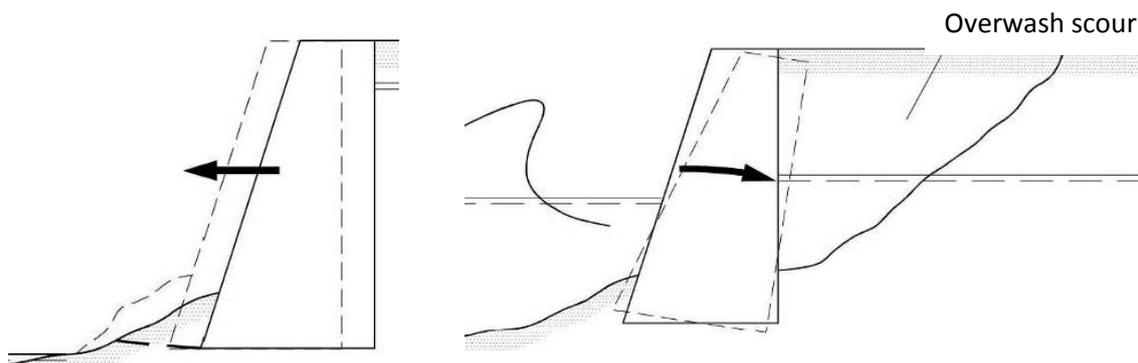
- sliding of a gravity wall - when the resulting pressure on the rear of the wall from active soil pressure and groundwater exceeds the sum of the frictional resistance over the base of the wall and the passive resistance at the toe, which may be lost due to toe scour.
- overwash scour - heavy overtopping can cause rear side scour and, thereby, the loss of passive resistance from the backfill. With the wave loads on the front, this could cause a landward overturning of the wall. This could occur with toe scour, as bearing capacity reduces with reducing overburden pressure.

**Figure 20 Sliding and overturning failure modes of mass gravity seawalls**

Left: Sliding; Right: Overturning (source: USACE 2011)

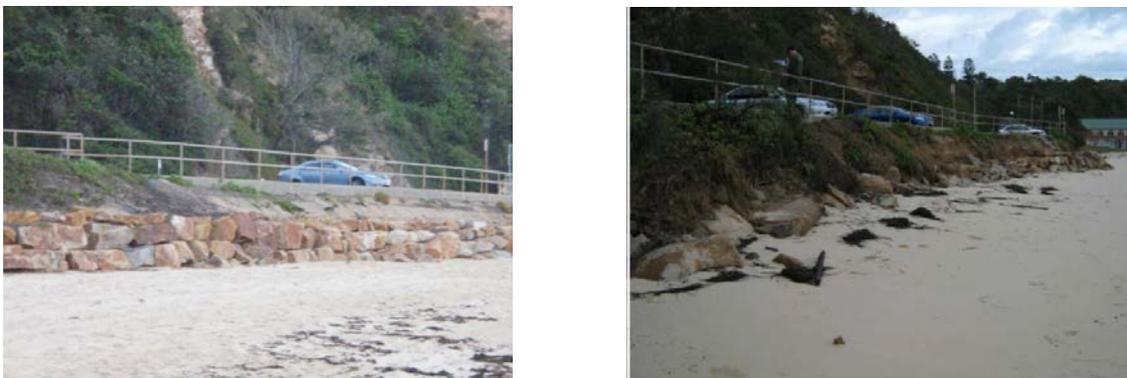
The failure modes of this type of seawall are similar to those for rigid mass gravity seawalls (rotational slip failure, backfill wash-out, sliding, bearing and overturning) with an additional component being the dislodgement of individual or a number of blocks. As each wall element may move independently, wave loads may dislodge the wall elements out of position, especially when rear side scour occurs during heavy over-wash (Figure 21). A further failure mode is the wash out of backfill material through the wall should there be inadequate filtering between the soil backfill and the blockwork.

**Figure 21 Blockwork gravity wall failure**

Left: Blockwork Gravity Wall (source Chris Adamantidis);

Right: Blockwork Gravity wall failure due to wave overtopping (source Chris Adamantidis)

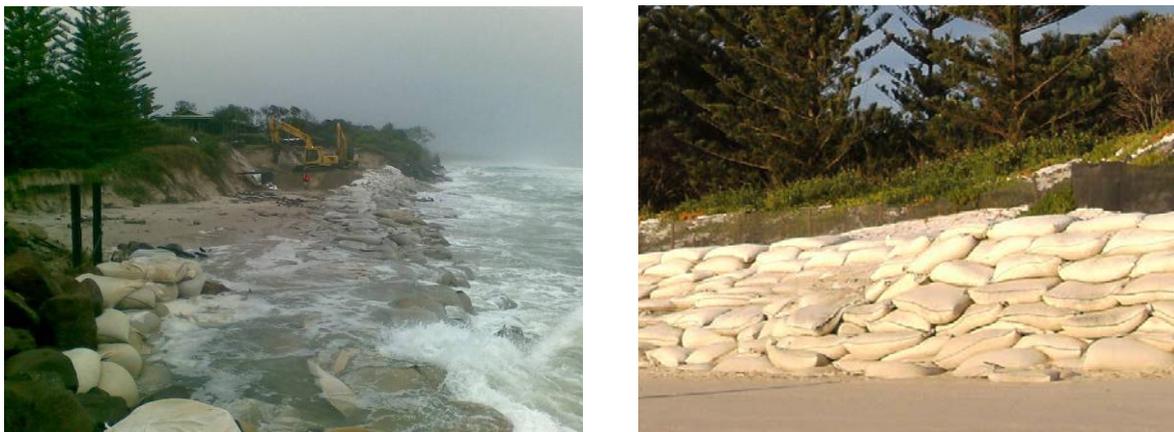
Other geotechnical failure modes of sandbag revetments include bag pullout and drag down resulting from wave overtopping and collapse as a result of poor friction at the geotextile interface.

**Figure 22 Sandbag seawall failures**

Left: Pull-out of sand bags due to wave overtopping (source: Ben Fitzgibbon, Byron Shire Council)

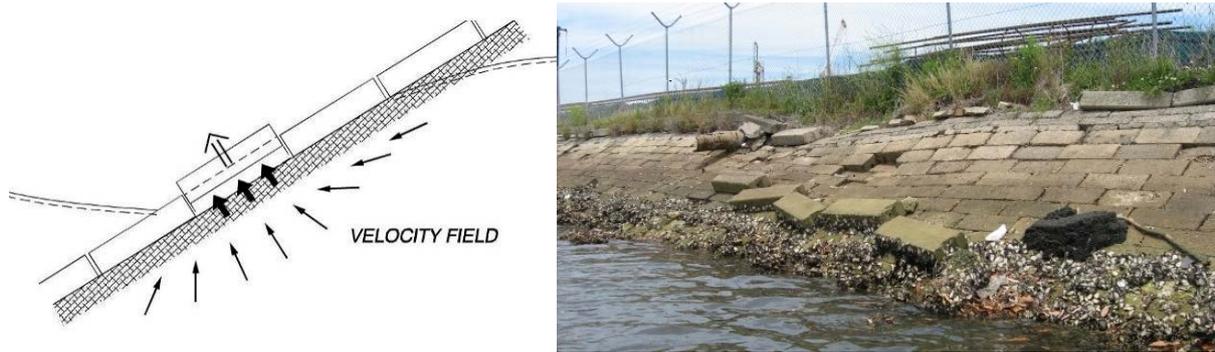
Push-out of slab elements can occur due to uplift pressures resulting from inadequate drainage. Slab elements could be pushed out when the resultant pressure forces exceed the resultant gravity and friction forces. Subsidence can occur when the substratum is incompetent, which can occur due to lack of consolidation prior to construction or as a result of high pore water pressures.

**Figure 23 Rigid sloping revetment push-out and subsidence failure modes**

Left: Push out schema for sloping slab revetments (source: USACE 2011)  
 Right: Subsidence due to incompetent substrata (source: Tom Pinzone)

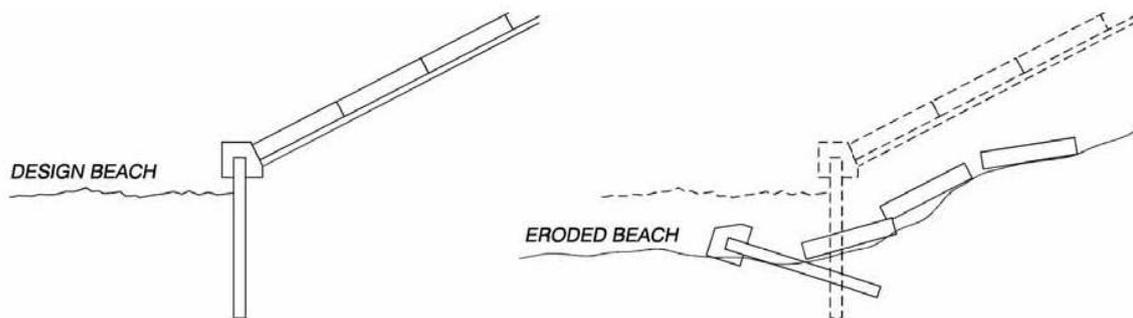
Some sloping revetments comprise a sheet pile toe wall which can fail during toe erosion or lowering of beach level.

**Figure 24 Rigid sloping revetment toe erosion failure schema**

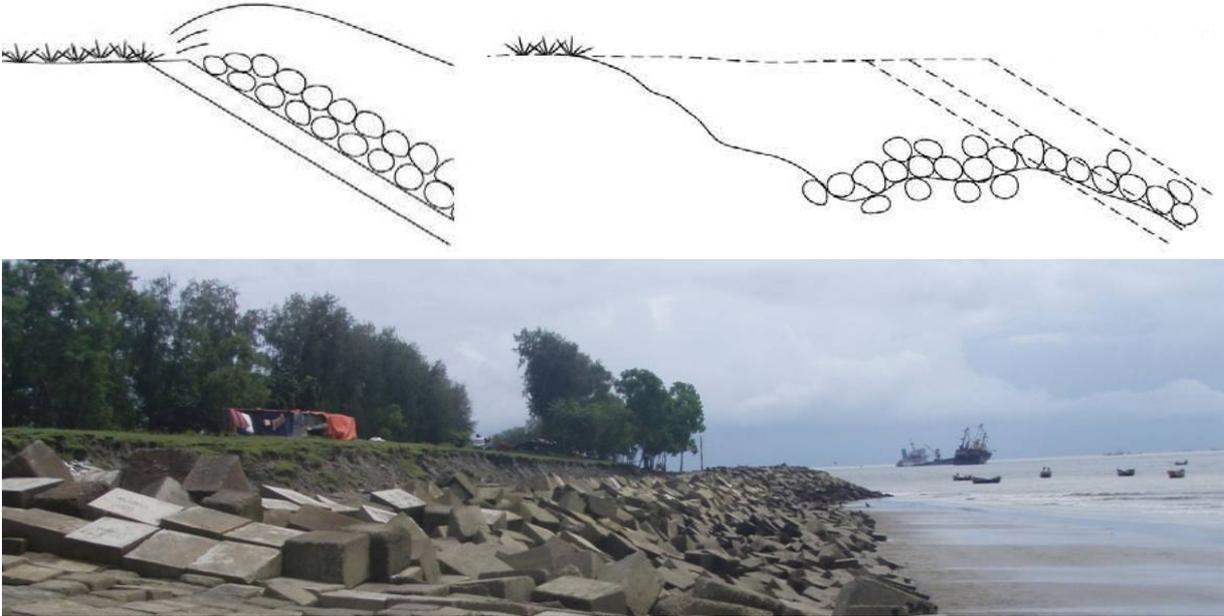
Excess overtopping could cause erosion and subsequent collapse of top of seawall structure (Figure 25).

**Figure 25 Concrete blockwork revetment failure due to wave overtopping**

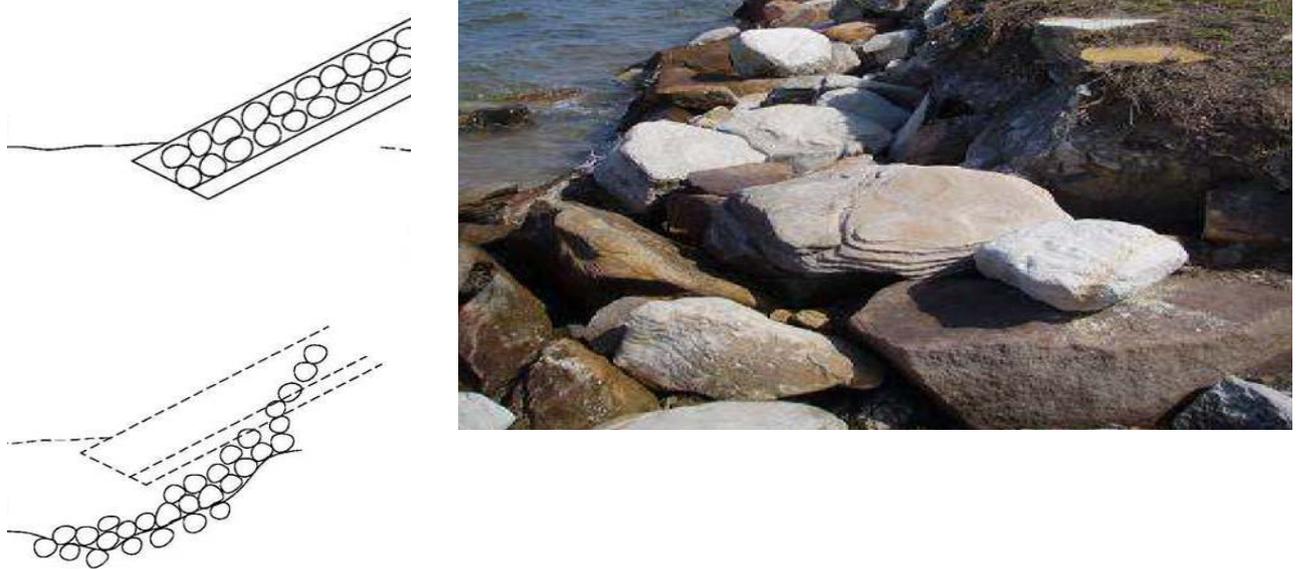
Lowering of the beach level below the design toe level of the structure could cause subsequent undermining. This can result in subsidence of the toe and/or dislodgement of the armour units.

**Figure 26 Toe erosion causing subsidence of a boulder wall**

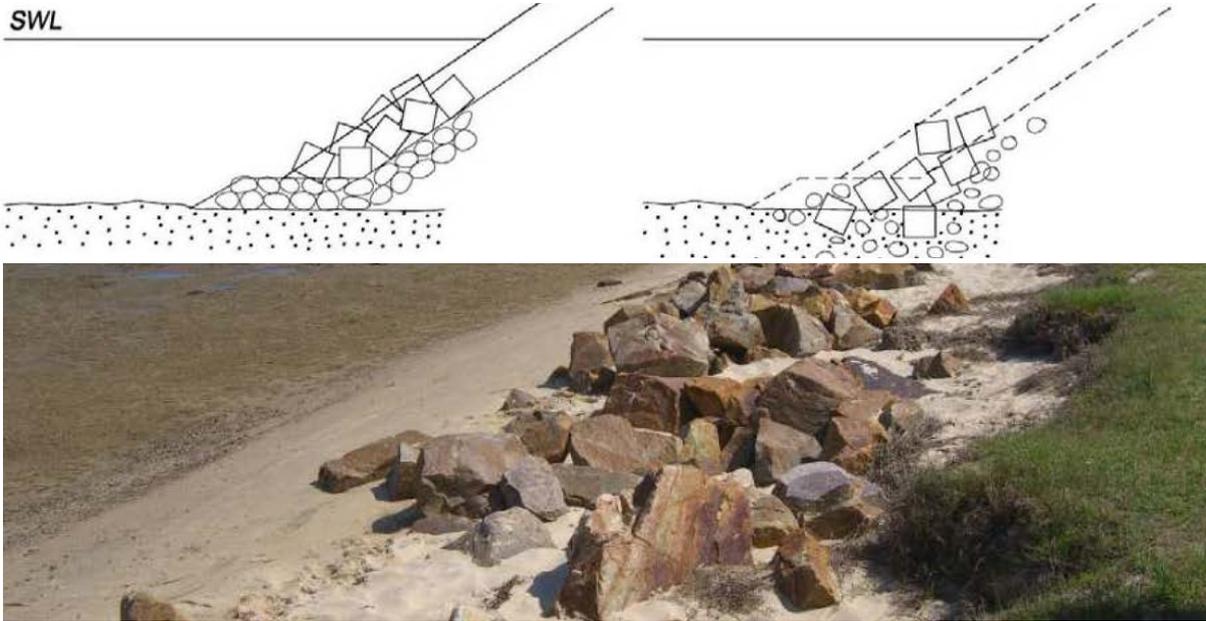
Underlayer rock and armour units may sink into the seabed if the filter layers are inadequate or if the bearing capacity of the seabed material is reduced, which can occur under elevated wave-induced pore water pressures during storms. This could also cause sliding of the main armour.

**Figure 27 Subsidence of Rock Armour into sand due to inadequate underlayer filtering**
